OIL PRESSURE SENSOR REPLACEMENT Prevost vehicles

Special Bulletin

SP14-300B

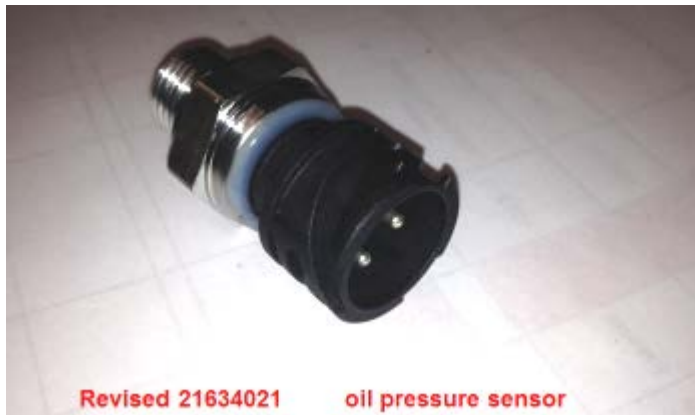
- 7) Unscrew the sensor from the engine block.
- 8) Inspect the engine harness for oil contamination. If a sensor is being replaced for electrical faults and oil has NOT wicked into the harness, **REPLACE THE SENSOR ONLY.** (p/n 21634021)
- a. Install the new pressure sensor (p/n 21634021). Torque: 18.5 ± 2 ft-lb.
 - b. Reinstall the connector and rotate clockwise to lock.
- 9) If a sensor has failed AND is wicking oil into the engine harness, **REPLACE THE SENSOR AND INSTALL THE JUMPER HARNESS** p/n 22205127.
- a. Clip applicable cable ties and remove P-clamps securing the oil pressure sensor harness.

- b. Disconnect the oil pressure sensor harness from the sensor.
 - c. Install the new pressure sensor (p/n 21634021). Torque: 18.5 ± 2 ft-lb.
 - d. Reverse the back shells on the jumper harness connectors before installing the jumper harness.
 - e. Clean out the electrical connector pins and sensor mounting surface with contact cleaner. Connect the 90 degree end of the jumper harness to the oil pressure sensor and the straight end to the harness. Install cable ties and P-clamps as necessary.
 - f. If oil has wicked to the engine control module connectors, clean the connectors thoroughly with electronic cleaner and dry with compressed air.
- 10) Run the engine and check for leaks.
- 11) Use Tech tool to clear any diagnostic trouble codes (DTC).
