Technical Bulletin

91 14 09 October 6, 2014 2031136 Supersedes T. B. V911305 dated February 8, 2013 to include a special claiming HST revision number in the warranty table.

Update Programming RCD-510 Radio (Premium 8)

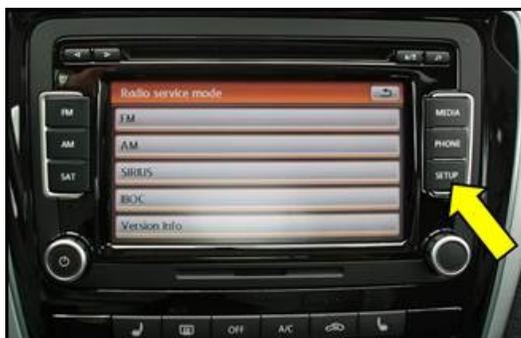
- Switch ignition ON.
- On the radio, hold “setup” button <arrow> for 3 to 5 seconds.
- “Radio service mode” will display <as shown>.

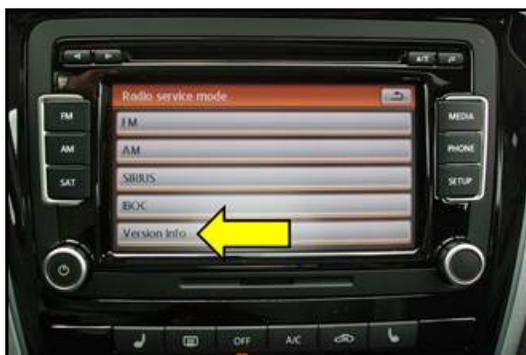
- On screen, press “Version Info” <arrow>.

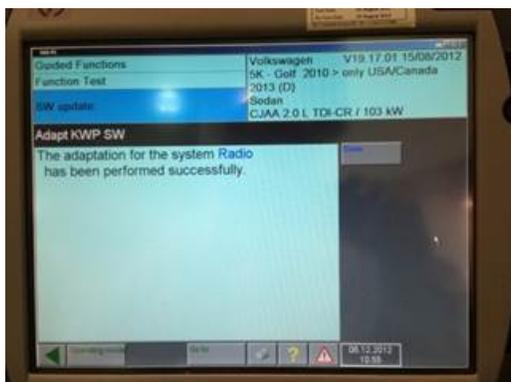
This software update may take up to two hours to complete.

- After the software update is complete the screen should state performed successfully.
- Press the done button.
