Technical News 157
May 2014
Strictly Confidential

Item	Subject	Model Affected
Item 1.	Fork Oil Level	Thunderbird Commander and Thunderbird LT
Item 2.	Service Manual Amendment - Exploded View ABS System	Tiger Sport
Item 3.	Torque Change, Seat Infill Panel Locating Lug Fixings	Tiger Explorer and Tiger Explorer XC
Item 4.	Harness, Gear Position Sensor and Harness/ Gear Position Sensor Parts Kit	Rocket III Roadster
Item 5.	Torque Change, M10 ABS Hard Line Unions	Speed Triple ABS, Speed Triple R ABS and Sprint GT
Item 6.	Front Fork Disassembly and Assembly	Daytona 675 Models from VIN 564948 and Street Triple Models from VIN 560477
Item 7.	New Packing Crate and Footboard Reassembly	America
Item 8.	Main Frame Parts Kit	Daytona 675 Models from VIN 564948 and Street Triple Models from VIN 560477
Item 9.	Torque Change, Clutch Cover Fixings	Daytona 675 and Daytona 675R from VIN 564948
Item 10.	ABS Front Brake Line	Tiger Sport, Tiger 1050 ABS

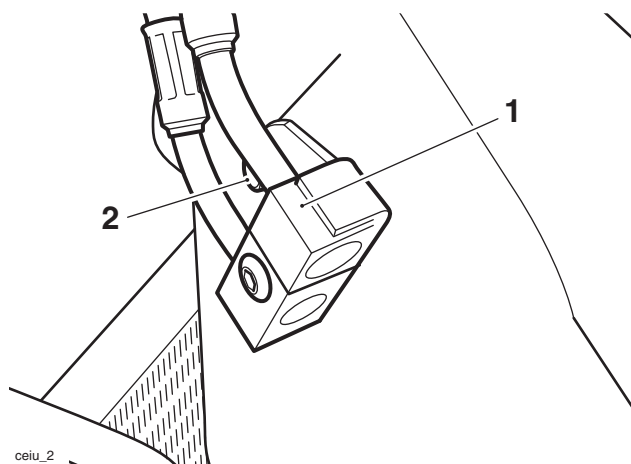
The new condition front brake line connector housing has a larger threaded hole for the hard line M12 union.

- Fit the new front brake line connector housing to the frame routing the front caliper hose and front brake master cylinder hose as noted for removal. Tighten the fixing to **3 Nm**.

- Front brake line connector housing**
- Fixing**

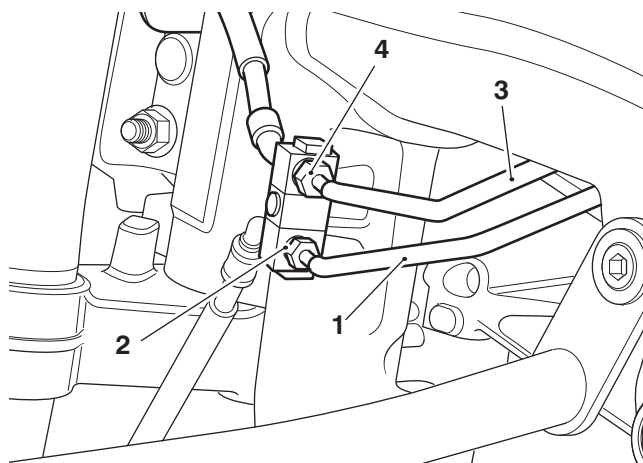
The new condition hard line has a M12 union for the front brake line connector housing; the union for the ABS modulator end remains the same at M10.

- Connect the brake hose to the front caliper, incorporating new sealing washers on each side of all hose connections.
- Tighten the front brake hose union to **25 Nm**.
- Connect the brake hose to the front brake master cylinder, incorporating new sealing washers either side of the hose connection. Tighten the brake hose union to **25 Nm**.
- Ensure the front brake hoses are secured into their clips as noted for removal.
- Connect the front brake caliper hard line to the connector housing and tighten its M10 union to **15 Nm**.
- Connect the front brake master cylinder hard line to the connector block and tighten its M12 union to **19 Nm**.

- Front brake caliper hard line**
- M10 union**
- Front brake master cylinder hard line**
- M12 union**
