## Technical News 158

August 2014

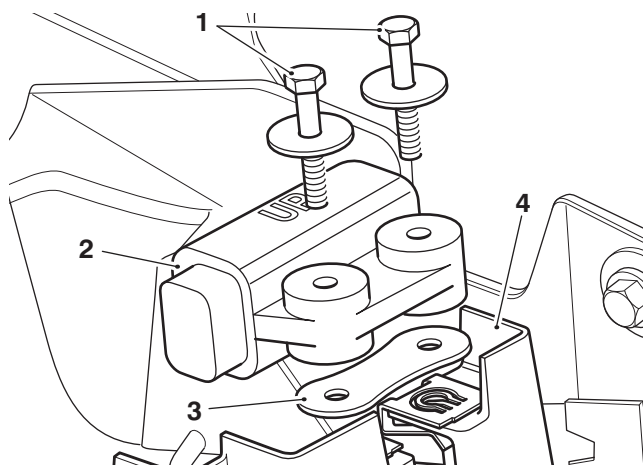
- 1. Fixings
- 2. Fall detection switch
- 3. Retention plate
- 4. Battery tray

The removal and installation of the fall detection switch is as described in the Service Manual noting the addition of the retention plate.

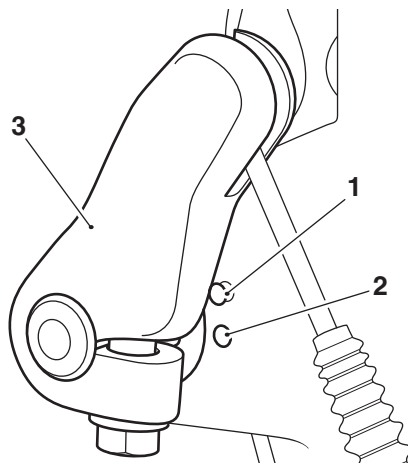
A new clutch cover has been introduced to the above models which has a single dot and two dot alignment marks for the clutch actuation lever. Due to the various finishes of the clutch covers, the new clutch cover has been introduced at various engine numbers with the first at engine number 669585.

- 1. Two dot alignment mark
- 2. Single dot alignment mark
- 3. Clutch actuation lever

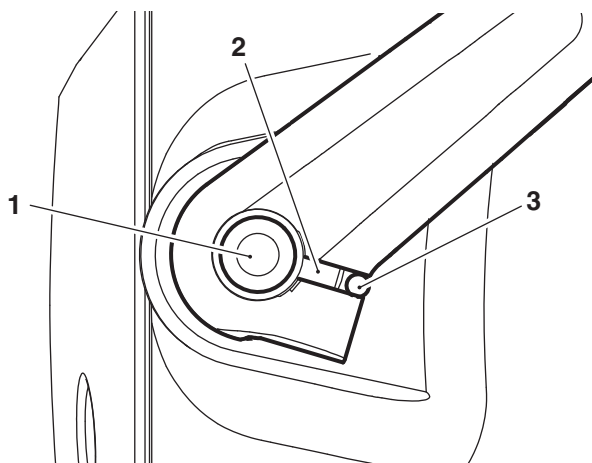
- 1. Clutch shaft
- 2. Split
- 3. Single dot alignment mark

With the clutch cable attached to the actuation lever, rotate the clutch shaft clockwise until the shaft makes contact with the clutch pressure plate bearing. Align the split to the single dot alignment mark and fit the actuation lever to the clutch shaft as described in the Service Manual.

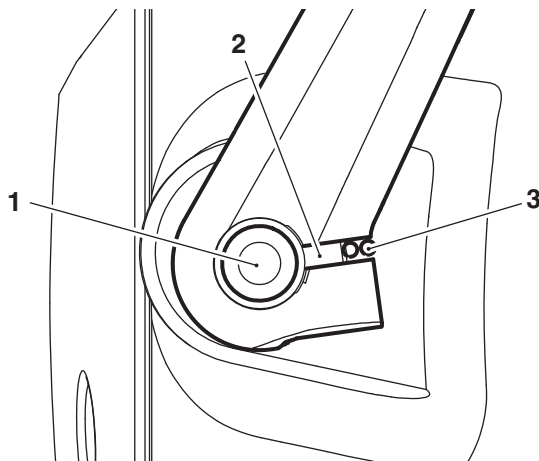
- 1. Clutch shaft
- 2. Split
- 3. Two dot alignment mark

With the clutch cable attached to the actuation lever, rotate the clutch shaft clockwise until the shaft makes contact with the clutch pressure plate bearing. Then align the split line in the clutch actuation lever to the two dot alignment marks on the clutch cover then fit the lever as described in the Service Manual.

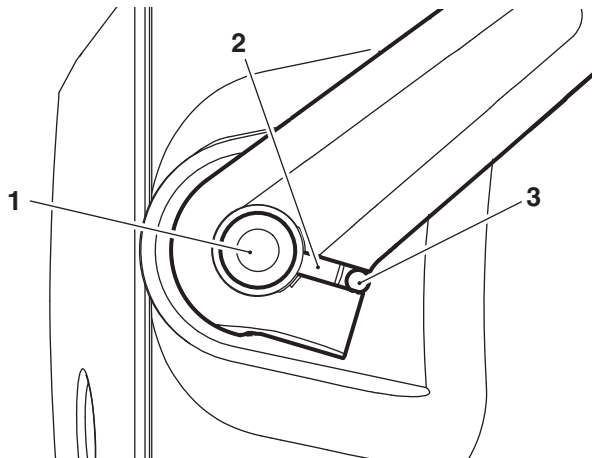
- 1. Clutch shaft
- 2. Split
- 3. Single dot alignment mark

1. Rotate the clutch shaft clockwise until the shaft makes contact with the clutch pressure plate bearing. Then align the split in the clutch actuation lever to the single dot mark on the clutch cover.

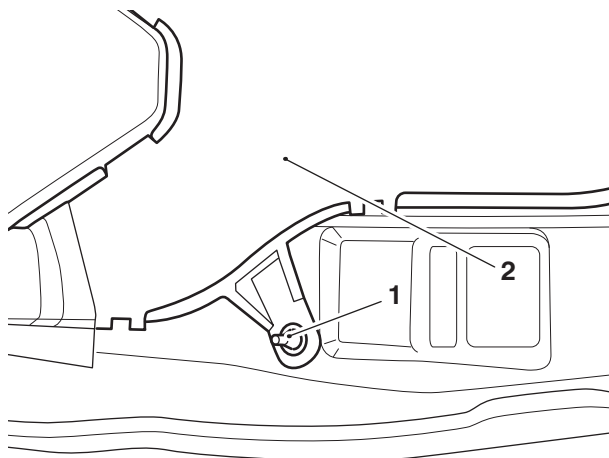
- 1. Scrivet
- 2. Conduit

The new conduit is held in position by the two scrivets that secure the front of the rear panel to the battery tray.

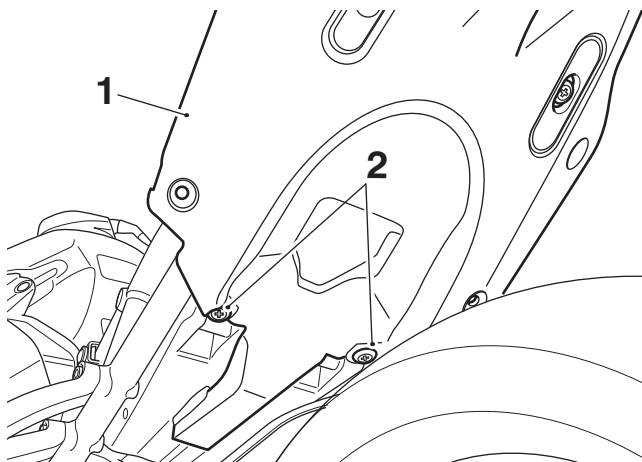
- 1. Rear panel
- 2. Scrivets

1. Remove the scrivets securing the front of the rear panel to the battery tray.

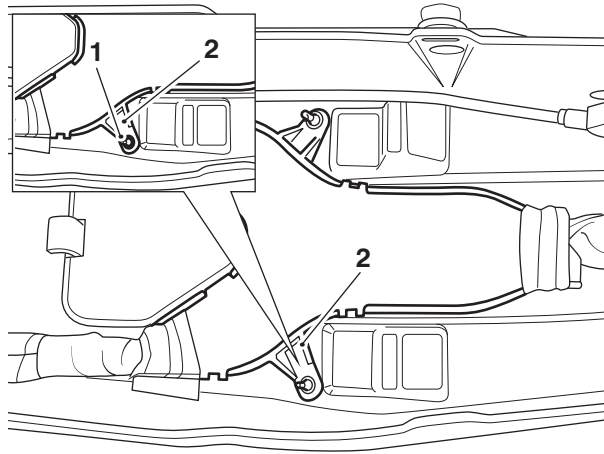
1. Scrivet
2. Conduit

2. With the conduit positioned in the battery tray as shown below, refit the two scrivenets ensuring they also secure the harness conduit.
