Technical Service Bulletin

91 How to update MMI MIB navigation map - potential customer concerns

91 14 54 2037809/1 July 30, 2014.

Model(s)	Year	VIN Range	Vehicle-Specific Equipment
A3	2015 - 2016	All	Navigation

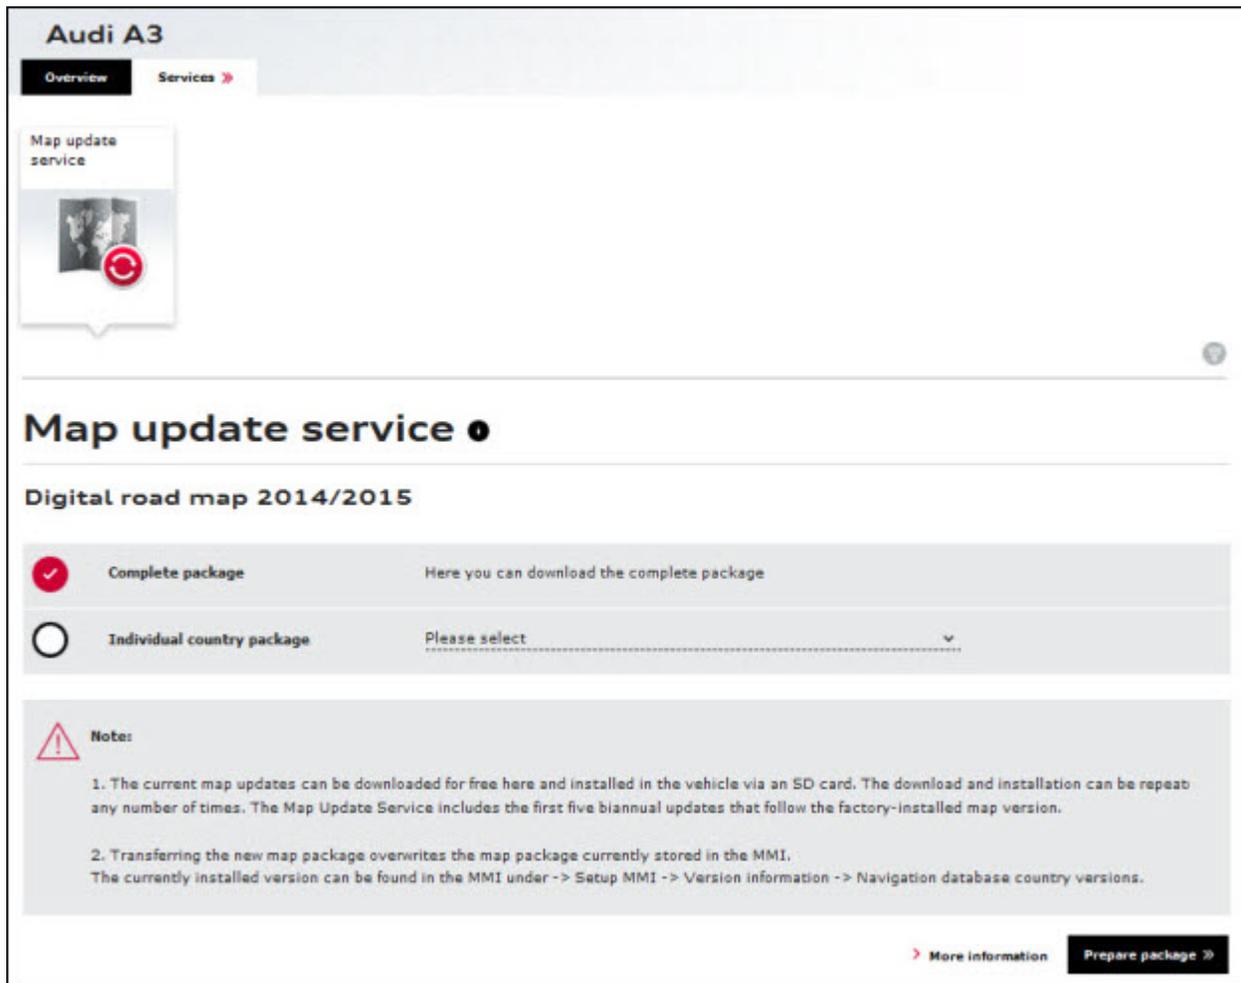
- The customer must register with the myAudi web site (my.audiusa.com).
- The customer must add the vehicle VIN to the profile on the web site in order to access the "Map update service" (Figure 1).

Figure 1. Map update service on the myAudi web site (my.audiusa.com).

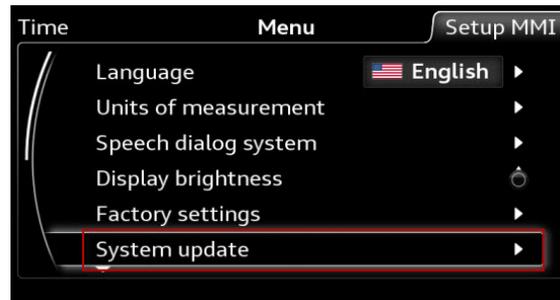
Figure 6. MMI option for customer map update

4. After the map data has successfully downloaded to the SD card, the SD card should be inserted into the MMI main unit. Once the SD card is inserted into the MMI main unit, the customer must initiate the download with the *MENU >> Setup MMI >> System Update* (Figure 6) function in the MMI. The update does not start automatically when the SD card is inserted.

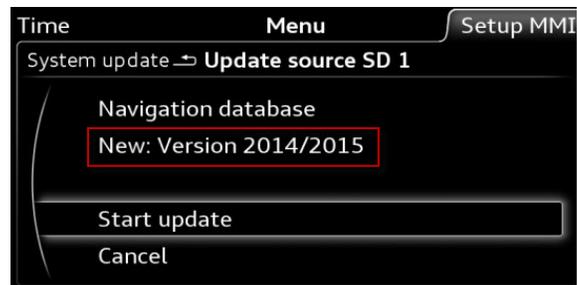
Figure 8. Selecting "Start update"

6. The new version of the map data will be indicated in the MMI screen. Selecting "Start update" begins the update (Figure 8).

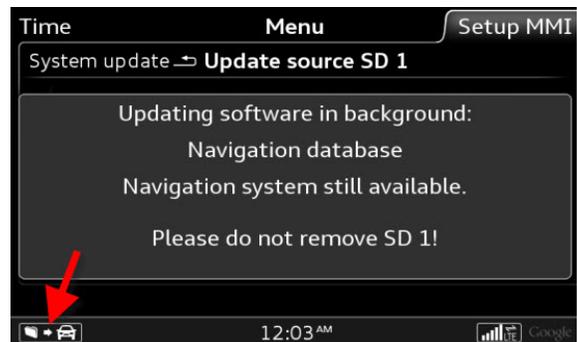
The MMI will automatically perform the update in the background, which is indicated by the file transfer icon in the lower left-hand side of the MMI screen (Figure 9).

Figure 9. The background update is indicated by the file transfer icon

Tell the customer that the vehicle can be shut off during the update process, but the SD card (or other update media) should never be removed from the MMI main unit. If the vehicle is turned off during the update process, the MMI will continue to perform the update in the background for approximately 30 minutes. The update will automatically begin again on the next ignition cycle. The complete process can take about 60-90 minutes with an SD card. If the customer chooses to use a DVD or a USB drive via AMI, then the update may take considerably longer.

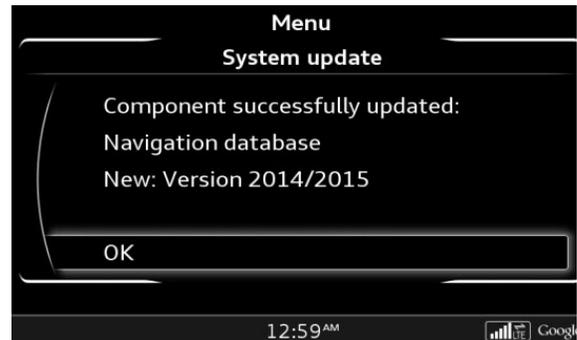
Figure 10. Successful update screen

7. After the update is complete, the icon in the lower left-hand side of the MMI screen will disappear. Additionally, a confirmation can be seen in the MMI system update screen: *MENU >> Setup MMI >> System Update* (Figure 10).
