Title: Updated I6 EVRT/VGT Diagnostics Check Sheet and Turbocharger Repair Procedures for engines that exhibit DTC 353 / 354

Applies To: 2004- 2006 MY EGR DT 466 and 570 with EVRT/VGT Turbos with ESN 2,000,001 - ESN 3,000,000

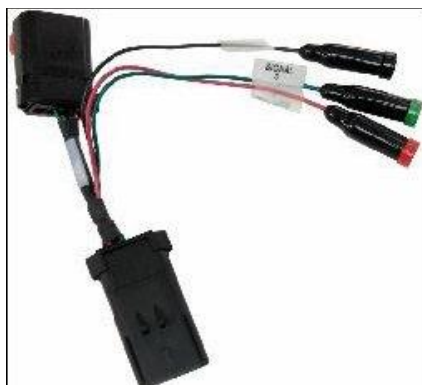
1. Connect the turbocharger breakout harness between the engine harness and the turbocharger actuator pigtail.

Note The male/female connector has an additional retention locking feature that must be disengaged prior to separating the male/female connectors. This slide locking tab may be coated with paint that will be required to be scrapped off to ease disassembly.
