DRIVE AXLE CRADLE TRIPOD MEMBER INSPECTION AND REPLACEMENT

Prevost vehicles

On the vehicles affected by this bulletin, replace the rear tripod member.

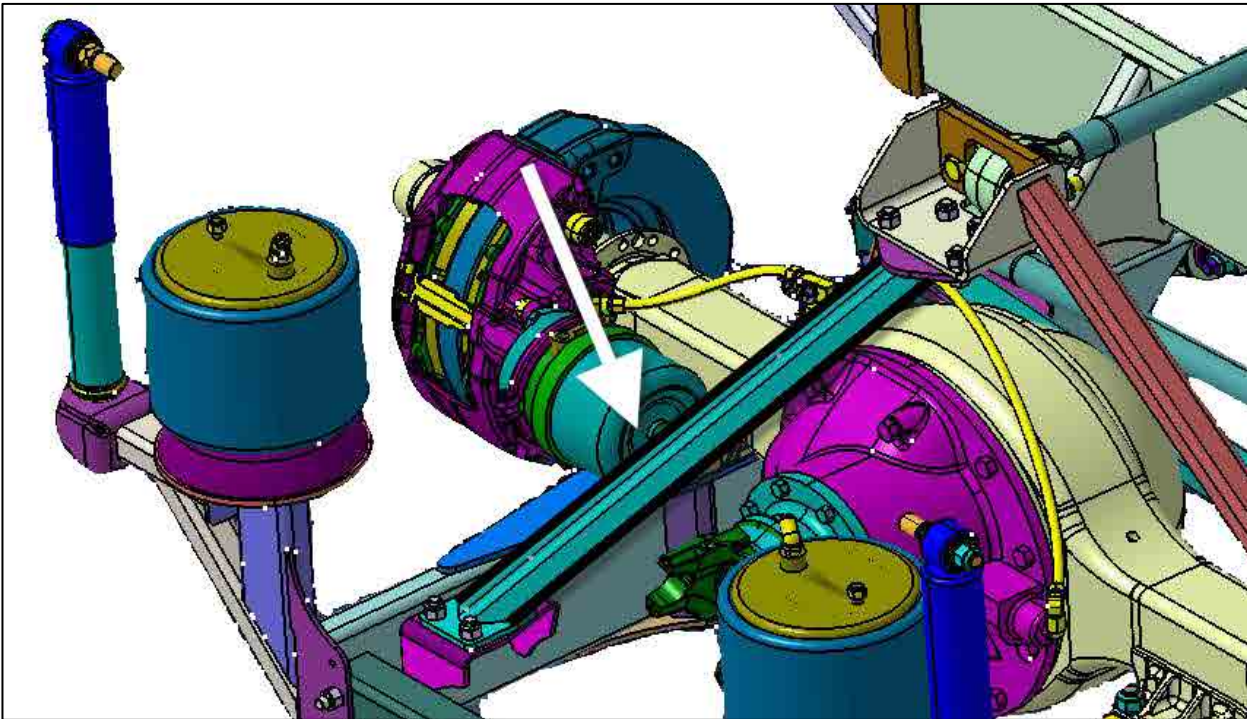
Park vehicle safely, apply parking brake, stop engine. In the rear electrical compartment, set the battery cut-off switch to the OFF position prior to working on the vehicle.

1. Lift the tag axle. On Entertainers and Motorhomes with "level low" system, leave the battery power and ignition key to "ON" for the rest of the procedure else the vehicle will not level itself automatically.
2. Lift the vehicle by the tag axle wheels or the usual vehicle frame lifting points.
3. With rear suspension at nominal ride height (11 1/2"), place supports (jack stands) under the drive axle cradle to maintain the ride height. Deflate the air springs.

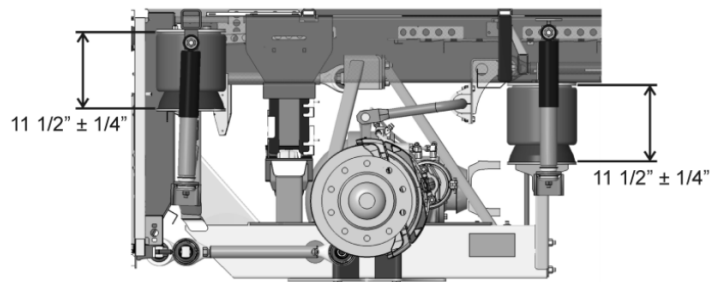
Note: This is to position the cradle assembly at a "dead" point where tension is minimized in the radius rods and structure.

4. To replace the rear tripod member, unscrew the top hardware (4).
5. Discard the nylon locking nuts.

Inspect screws to make sure they do not present any excessive corrosion or damage. Keep screws and washers (if used) for re-use.

Replace screws as required with new #5001590 M16x40 G10.9 hex cap screw.
