Service Bulletin

Bulletin No.: P11221

Subject: Excessive Wind Noise from Front Side Door Glass Area

Models: 2014 Chevrolet Silverado 1500
2014 GMC Sierra 1500

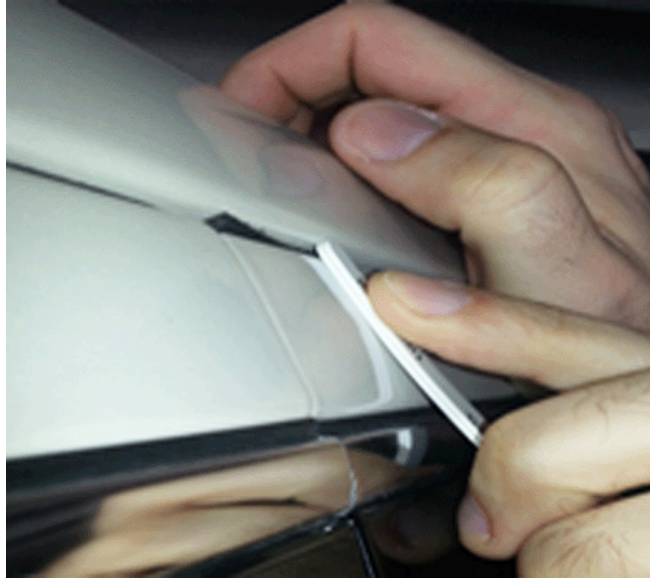
3806384

Note: The 2014 Silverado/Sierra uses an inlay door construction with the door fitting sub-flush to the body header by 1-2 mm (0.40–0.80 in).

1. At the two locations (1) shown in the illustration above, check the front door fit as to meeting the suggested 1-2 mm (0.40–0.80 in) sub-flush dimension.
