**SUBJECT****Noise from Rearview Mirror****MODEL**

F30 (3 Series Sedan)

Produced from July 1, 2011

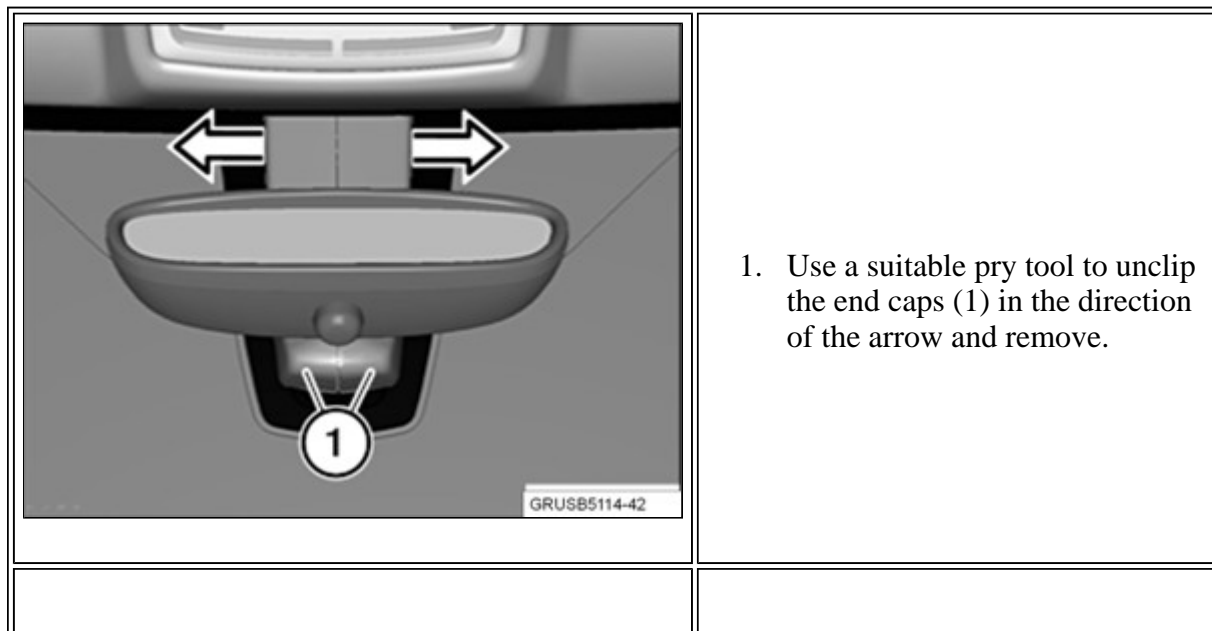
The mirror electrical connector is loose in the mirror base.

Confirm the customer complaint. If the rearview mirror area is the complaint, proceed to the next step and remove the rearview mirror.

Work may only be performed at a room/vehicle temperature of between 65° F and 82° F.

It is necessary to equalize the temperature of the windshield, mirror base and inside mirror (e.g., let the vehicle sit indoors to warm up or in the shade to cool down for at least 30 minutes).
