Service Action: Check and Repair the NVLD Wiring Harness

F83 (M4 Convertible)

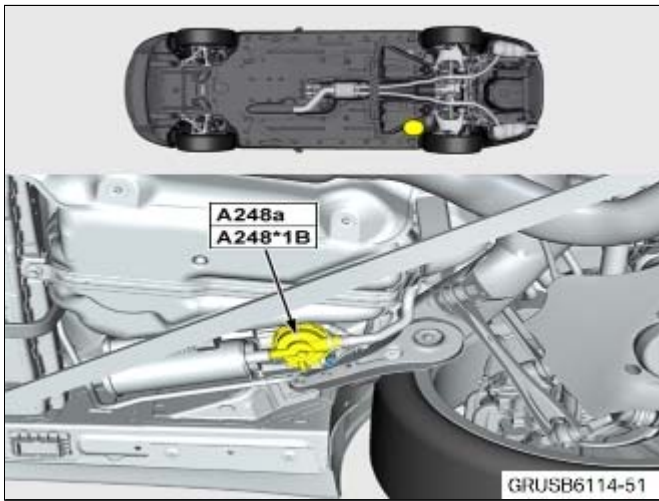
The wiring harness for the NVLD2 (Natural Vacuum Leak Detection: tank leak diagnosis) may rest against the right rear strengthening brace and chafe through the harness insulation. This may lead to a short circuit and blow Fuse 104.

4. The picture to the left shows the installed location of the NVLD, once the cover is removed.
