Service Action: Replace Cover on Battery Positive Terminal

F22 (2 Series Coupe)

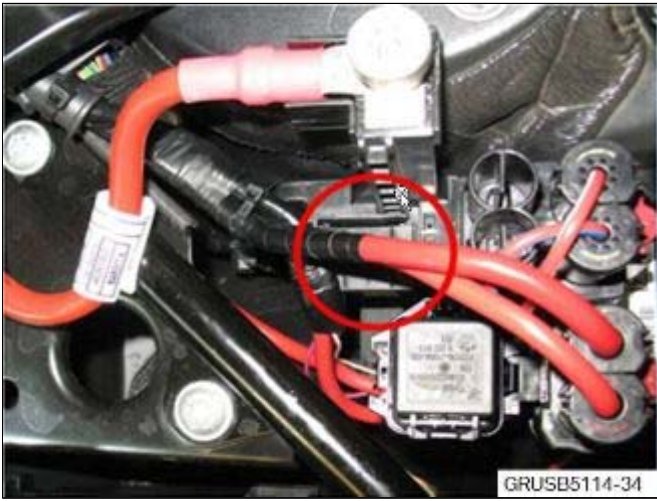
The connection point for the battery positive cable terminal in the engine compartment is not sufficiently protected, which may result in corrosion and poor contact at the connection point.

Defective cover for the battery positive cable connection point

- This picture shows the installation location of the cover to be replaced, below the battery positive cable.

Replace the cover for the battery positive cable connection point in the engine compartment.

- Remove the cover on the battery positive terminal in the direction of the arrow, and replace it.
