This Service Information bulletin supersedes SI M17 08 12 dated **January 2013**.

Service Action: Retrofit of the Engine Coolant Temperature Sensor

All with **automatic transmission** and either the N16 or N18 engine

This Service Action involves R55, R56, R57 and R58 MINI Cooper/Cooper S vehicles with the N16 or N18 engine which were produced from 8/2010 to 3/2012.

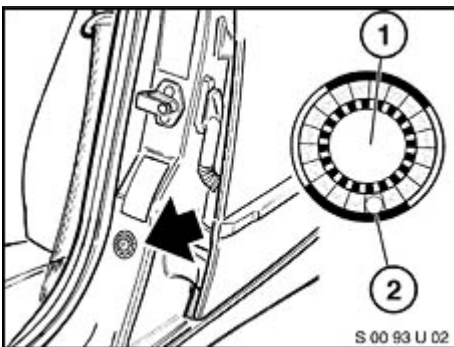
LABEL INSTRUCTIONS

This Service Action has been assigned code number **53**. After the vehicle has been checked and/or corrected, obtain a label (MD20-040) and:

- A. Emboss your MINI dealer's warranty number in the middle of the label (1);
- B. Punch out code number **53** (2), printed on the label; and
- C. Affix the label to the B-pillar as shown.
