N63 Engine: Check the Timing Chain

F01 and F02 (7 Series Sedan) produced from 3/2009 to 6/2012

This bulletin outlines the procedure to check the engine timing chains for wear and should be **completed in conjunction with [SI B11 06 14](#) “N63 Customer Care Package”**.

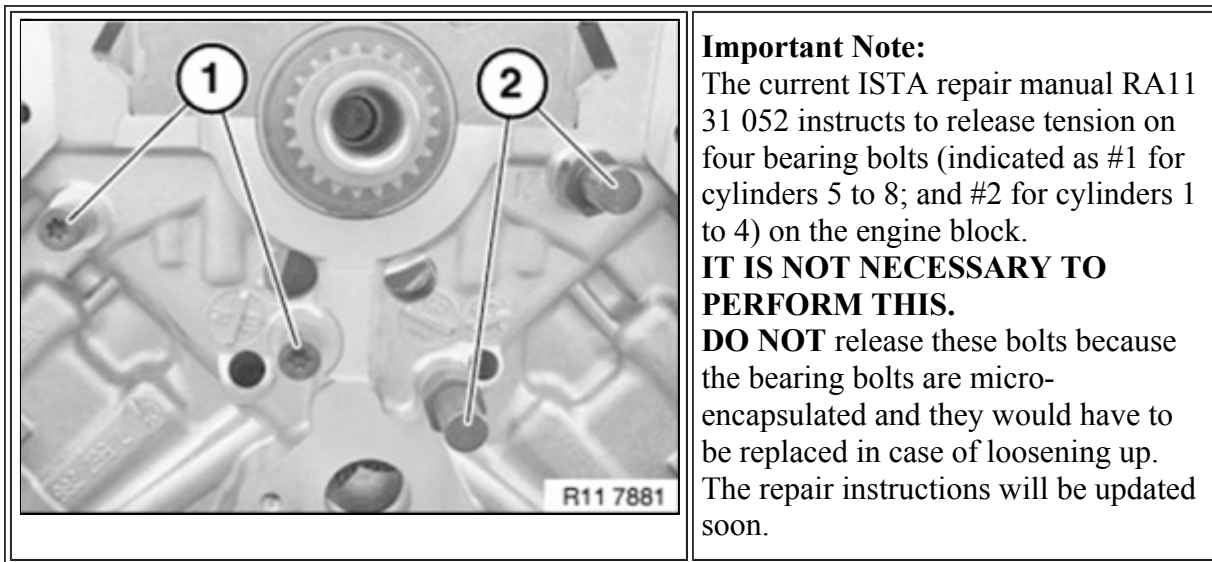
The current ISTA repair manual RA11 31 052 instructs to release tension on four bearing bolts (indicated as #1 for cylinders 5 to 8; and #2 for cylinders 1 to 4) on the engine block.

DO NOT release these bolts because the bearing bolts are micro-encapsulated and they would have to be replaced in case of loosening up. The repair instructions will be updated soon.
