Service Action: Inspect Front Driveshaft

E70 (X5)

E71 (X6)

E72 (X6 ActiveHybrid)

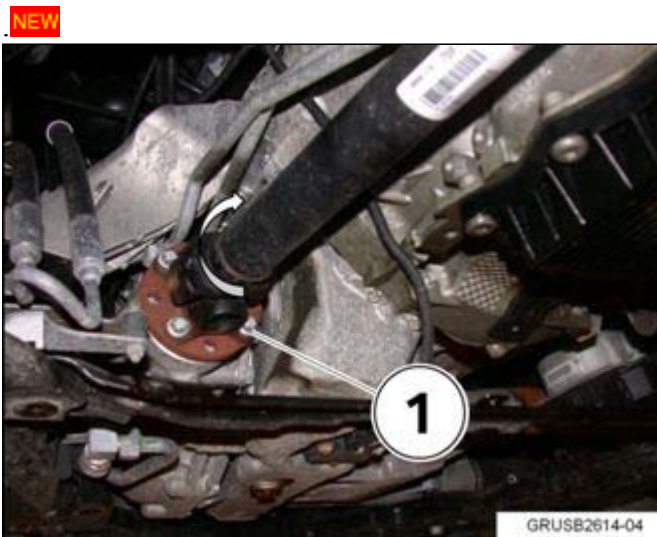
Hold the output flange (1) on the transfer case and check for radial play in the U-joint (2). There should be no excessive play.

3. Rotate the driveshaft 90° and repeat steps 1 and 2. Rotate the driveshaft another 90° and recheck for play. Rotate a total of four times (the driveshaft has now been rotated 360° total). There should be no excessive play in the U-joints.

NEW If any of the above conditions are present, replace the driveshaft. Refer to Repair Instruction 26 20 000, "Removing and installing front propeller shaft as of 4/2010."
