| US 59123693-02 | The windscreen is breaking away at the fastening points. | |

All windscreens for the R 1200 GS (K50) and the R 1200 GS Adventure (K51) have been changed.

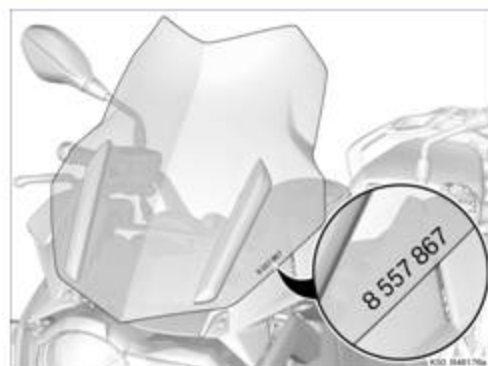
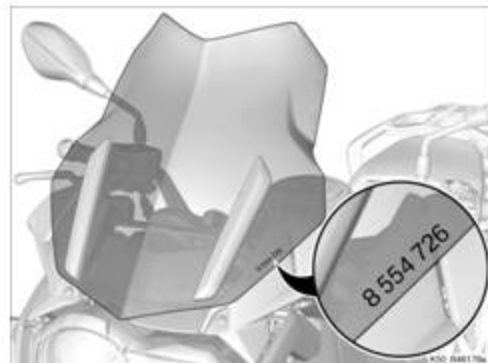
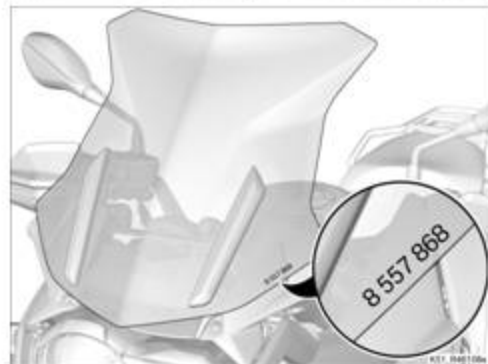
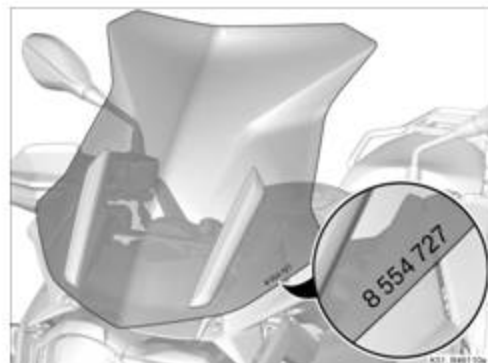
K51

The construction status can be identified by the part number on the windscreen.

See accompanying pictures.

When repairing vehicles with the older construction status, the new windscreen must only be fitted in conjunction with all the fasteners listed below:
