**Service Action: Repair Corrosion Protection in Engine Compartment**

F30 (3 Series Sedan)

F30H (ActiveHybrid 3)

Produced from September 2011 to May 2012

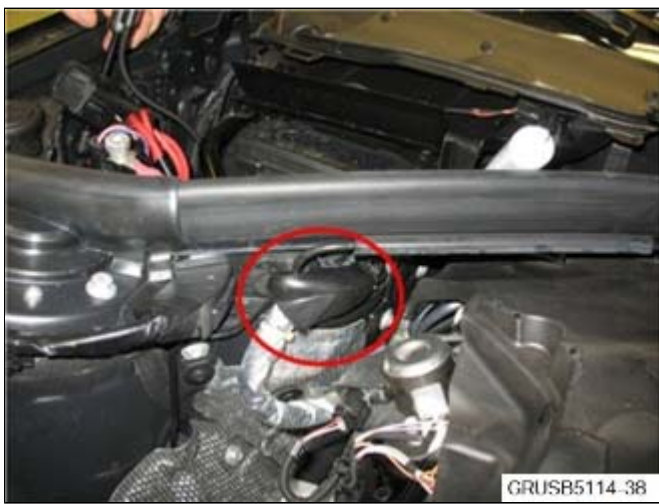
Various engine compartment battery cable mounting points are not sufficiently protected against corrosion.

Lack of corrosion protection can lead to improper battery cable connections.

Coat the battery positive terminals in the engine units compartment with contact grease, using a locally sourced flat brush.

- Reinstall the cover on the battery positive terminal in the engine compartment.
- Reinstall the engine compartment acoustic cover if it was previously removed.
