Front Door Loudspeaker Make Noises When Cold

F22 (2 Series Coupe)

F30 (3 Series Sedan)

F32 (4 Series Coupe)

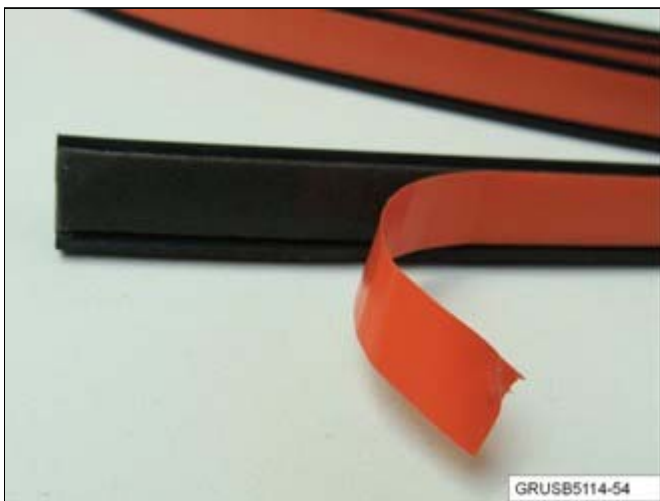
lower edge of the glass can be easily accessed through the speaker opening, as shown.

9. Prepare a length of self-adhesive sunroof seal (5 cm long).
