### Automatic Trunk Lift Operation Creates AM Radio Static

F34 (3 Series Gran Turismo)

Produced from January 31, 2013 to June 19, 2014

With option 0316 (automatic trunk lift)

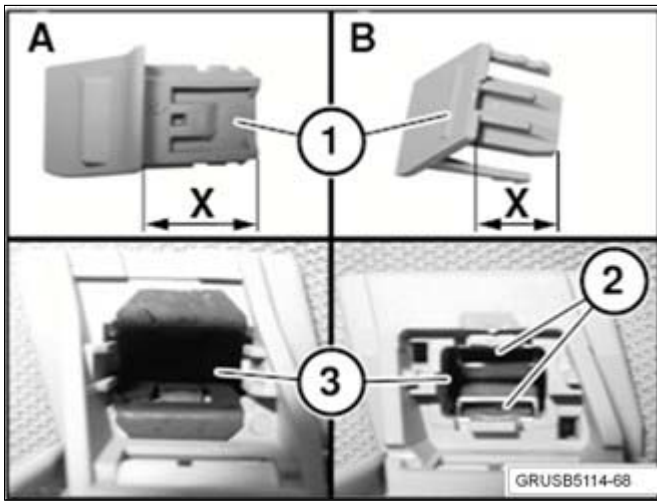
The version of the grab handle must be determined for the following procedure.

**Stem length of locking wedge (1)**

Version A: 22mm
