This Service Information bulletin supersedes SI B54 04 14 **dated April 2014**.

**NEW** Service Action: Wiring Harness Sensor Rear Module

E89 (Z4)

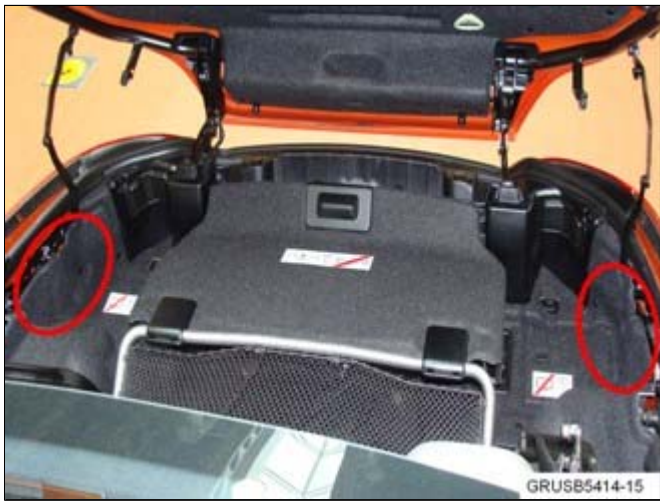
<ol style="list-style-type: none"> <li>The areas to be worked on are highlighted by red circles.</li> </ol> <p>Note: In this picture, the convertible top is in the service position with the rear module completely open. You can also perform this repair by opening the trunk.</p> <p><b>Safety:</b> Be sure to secure the rear module in the up position,</p>
--	---

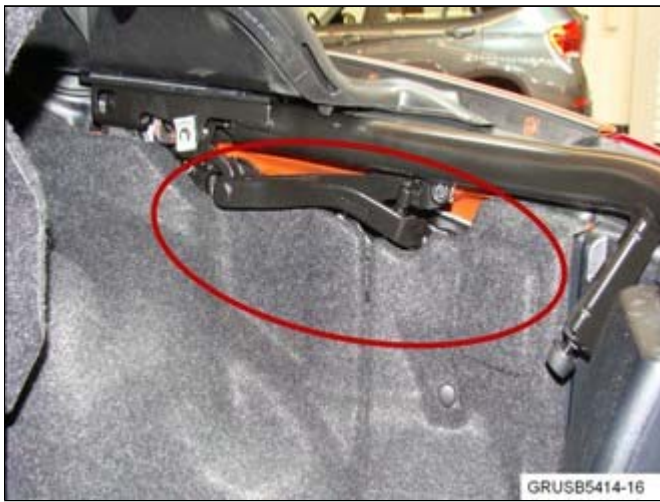
2. A closer view of the area that needs to be inspected is highlighted in red.
