Service Action: i3 Business Navigation – Retrofit

I01 (i3 REx)

Produced to 06/06/14

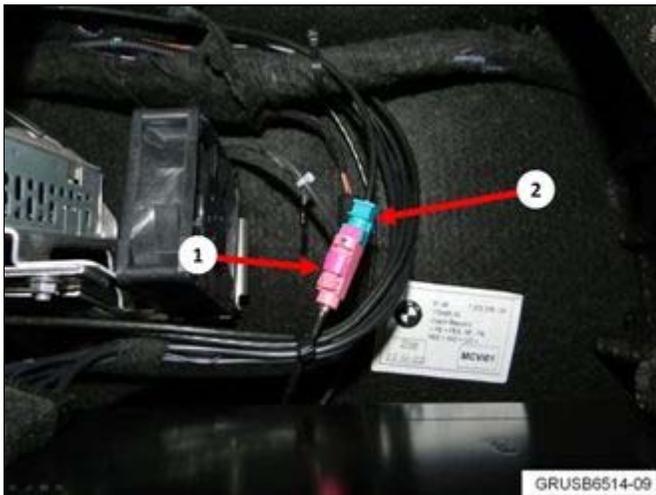
10. Identify the pink GPS antenna connector that was removed from the old TCB (1). Connect the male end of the adapter cable (2) to this pink connector. The adapter cable (P/N 61 12 2 361 716) will extend the antenna cable to its new terminal end at the head unit.

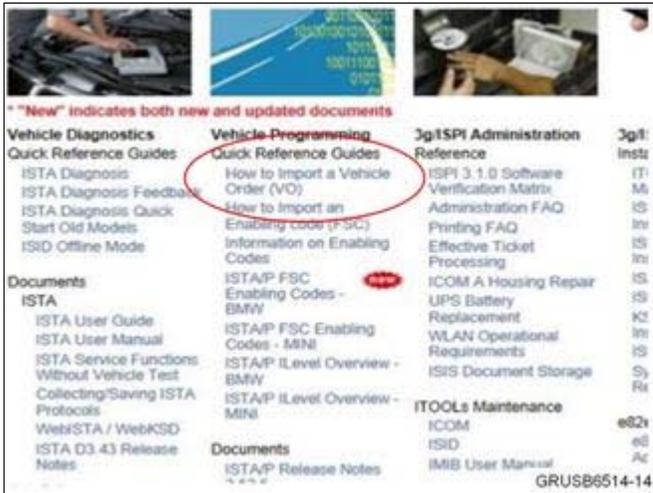
17. Refer to Workshop Technologies in Centernet. Select the hyperlink **How to Import a Vehicle Order**. Follow those instructions to install the VO.
