## Field campaign

<b>Topic</b>	Flying Spur - Front Seat Rail - Proximity Sensor Check (SC14/15)
<b>Market area</b>	United States E05 Bentley USA and rest America (6E05)
<b>Brand</b>	Bentley
<b>Transaction No.</b>	2037363/1
<b>Campaign number</b>	EA15
<b>Note</b>	EA15
<b>Type</b>	EA15
<b>US code</b>

### Flying Spur - United States and rest of America

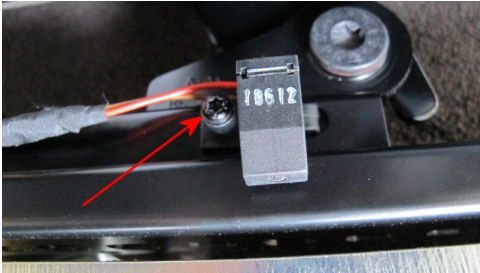
Figure 1

The front seat proximity sensors are located under both front seats at the front of the inner seat rail. The screw which secures the front right hand seat proximity sensor (Figure 1) and the screws which secure the left hand front proximity sensor and proximity sensor bracket (Figure 2) require replacing using a later specification part.

**Section 1** – The sensor screw (right hand seat) along with sensor and sensor bracket screw (left hand seat) require replacing using a later specification part. Sensor confirmation checks are also required after the screws are replaced as detailed.
