Topic	Flying Spur - Potential mismatch - Keys to entry and start authorisation control unit control J518 (SC14/12)
Market area	Worldwide Bentley (1WBE)
Brand	Bentley
Transaction No.	2037366/1
Campaign number	EA12
Note	
Type	
US code

EA12

Transaction No.: 2037366/1

Flying Spur - Potential mismatch - Keys to entry and start authorisation control unit control J518 (SC14/12)

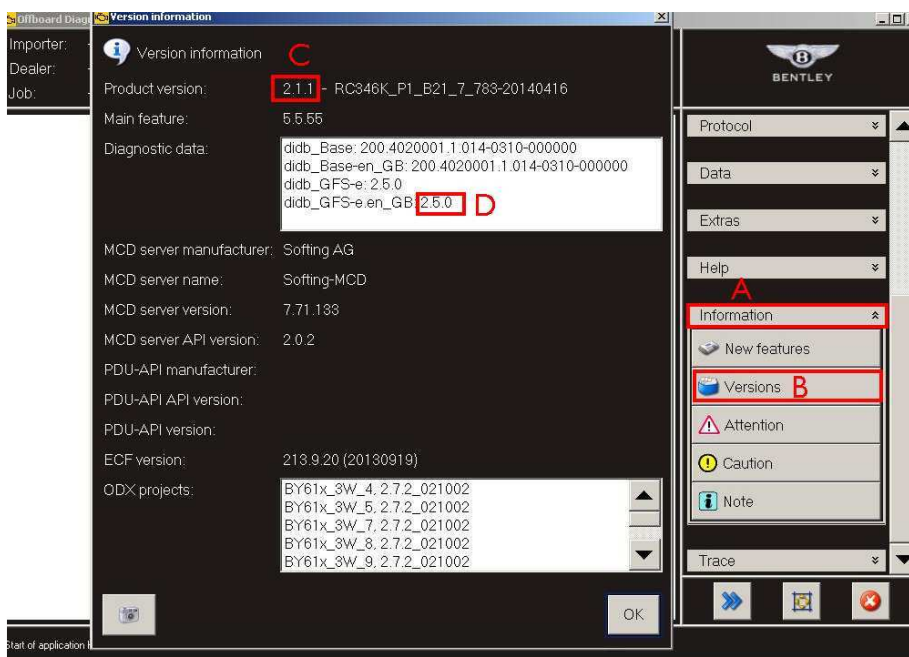
Figure 2

- Referring to Figure 2, from the Offboard Diagnostic Information System Service home screen select Information (Point A)

- At Point C, check the Offboard Diagnostic Information System Service product version which must be 2.1.1 or higher

- At Point D, check the Diagnostic data level which must be 2.5.0 or higher

In the event that one or both versions do not meet the afore mentioned criteria please update your Offboard Diagnostic Information System Service to the appropriate level.

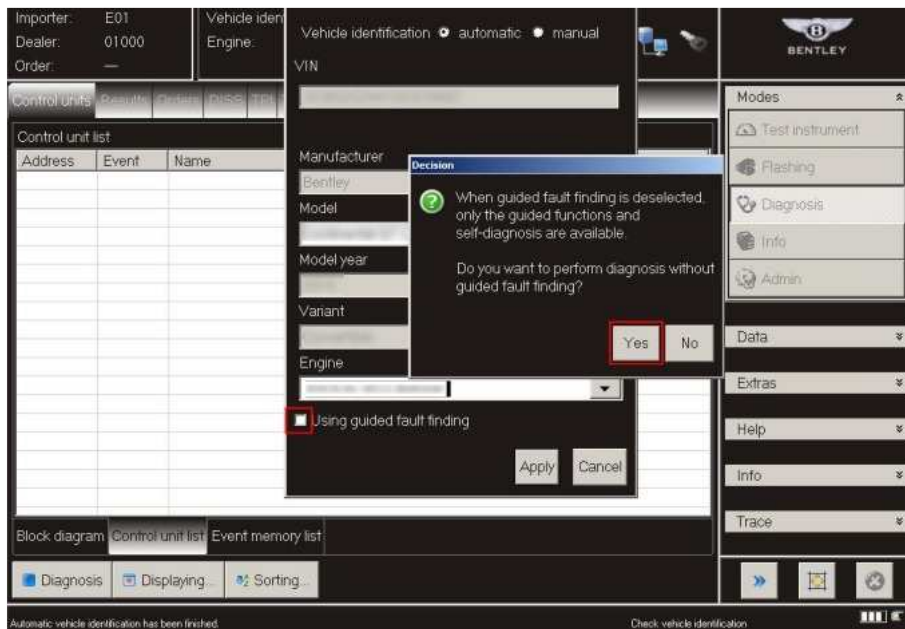
Figure 3

6. Deselect Guided Fault Finding – remove tick from *Using guided fault finding* option – then select *Yes* at pop-up and *Apply* (Figure 3)

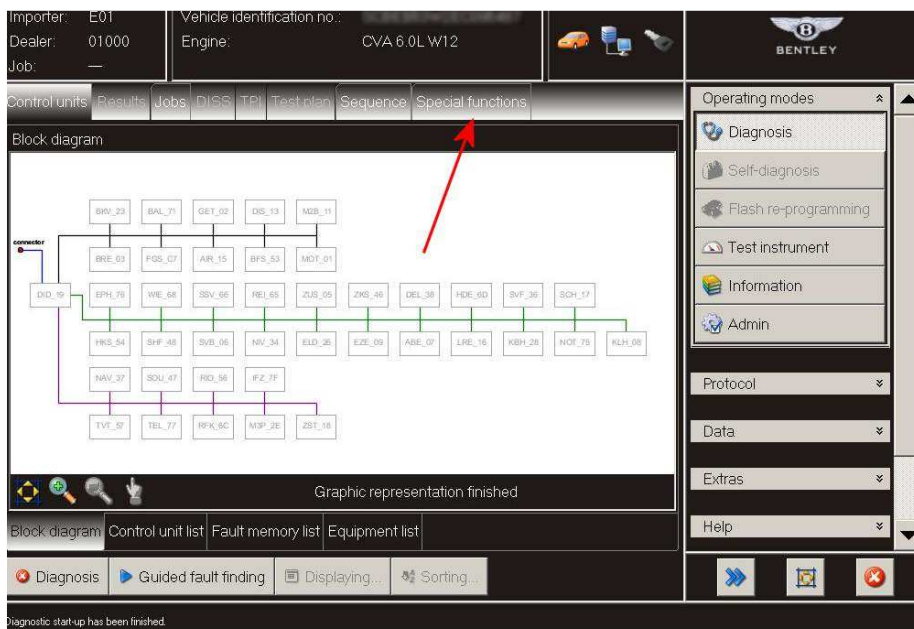
- Referring to Figure 4 select – Special functions

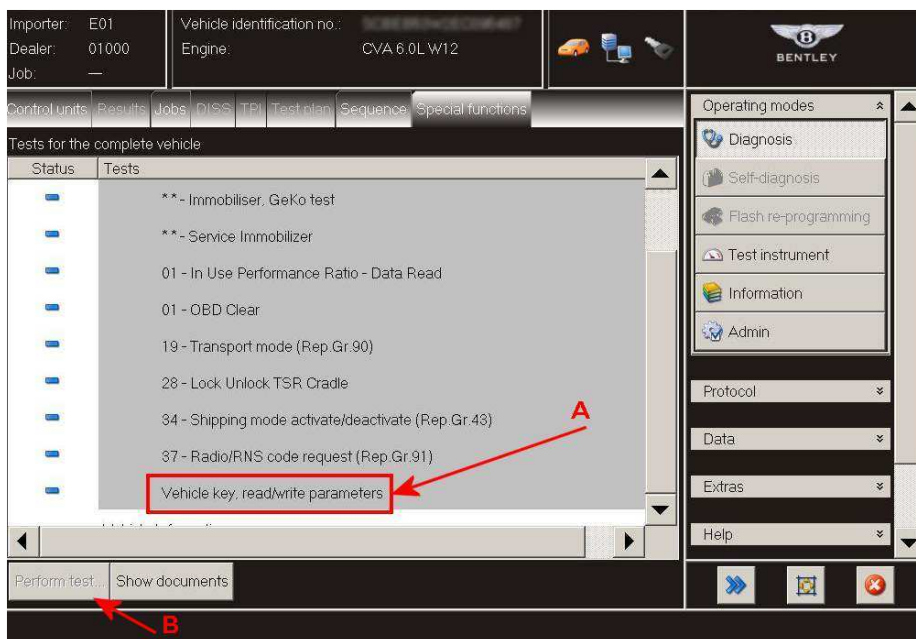
Figure 5

- Select Vehicle key, read/write parameters (Figure 5 Point A)

- Select Perform test (Figure 5 Point B) and follow all on screen prompts until you reach the screen shown in Figure 6
