Group:	27-Electrical System
Bulletin No.:	SB-14-025
Issue Date:	02-05-2014

# TECHNICAL SERVICE BULLETIN

## 2011MY-14MY JUNCTION BOX CORROSION DUE TO WATER INTRUSION

2011MY – 2014MY Hino Conventional NE8J, NJ8J, and NV8J vehicles

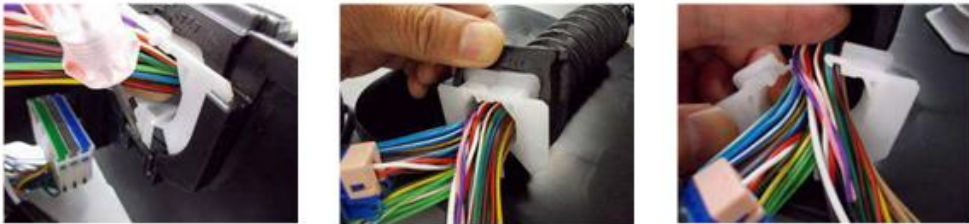
**1.** Inspect the upper wire harness support inside the rubber grommet. If the upper harness support is white in color, it will need to be replaced with the enhanced gray wire harness support.

**2.** If a white harness support is present, release the black clips on the junction box using a flat blade screwdriver. Remove the harness support from the grommet, unlock the harness support, and remove it from the harness.
