L83X- A.04.14	<b>To:</b> <b>Subject:</b> <b>Date:</b> <b>Pages</b>	<b>Official After Sales Network</b> <b>Drivability enhancement</b> <b>11<sup>th</sup>/07/2014</b> <b>26</b>	 
------------------	---	--	---

Drivability enhancement

All Lamborghini Aventador MY **13** and **14** and up to VIN **ELA02756**.

As a result of continuous product monitoring, Automobili Lamborghini Spa has introduced a new software that manage engine, gearbox and instrument cluster to enhance driveability.

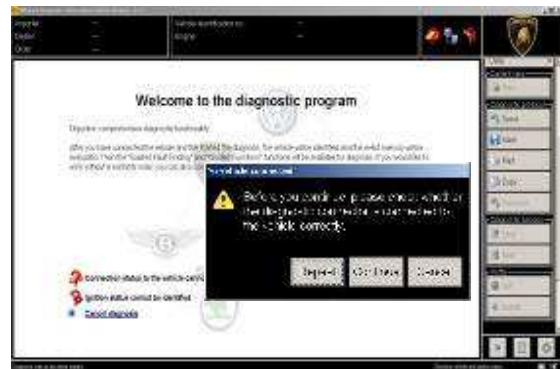
A. If the error message regarding the VAS5054 interface and the 2 icons for status of on board connection and key on are shown as in the picture below:

- Click “Cancel”;
- Repeat the VAS5054 HW interface installation following the procedure (\*) “VCI Manager v2.0”, by entering in the menu “Extras” on the right side and clicking on “Diagnostic interface”.

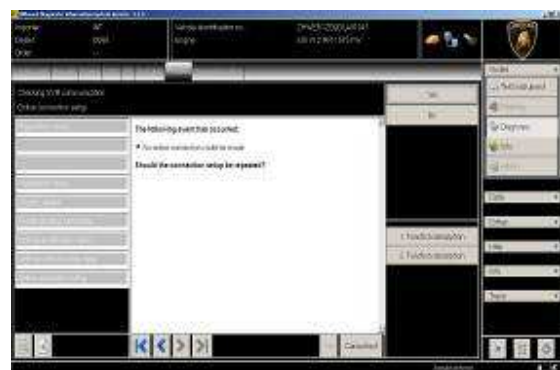
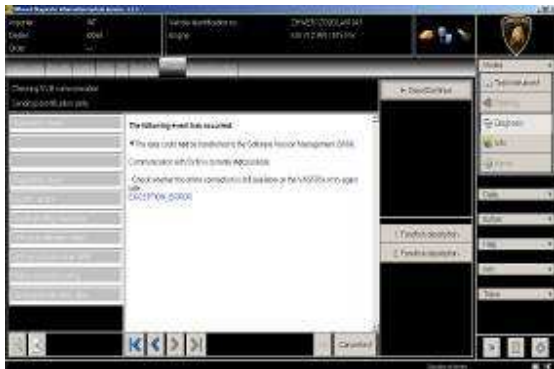
B. If one of the connection errors screens is shown as in the pictures below:

- it is not possible to establish a connection with the central server. Please check carefully that the diagnosis laptop is properly connected to the internet network and retry clicking “Yes” or “Done/Continue”.

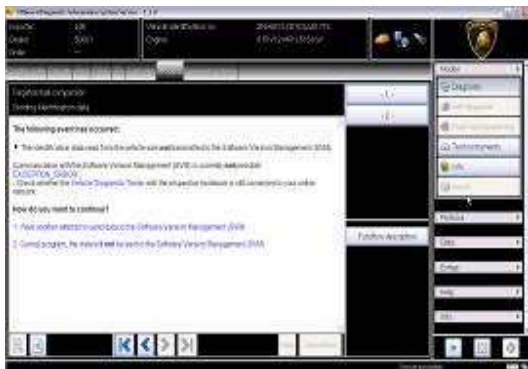
**C.** If the loss of connection happens during the target/actual comparison.

- It is not possible to connect to central server, check the working connection of internet and retry by clicking “1”.

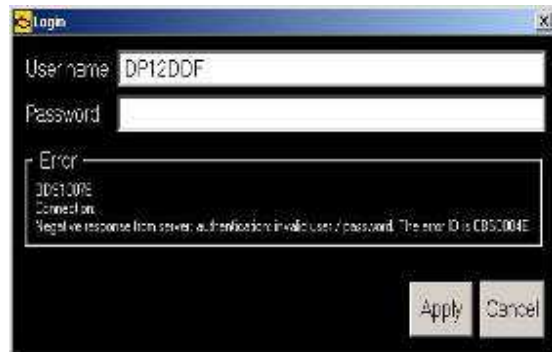
**D.** If the incorrect identification message is shown as in the picture below (error code: ODS1007E):

- be sure that your Geko account is valid;
- be sure that the label “Geko” is written on the token that you are using for the authentication;
- be sure the Password inserted is correct;
- click on Cancel and perform the application test (see document “ODIS\_Checking\_ConnectionServer\_SVM\_2.0” (\*)).

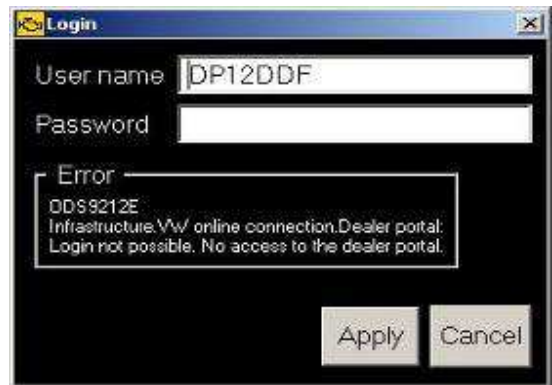
**E.** If the infrastructure error message is shown as in the picture below (error code: ODS9212E):

- be sure that your Geko account is valid
- be sure that the label “Geko” is written on the token that you are using for the authentication
- verify in ODIS settings you have “Internet” instead of “CPN” (see document “ODIS\_Initial\_Setup\_2.0” (\*))
- click on Cancel and perform the application test (see document “ODIS\_Checking\_ConnectionServer\_SVM\_2.0” (\*))

If the same error was present during the application test, try following procedure:

- quit ODIS;
- Enter the folder C:\Program Files\Offboard\_Diagnostic\_Information\_System\_Service\automatic\_sessions on your diagnosis laptop;
- delete the only file present in that folder.
