L83X-A.12.14	<b>To:</b> Official After Sales Network <b>Subject:</b> Wheel housing rework. <b>Date:</b> 01 <sup>st</sup> /08/2014 <b>Pages:</b> 4

**Subject**  
Wheel housing rework.

**Model**  
All Lamborghini Model Aventador Coupé and Roadster MY 12, 13 and 14 from VIN ELA00091 to VIN ELA02597.

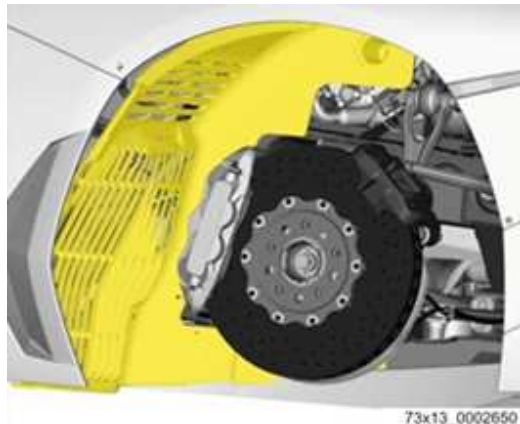
**Working area identification.**

**Information to the field**  
As a result of continuous product monitoring, Automobili Lamborghini Spa has found that on some vehicles rear wheel houses may become distorted due to high temperature.

surface which needs to be reworked can be detected by mean of a visual inspection: check in the pictures below the area circled in red.

**Field solution**  
Rework both rear wheel housings.
