L834-
T.01.14

To: Rete di Assistenza ufficiale Lamborghini
Subject: A Pillar Monocoque Sealing
Date: 07th/02/14
Pages: 3

Monocoque A pillar sealing.

All Lamborghini Aventador LP 700 Coupe MY 12 and 13 from VIN **CLA00091** to VIN **DLA01695**

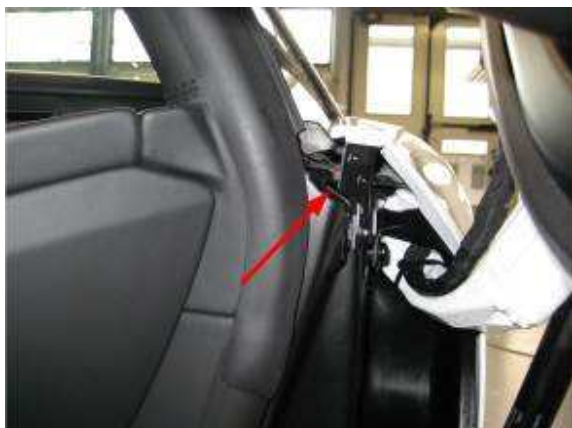
As a result of continuous product monitoring, Automobili Lamborghini Spa has found that on some vehicles a lapping noise can be heard at the base of the A pillars as a consequence of water ingress into the carbon monocoque.

1. Remove the wheel arch undershield: left and right sides (chapter 08 21 – A).
2. Drain the water from the intermediate hole located in the wheel housing on both sides as shown in picture: holes are symmetrical on the left and right.
