EC13-016a

July 18, 2014

2011 – 2012 QX56; MIL "ON" WITH DTC P0420 AND/OR P0430

APPLIED VEHICLES: 2011 – 2012 QX56 (Z62)

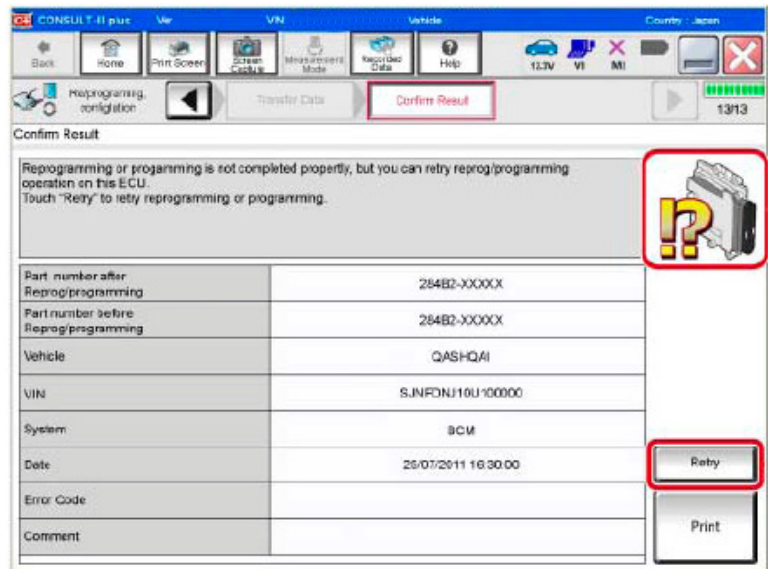
Figure 5

If reprogramming does not complete and the “!” icon displays as shown in Figure 5:

- Check battery voltage (12.0 - 15.5 V).
- Ignition is ON, engine OFF.
- External Bluetooth® devices are OFF.
- All electrical loads are OFF.
- Select retry and follow the on screen instructions.
- “Retry” may not go through on first attempt and can be selected more than once.

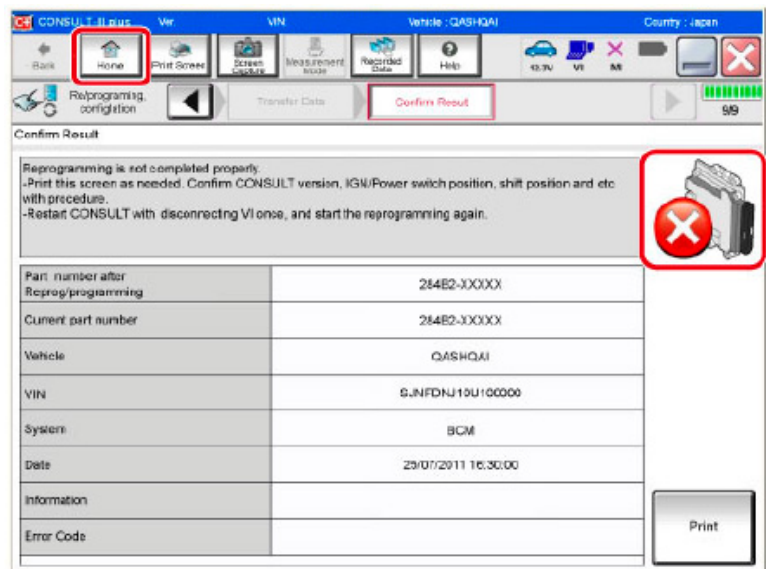
Figure 6

If reprogramming does not complete and the “X” icon displays as shown in Figure 6:

- Check battery voltage (12.0 - 15.5 V).
- CONSULT A/C adapter is plugged in.
- Ignition is ON, engine OFF.
- Transmission is in Park.
- All C-III plus / VI cables are securely connected.
- All C-III plus updates are installed.
- Select Home, and restart the reprogram procedure from the beginning.
