SERVICE BULLETIN

Classification: EL13-035b	Reference: NTB13-085b	Date: October 13, 2014
------------------------------	--------------------------	---------------------------

2014-2015 ALTIMA & 2014 ROGUE; AUDIO VISUAL SYSTEM SOFTWARE UPDATE

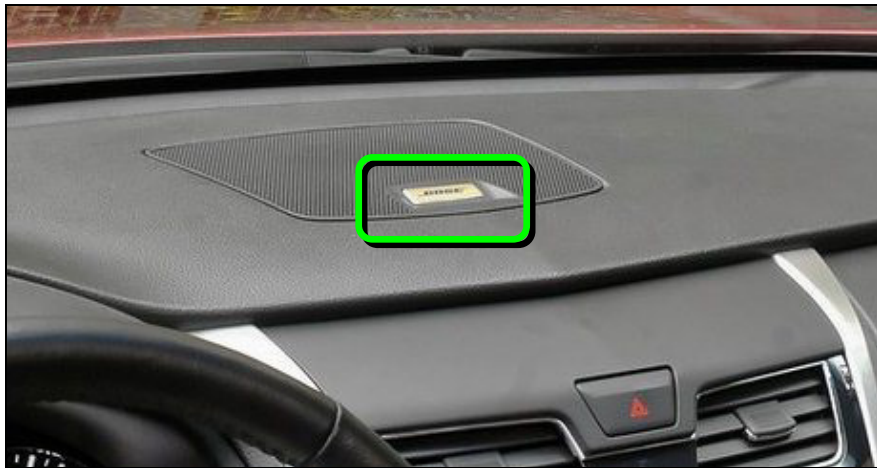
Figure 1

Altima: Check if the audio system is BOSE® (see Figure 1):

- **Non-BOSE:** Use USB Flash Memory #1.
- **With BOSE:** Use USB Flash Memory #2.

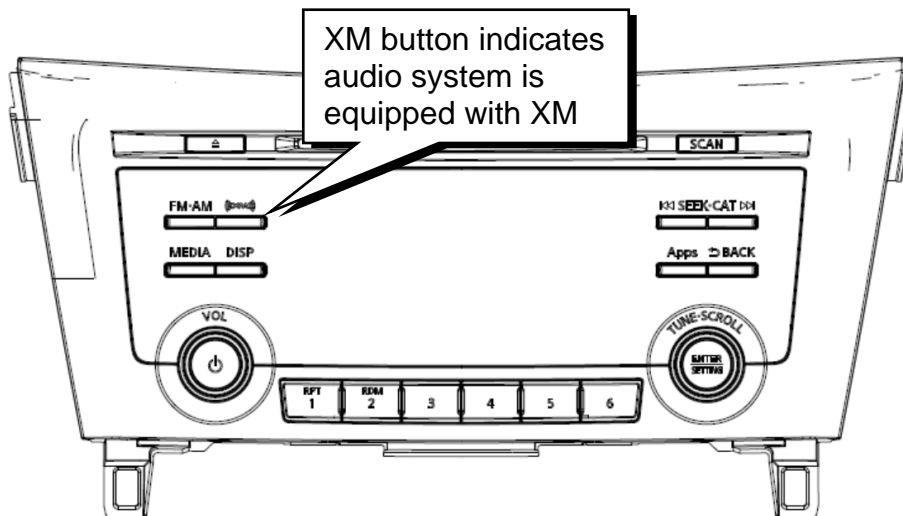
Figure 2

Rogue: Check if the audio system is equipped with XM radio (see Figure 2).

- **With XM:** Use USB Flash Memory #3.
- **Non-XM:** Use USB Flash Memory #4.

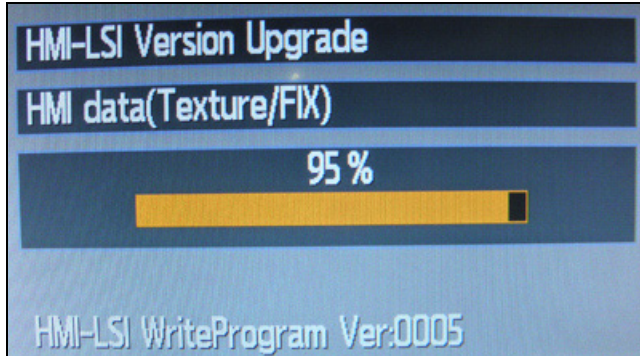
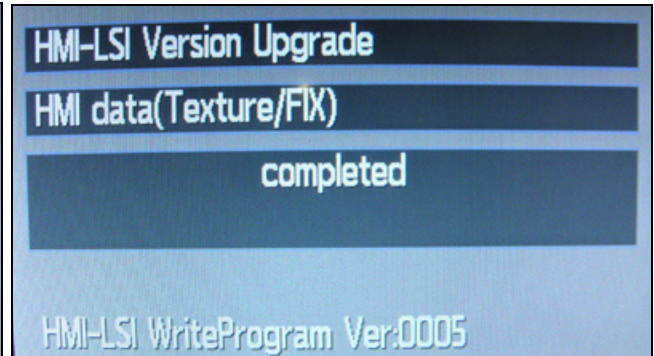
- During the entire software update, 2 to 5 individual sub-upgrades will be displayed, each with a progress bar and then a “completed” screen (examples shown in Figures 6 and 7).
- Between each individual sub-upgrade, an audible “pop” will be heard through the speakers.

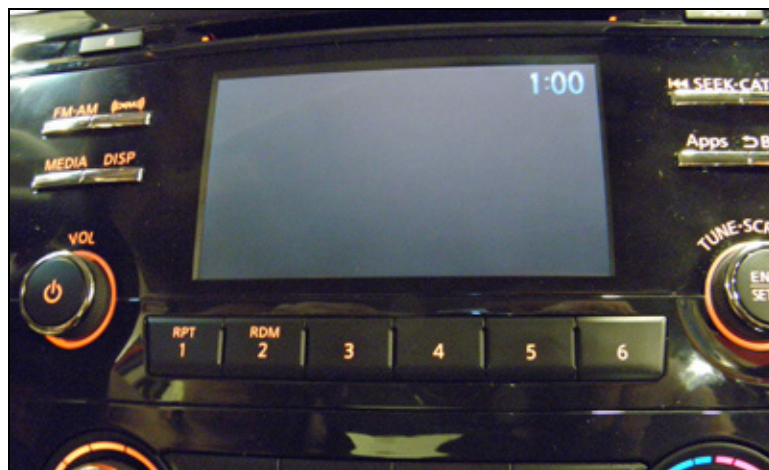
Figure 8

- A long beep will sound, and
- The audio OFF screen (blank with clock) will be continuously displayed (see Figure 8).
