Reference	SSM72108
Models	LR4 / L319
Title	2015 LR4 Instrument Cluster Message Center Display Concern
Category	Electrical
Last modified	11-Dec-2014 00:00:00
Symptom	204000 Instrumentation
Attachments	TO Message Center Display Concern.jpg

2015 LR4

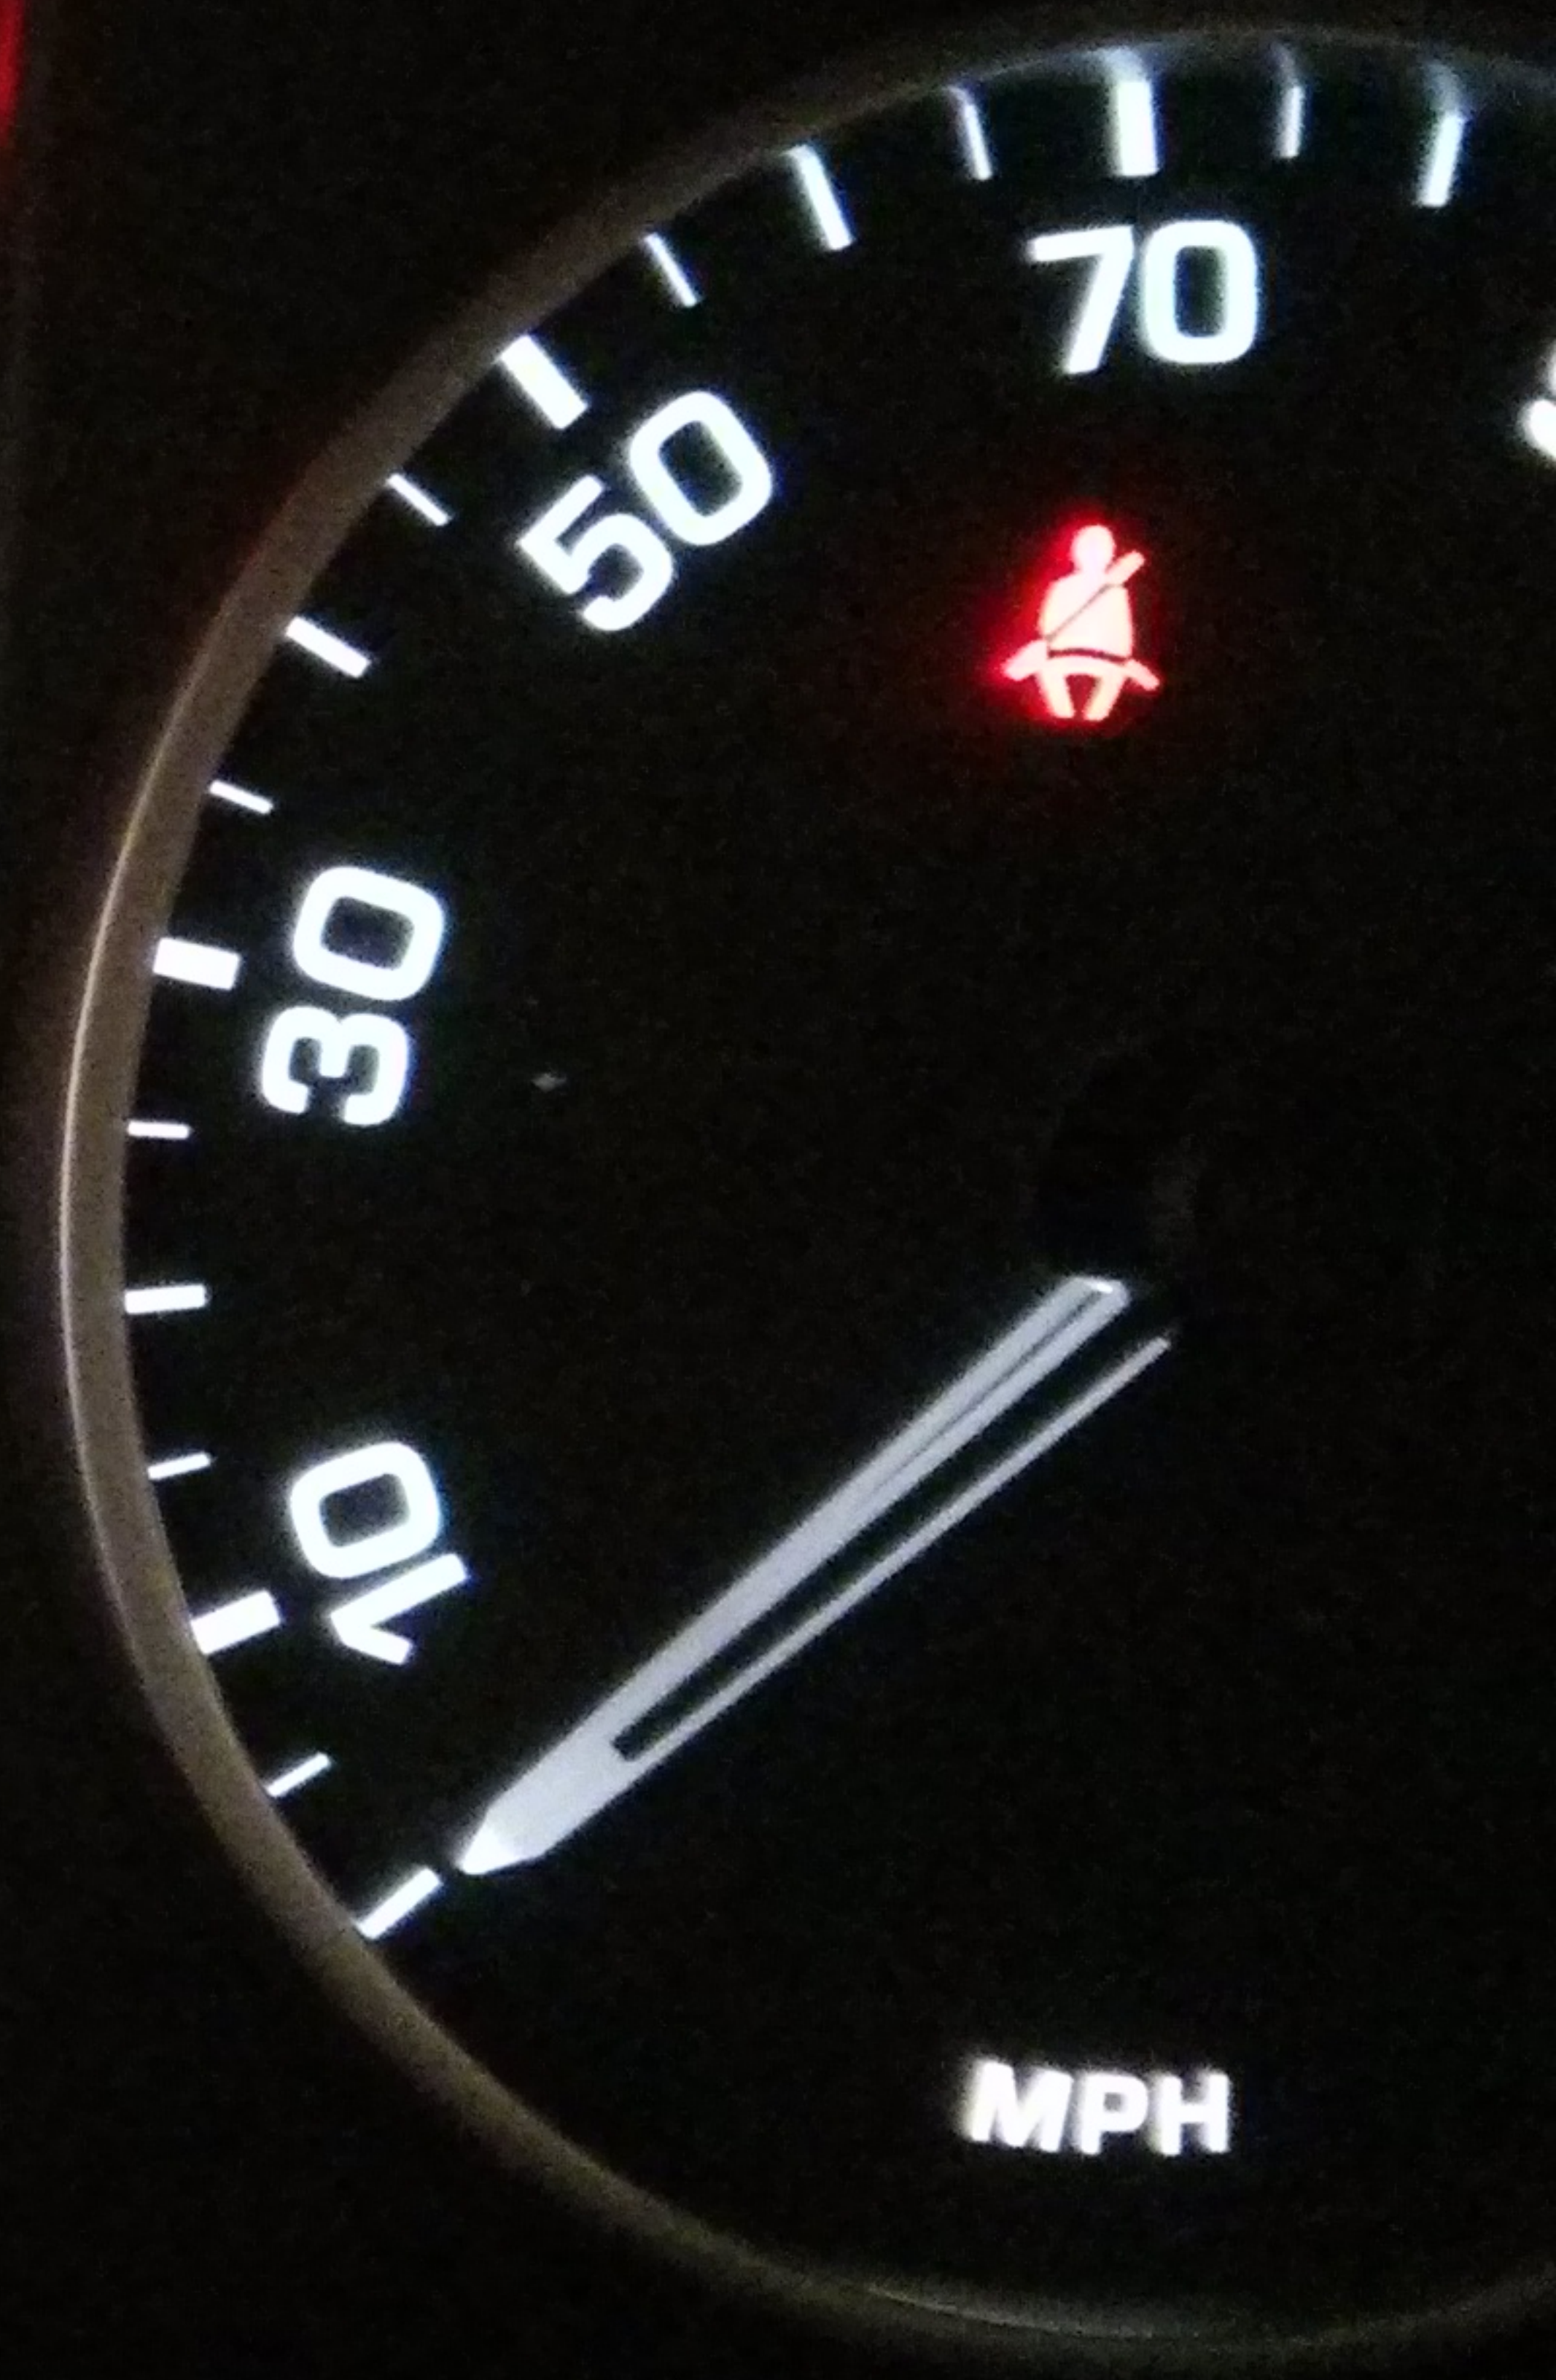
A customer may state their Terrain Optimisation display in the Instrument Cluster Message Center does not correctly match the actual terrain mode which has been selected. Also the text in the Instrument Cluster Message Center, for the selected terrain mode, does not display correctly. "BMP_TR_VEHICLE" is displayed instead of the correct corresponding text for the selected terrain mode.

Instrument Cluster software fault for the "English US" language selection.

For further clarification a photo has been attached showing the described concern.

New Instrument Cluster software is being developed and will be released as soon as possible. A further communication will announce the new software, when it becomes available.

As an interim solution, the customer may select "English UK" from the Instrument Cluster display menu as follows:

Main Menu > Display Settings > Language

Until further notice it is recommended that the UK English language instrument cluster option is selected as a PDI default prior to vehicle delivery and that customers are advised to retain that language option to prevent display concerns.
