TECHNICAL BULLETIN  
K219NAS1  
25 FEB 2014

Service Action: Power Cable Through-Panel Stud

<b>XK Range (X150)</b>	
<b>Model Year:</b>	2014
<b>VIN:</b>	B53580-B54243

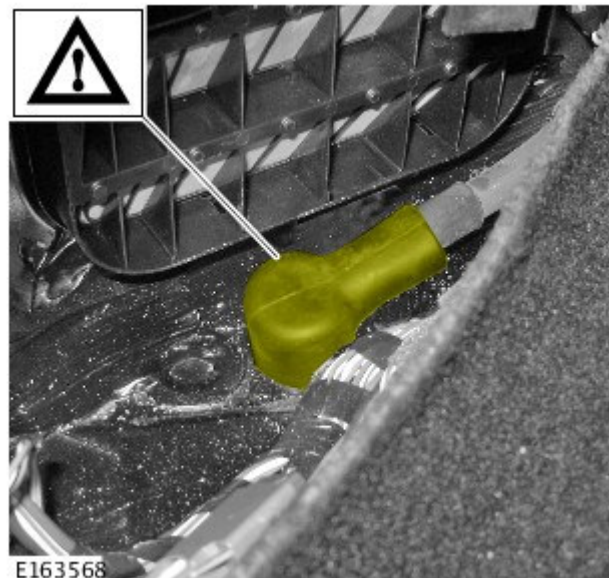
**NOTE: View from the rear left of the vehicle.**

Remove the power cable cover.

4. Loosen but do NOT remove the securing nut from

the stud.

- Apply downward pressure to the stud.
  - If the stud does not move downwards, carry out Procedure 1.
  - If the stud does move, in a downward direction, carry out Procedure 2.

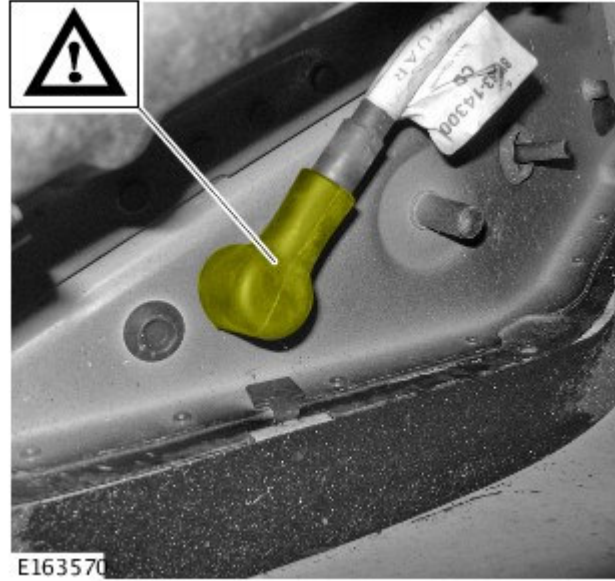
**NOTE: View from the rear left of the vehicle.**

Remove the power cable cover.

9. Tighten the securing nut.

- Torque: 9Nm.
- Install the power cable cover.
