**SERVICE BULLETIN**

**APPLICABILITY:** 2014MY XV Crosstrek Hybrid (HEV)

**NUMBER:** 07-81-14

**SUBJECT:** Revised Rear Combination Lamp to Prevent Condensation

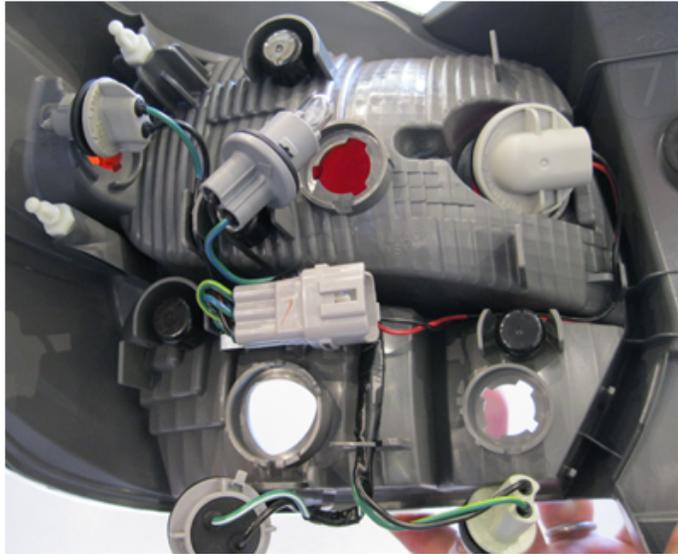
- The wiring harness assembly must be transferred over to the replacement combination lamp.
- **NOTE:** To properly position the harness into its retaining groove in the housing, the new additional sealing material just above the harness connector will need to be partially removed for access as shown in the photo sequence below. Do not disturb the material any more than necessary to properly position the harness.
- **CAREFULLY** lift/ peel the material up then, once the harness is tucked fully into the groove using a plastic trim tool, push the material back down into place.
