## SERVICE BULLETIN

**APPLICABILITY:** 2012 (AFTER VIN C\*411693)- 14 MY  
 Forester Models with 2.5L FB Engines

**NUMBER:** 02-144-13R

**SUBJECT:** Surface Treatment Change To Oil Control  
 Piston Rings

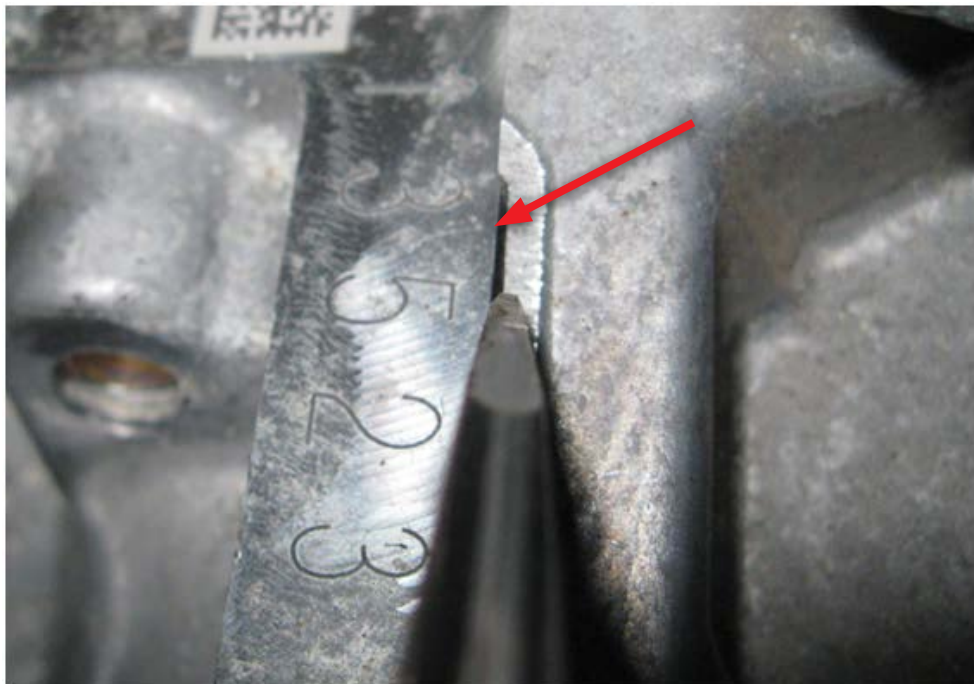
- To make separating the transmission (CVT) from the engine easier, there is a pry relief shown below in the machined mounting surface of the transmission case near the engine number. Use caution when applying any prying pressure and avoid twisting the tool to prevent case damage.

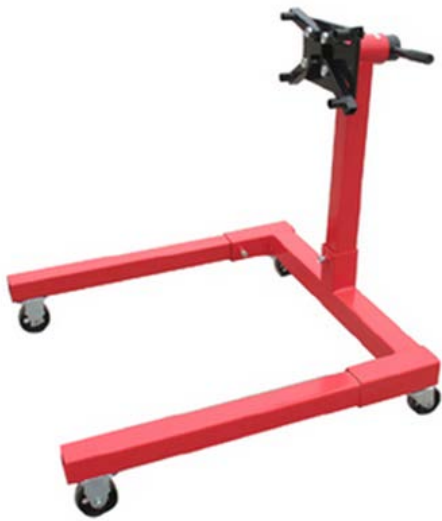
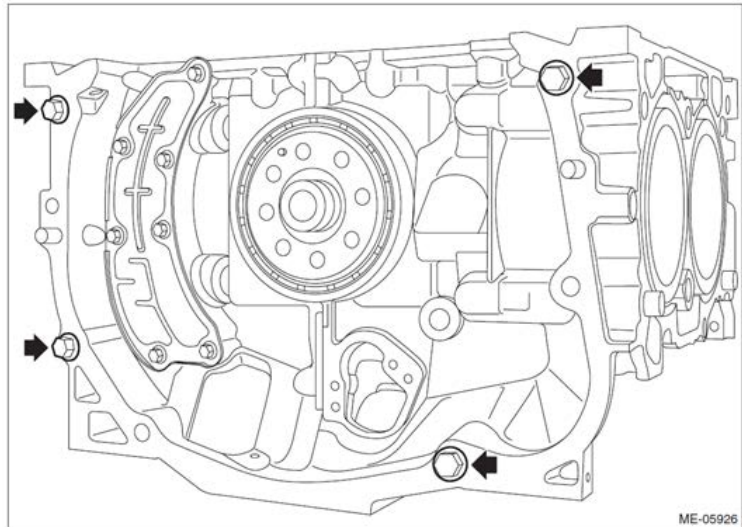
- Once the engine is removed, if you are using a generic engine stand (preferable since engine rotation is necessary), use the four mounting holes on the engine block shown below to mount it. Do not use the studs in the upper oil pan as the upper oil pan has to be removed to access the connecting rod bolts. **NOTE:** The connecting rod bolts are one-time-use and must be replaced.

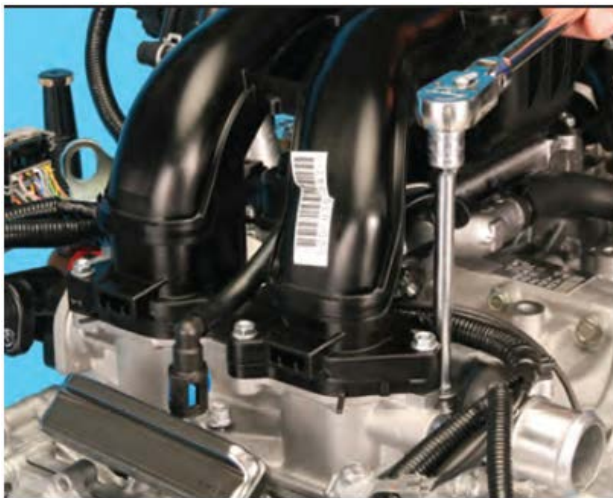
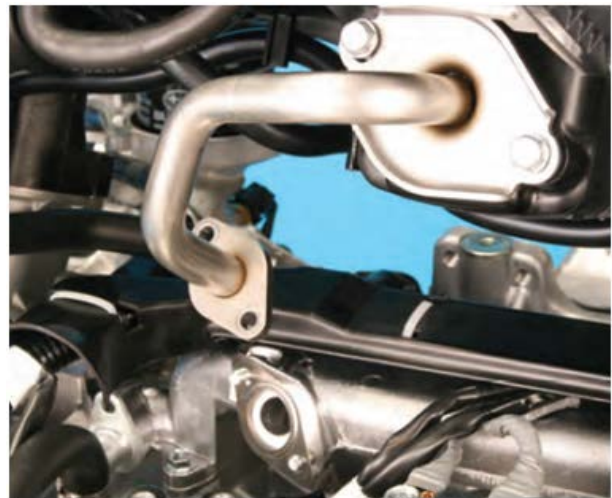
- When removing the intake manifold, as shown in the photos below, leave the TGV assemblies attached to the upper intake, remove the 2 nuts holding the EGR tube to the water pipe then remove the complete assembly from the cylinder heads as a unit.

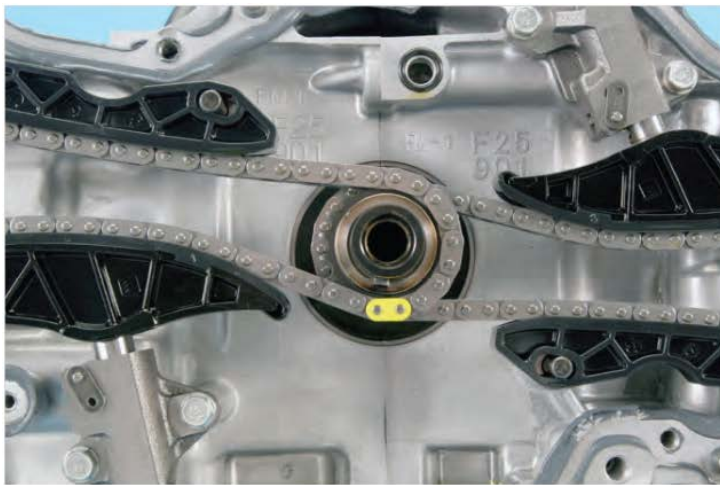
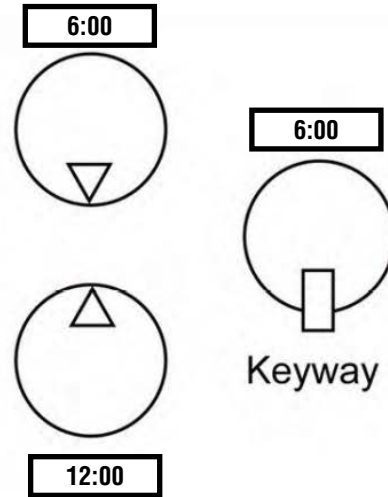
- Begin timing chain removal by positioning the crankshaft keyway at the 6:00 position. The RIGHT bank intake camshaft timing mark (Δ) must be at 6:00 with right bank exhaust timing mark at 12:00 (camshafts will be unloaded).

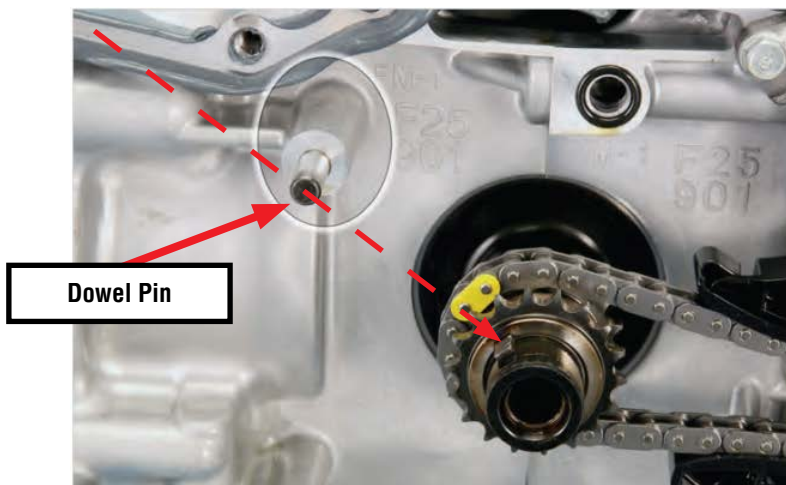
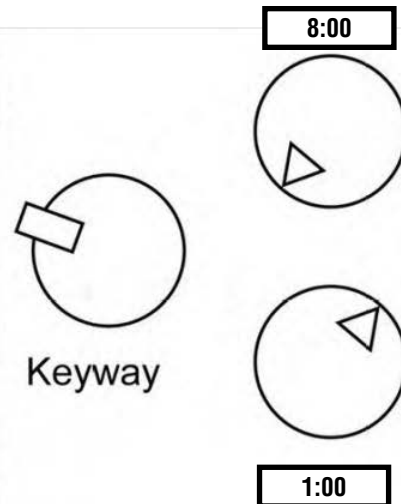
- Compress the chain tensioner by hand, insert a pin through the lever into the access hole to lock the plunger in place then remove the 2 bolts, tensioner, guides and right side timing chain.
- After turning the crankshaft **CLOCKWISE**, repeat the procedure for the LEFT side with the timing marks (Δ) positioned as shown below. Align the crankshaft sprocket keyway with RH chain dowel pin (shown in red below).

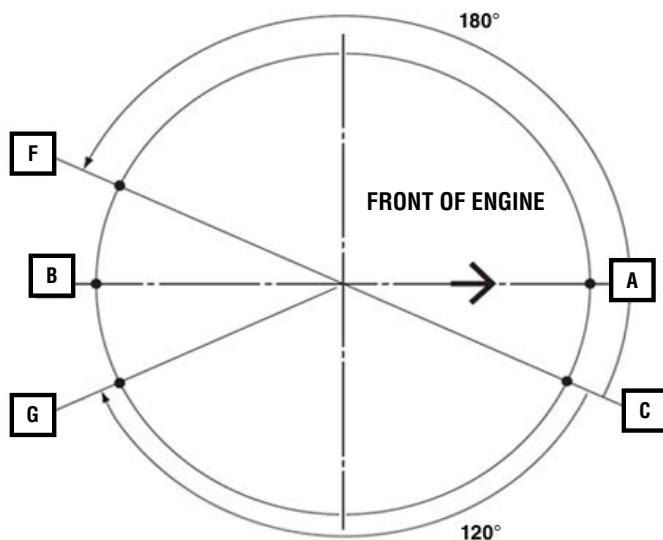
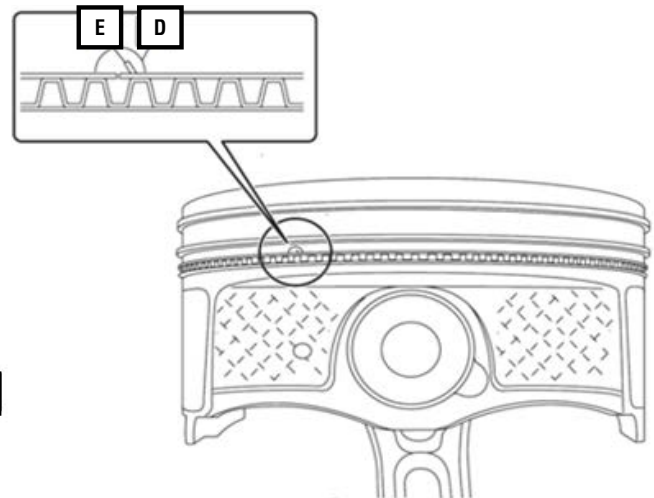
- “A”- Top compression ring end gap location
- “B”- Second compression ring end gap location (180 degrees away from “A”)
- “C”- Top oil control scraper ring end gap
- “D”- Recess in top of ring land to accept the “tang” of the upper oil control scraper ring - “E”
- “F”- Expander gap (180 degrees away from “C”)
- “G”- Bottom oil control scraper ring end gap (120 degrees away from “C”)

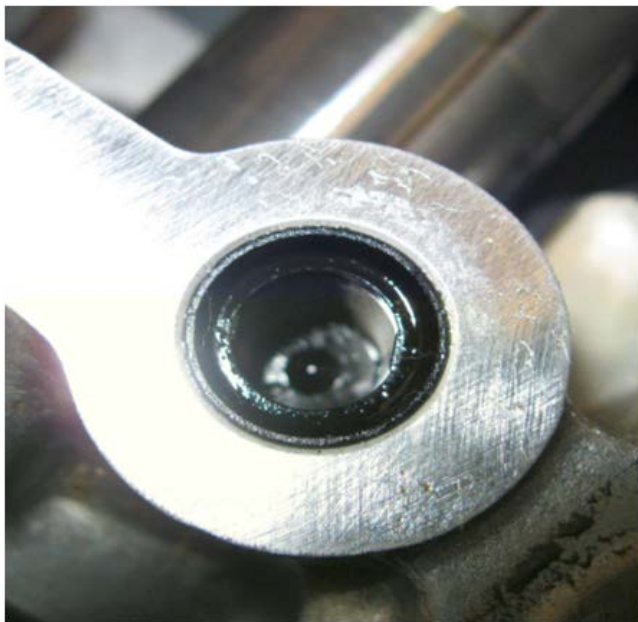
**Cam Carrier Filter Screen**

- ALWAYS install new connecting rod bolts as they are one-time use items.
- It is very important to take the time necessary to thoroughly clean the old silicone sealer from all the removed components before reassembly. It is a good idea to clean the surrounding areas then use tape to block off any oil passages in the front cover and cam carrier so any small bits of removed silicone debris are kept from entering the oil passages and possibly causing problems after reassembly. Once all the old sealer has been removed, remove any block-off tape, rinse out any oil passages thoroughly with brake cleaner and shop air.
- Don't forget to clean (**without removing**) the filter screens in the cam carriers (one filter in each carrier). In addition, always be sure to do a thorough inspection and cleaning of the oil pan, pick-up tube and screen as shown in the photos below before reassembly.

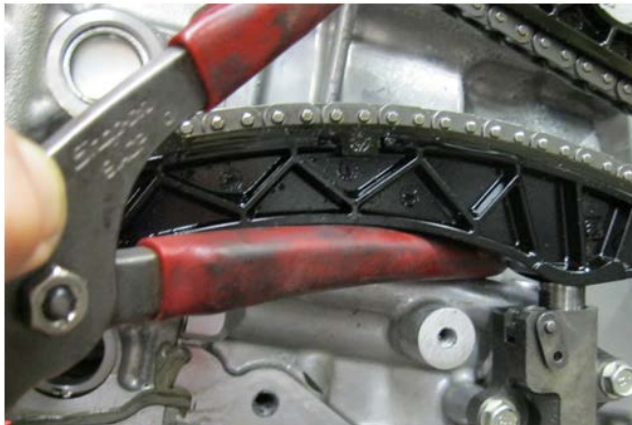
- Same as the left side, align the indicator links to the timing marks found on the cam sprocket assemblies. Install the chain guides and tensioner. Once proper positioning has been confirmed, pull the pin to release the tensioner. With your hand, grab and squeeze the upper and lower left side chain / guides together to allow the plunger in the tensioner to fully extend and click into its furthest notch as shown in the previous (right side) photo. If necessary, insert a rubber-coated plier handle between the ledge area on the front of the block and the right side (B1) lower chain guide. Then, **VERY CAREFULLY** lift up on the guide just enough to get the extra “click” on the tensioner as shown in the photo below.

Rubber-coated plier handle inserted between a ledge area on the front of the block and the B1 lower chain guide **VERY CAREFULLY** lifting upward on the lower guide.
