ARTICLES CONTAINED IN THIS ISSUE

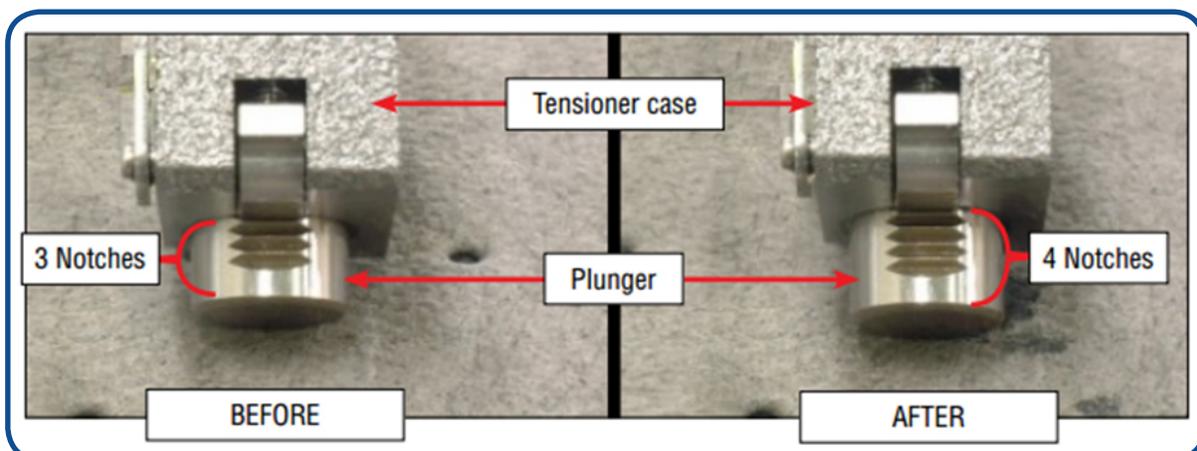
For example: If after timing component reassembly, you have 3 notches showing on the plunger, push down firmly on the upper chain guide to get the extra click so you end up having 4 notches showing. If you have 4 notches showing, you want to get the extra click to end up with 5. Whether you start with 3 notches or 4 showing depends on the amount of wear there is on the guides and timing chain.

NOTE: It is **NOT RECOMMENDED** to use a pair of large channel lock-type pliers to squeeze the chain guides together and achieve the desired tensioner setting. Damage to the guides will likely result.

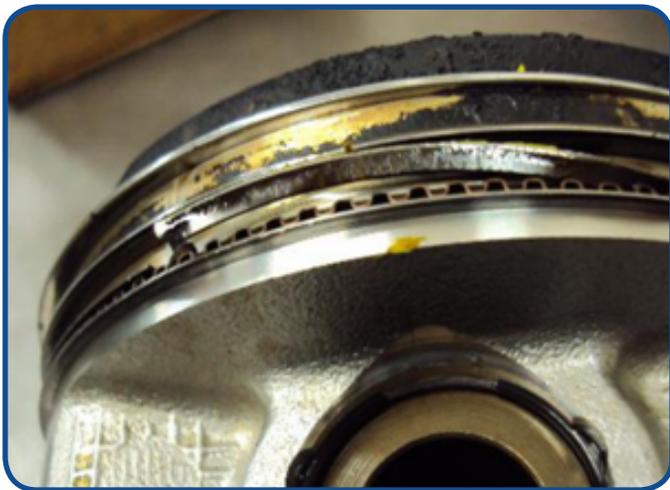
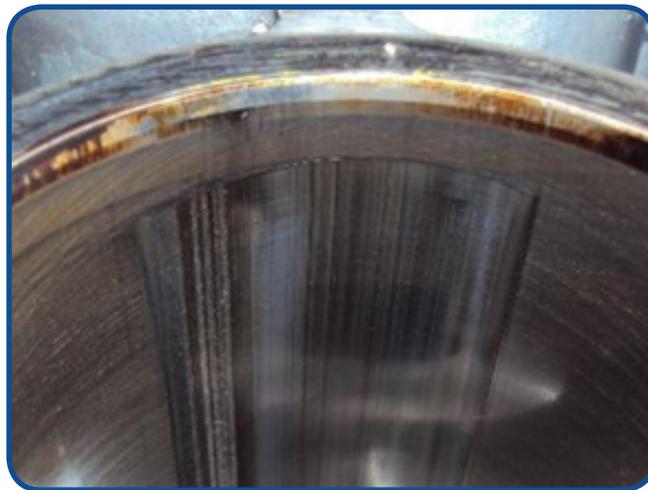
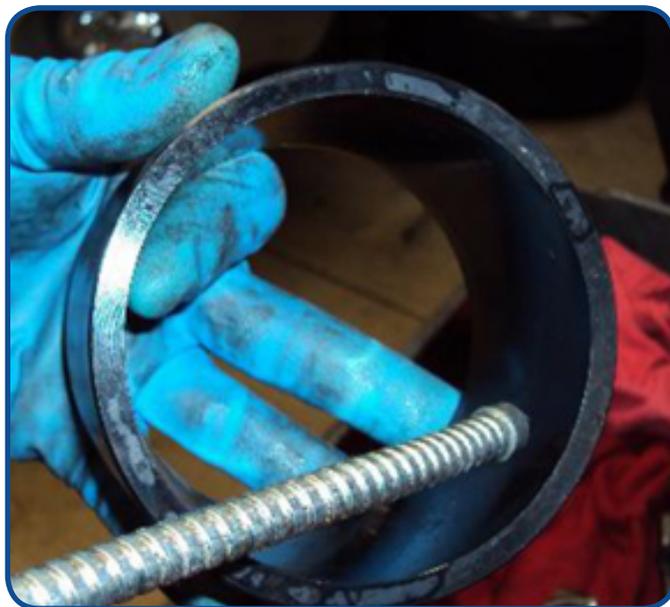
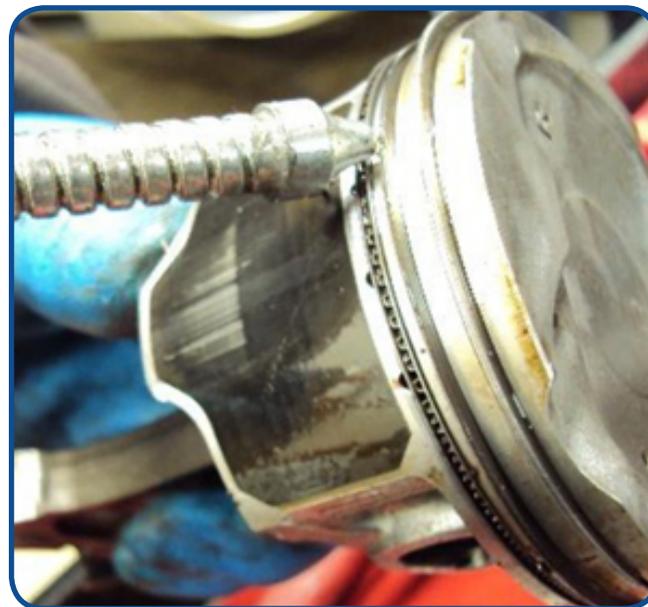
The Techline has received a limited number of reports with concerns of unusual oil consumption even after piston ring replacement. Most times, this condition is a result of incorrect piston ring installation resulting in either oil control rings being damaged or the piston ring end gaps becoming lined up. To build upon the piston ring replacement procedures included in the three recent surface treatment change to oil control / piston ring TSBs, the following tips are provided below.

This type of piston ring compressor takes the guesswork out of whether the rings are compressed sufficiently to enter the cylinder. This can be difficult to determine when using an adjustable band - type compressor resulting in a grip that may be too tight or too loose on the piston assembly. It also provides the best “seal” to the block deck surface when installing the piston assembly into the bore and minimizes the chance of oil scraper rings popping out from between the ring compressor and the block deck surface. It is important to always hold the compressor firmly on the block surface as shown in the above, right photo. Use one firm, direct motion for the actual piston assembly insertion. If an oil scraper ring is displaced during engine assembly, severe piston and cylinder wall damage will result. At that point, the need for a short block replacement is virtually guaranteed. The photos below illustrate damage that occurred when an improperly installed oil control ring went undetected during engine reassembly. Always turn the engine over after each piston assembly is installed and develop a “feel” for how much turning effort is required. If it doesn’t “feel” right and seems to take more effort than normal, a loose / bent over scraper ring might just be the cause. In addition, check for any unusual vertical markings on the cylinder walls after rotating the crankshaft by hand. The photo at the top of page five (5), on the left, shows an upper oil scraper ring bent over and on the right, the resultant damage to the cylinder wall after the engine was taken apart again because of persistent, unusual oil consumption.

All three bulletins (02-143-13R, 02-144-13R and 02-145-13R) recommend the use of the factory tapered or non-adjustable - type piston ring compressor, J-50553 for 2.5L FB engines and J-50984 for 2.0L FA engines as illustrated below.

As a reminder, always lubricate the rings, cylinder walls and the ring compressor liberally with engine oil then give a final check of the ring end gap positions before installation into the ring compressor and cylinder bore.
