**SERVICE BULLETIN**

**APPLICABILITY:** 2015MY WRX Models with 2.0L DIT Engine      **NUMBER:** 09-59-14  
**SUBJECT:** Rust Treatment Procedure for Heat Shield Retaining Bolt Heads      **DATE:** 11/18/14

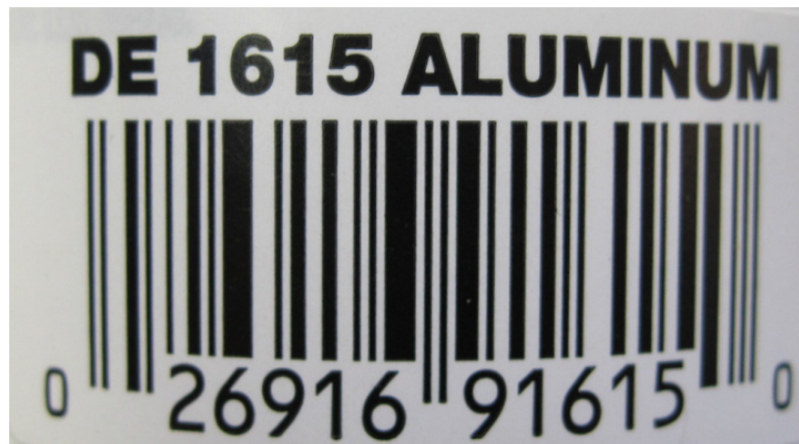
- 1 - 12 ounce aerosol can of silver or aluminum color High Heat Engine Enamel. During the development of this bulletin, Dupli-Color® # DE1615 Aluminum Engine Enamel aerosol spray was used. This product is available at most major auto parts retailers

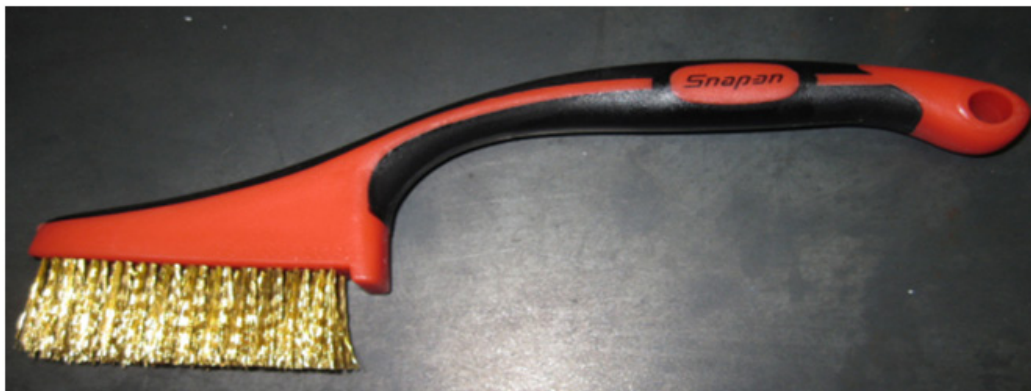
- 1 - **BRASS** wire bristle detail brush. **CAUTION:** Stainless bristles are likely to be too aggressive and may damage the coating applied to the surrounding heat shield material.

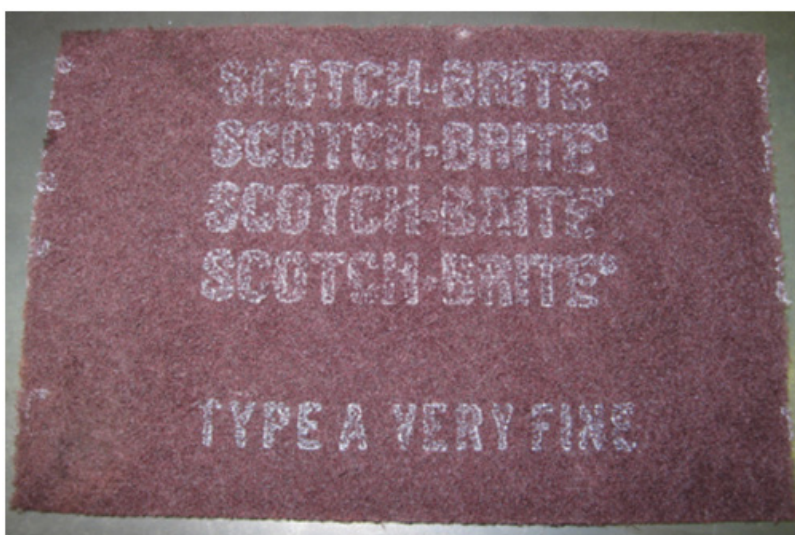
- 1 - Scotchbrite® surface conditioning pad.

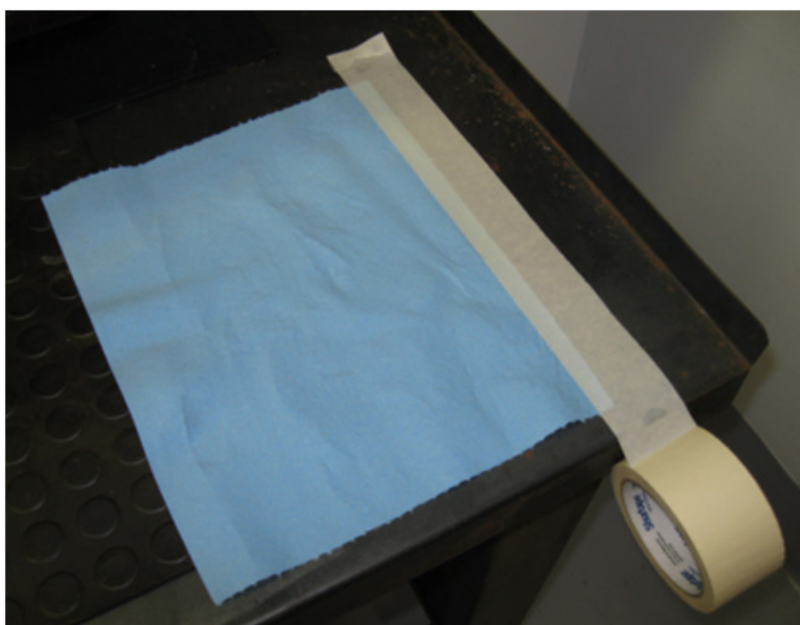
Paint Masking materials consisting of masking tape and paper to protect the surrounding components from overspray.
