VW Elsa Newsletter

Edition 94: July 14, 2014

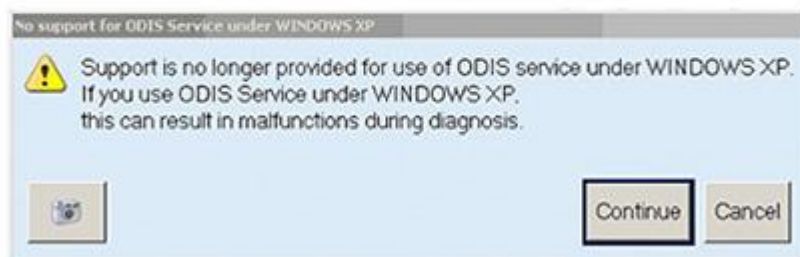
- Beginning with application **version V2.2.0 – feature number 6.0.5**, ODIS Service functions are no longer supported on devices with Windows XP.
- ODIS Service application **version 2.2.0 – feature number 6.0.5** is scheduled for online update release **on July 14th**. The successful installation and function of this update is only possible on VAS diagnostic devices with Windows 7.
- **DO NOT** attempt to install an online update identified by **feature number 6.0.5** (or higher) on devices with Windows XP! The feature number is always indicated in the download prompt.
- If the update specified above is inadvertently installed and ODIS Service is started, the following message will appear:

- To ensure that the latest versions of ODIS Service are always installed, we urge you to update all eligible diagnostic devices from Windows XP to Windows 7 immediately.
