Program Bulletin

CUSTOMER SATISFACTION PROGRAM

SUBJECT: Front Strut - Noise

MODELS: 2012-2013 Chevrolet Colorado
2013 Chevrolet Trailblazer

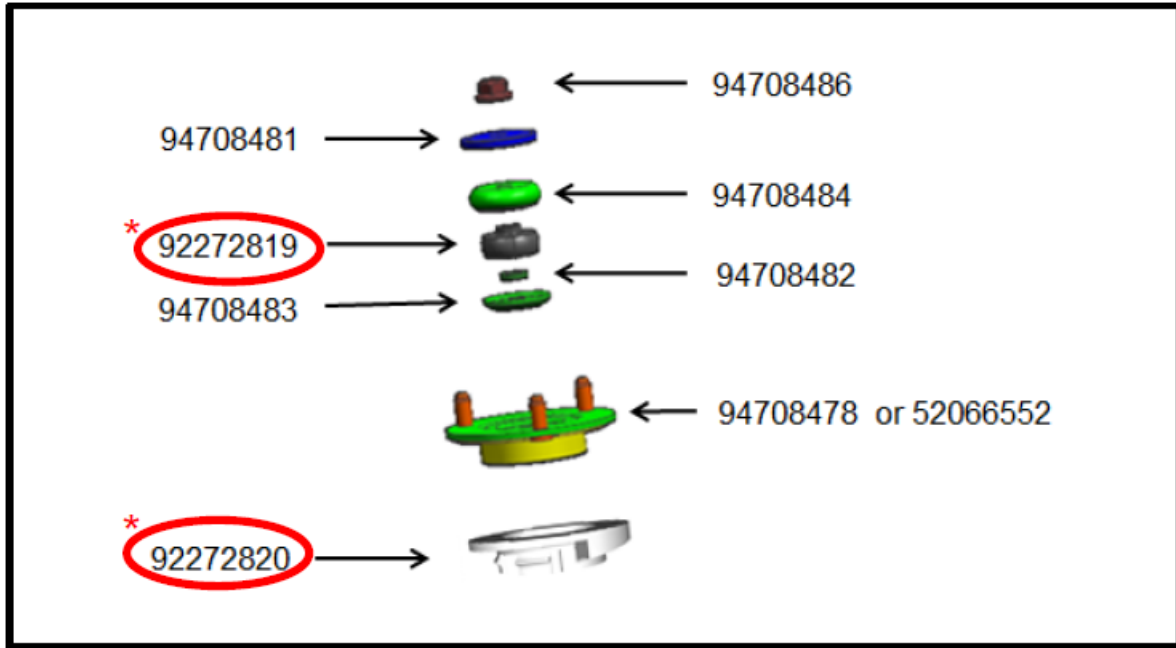
Improved part – Change all of the affected VINs

Item	Part No	Quantity	Remark
Spring Seat Isolator (Improved part)	52057793	2	Replace all VINs
BUMPER, FRT S/ABS UPR ((LOWER) (Improved part)	92272819	2	Replace all VINs
