# Recall Bulletin

## PRODUCT SAFETY RECALL

**SUBJECT:** Brake Booster Pump – Cavity Plug

**MODELS:** 2013 and some 2014 Cadillac XTS

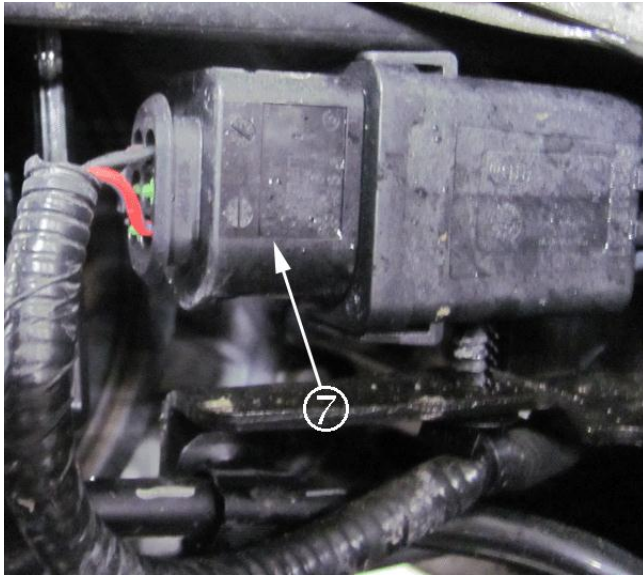
3773716

3. Locate the power brake booster pump electrical connector (7).
4. Disconnect the power brake booster pump electrical connector (7).
5. Inspect the connector for debris and/or corrosion. Clean the connector if required.
6. Determine if three green plugs are installed in the backside of the connector. The green plugs are installed into three of the six cavities on the backside of the connector. Refer to the photograph below.

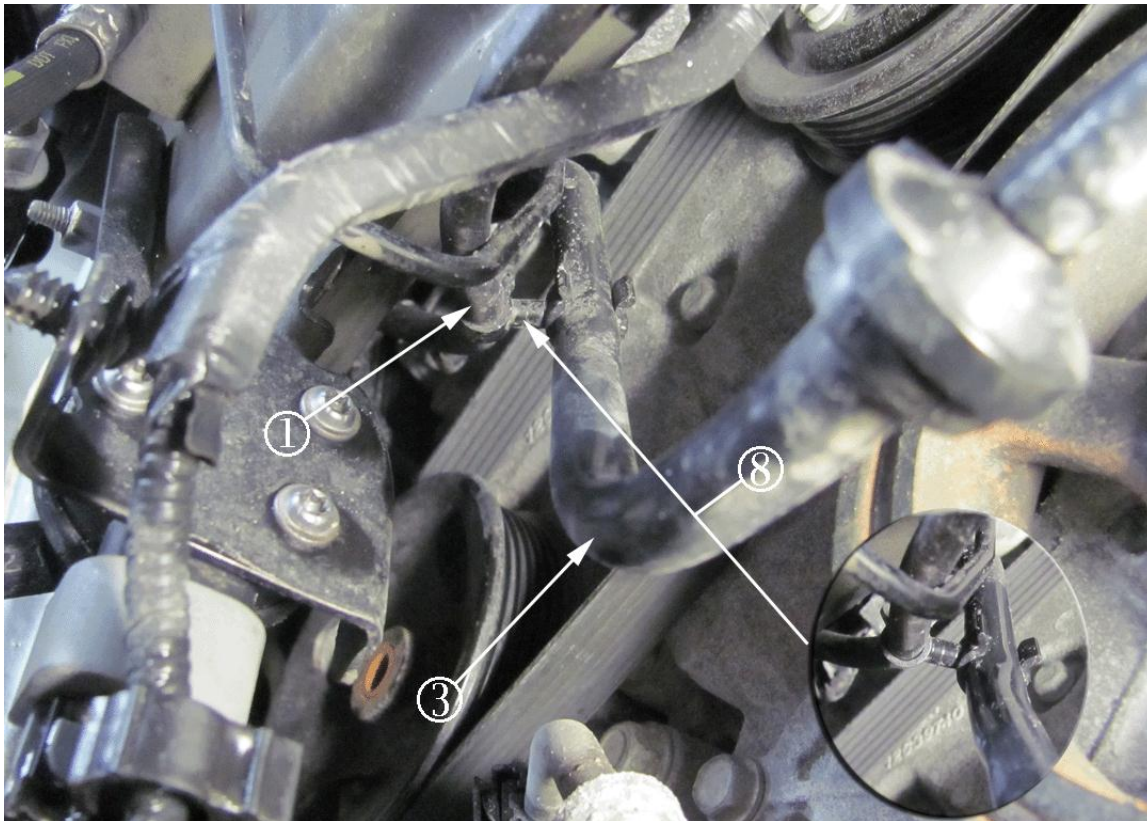
3773720

10. Locate the dual hose/pipe clip (8) that secures the power brake booster pump inlet pipe (3) and vent hose (1).
