Recall Bulletin

PRODUCT SAFETY RECALL

SUBJECT: Front Safety Belt Anchor

MODELS: 2009-2014 Buick Enclave
2009-2014 Chevrolet Traverse
2009-2014 GMC Acadia
2009-2010 Saturn Outlook

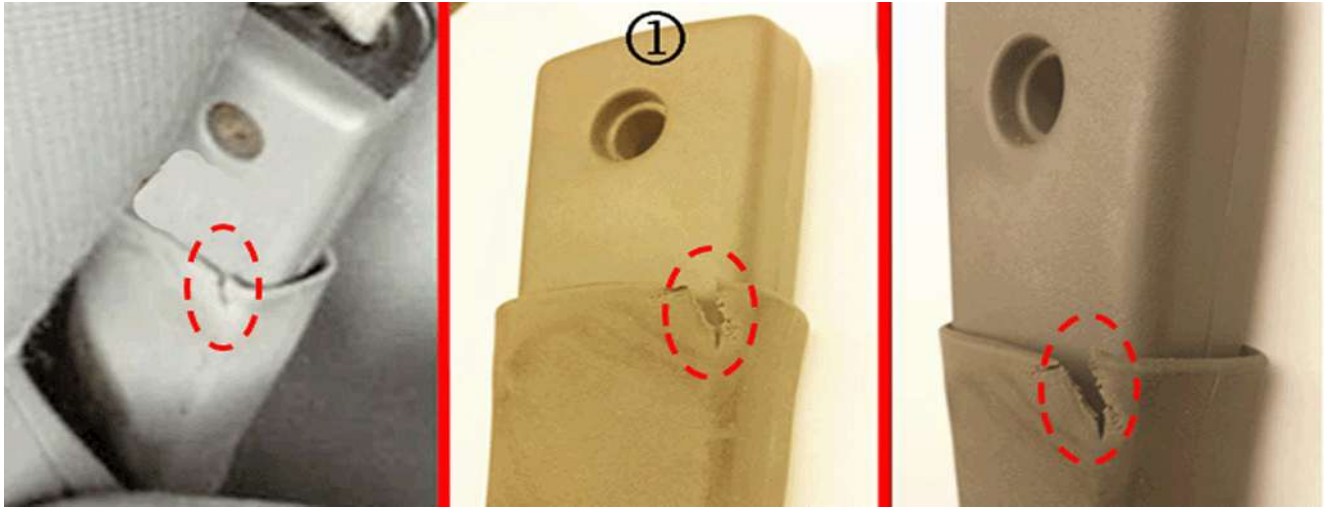
3910757

2. Inspect the seat belt anchor plate tensioner sleeve for any tears (1), holes (2) or wear (3).
 - If the driver **AND** passenger seat sleeves show no visible tears, holes or wear – Proceed to the *Rework Service Procedure*.
 - If either **ONE, OR BOTH**, of the driver and/or passenger seat sleeves show tears, holes or wear – Proceed to the *Rework Service Procedure* for the **UNDAMAGED** sleeve, then continue on to *Front Seat Belt Tensioner Replacement Procedure* for the **DAMAGED** sleeve(s).
