Program Bulletin

CUSTOMER SATISFACTION PROGRAM

SUBJECT: Power Steering Hose Leak

MODELS: 2006 Chevrolet Impala, Monte Carlo (V6 & V8 Engine)
2005-2006 Pontiac Grand Prix (V8 Engine)

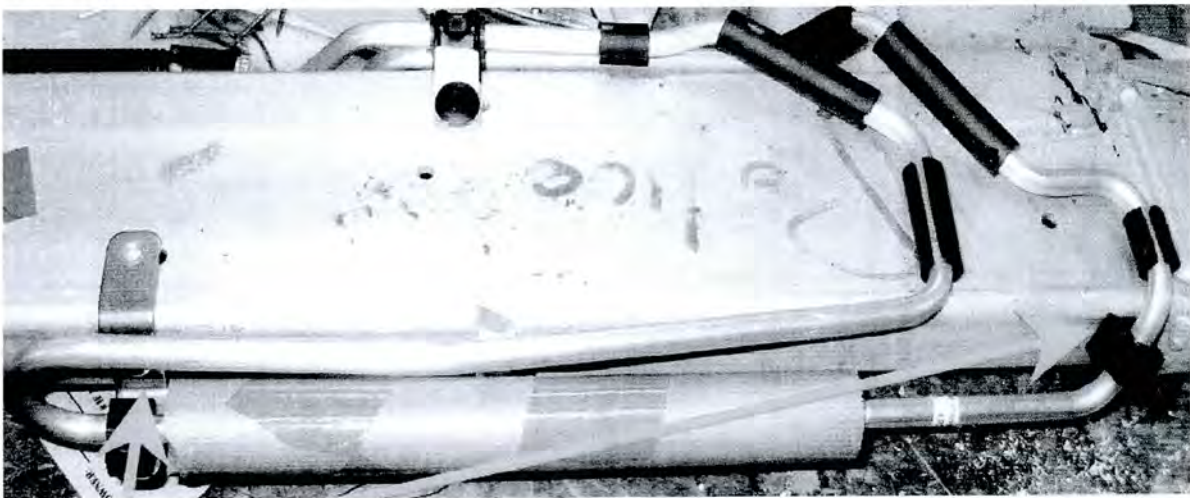
1854947

Note: The location of the leak (1) is shown above. Fittings on the hose are crimped socket and are not likely to leak.

- Two holes will be drilled for retro-fitting 2006 cradles with 2007 cooler pipe.
 - Technician will need to remove one clip from cooler pipe on top and replace with isolator, and move the other to the front face of the cradle (and replace with isolator).
 - Technician will need to glue down the two isolators with SAF-T-LOK IB-45 (ETHILCIANOCRILATO) or GM equivalent.
1. Raise and support the vehicle. Refer to the *Lifting and Jacking the Vehicle* procedure in SI.
 2. Place a drain pan under the vehicle to capture the power steering fluid when disconnecting the power steering return line.
 3. Remove the air deflector.
 4. Remove the power steering cooler pipe/hose from the retaining clips on the frame.
