Bulletin No.: PIC5428D

Service Bulletin

Subject: EBCM Wheel Speed Sensor Diagnostic Aid for ABS Message - Click Or Ratchet Noise - Service Traction Message - Service StabiliTrak Message

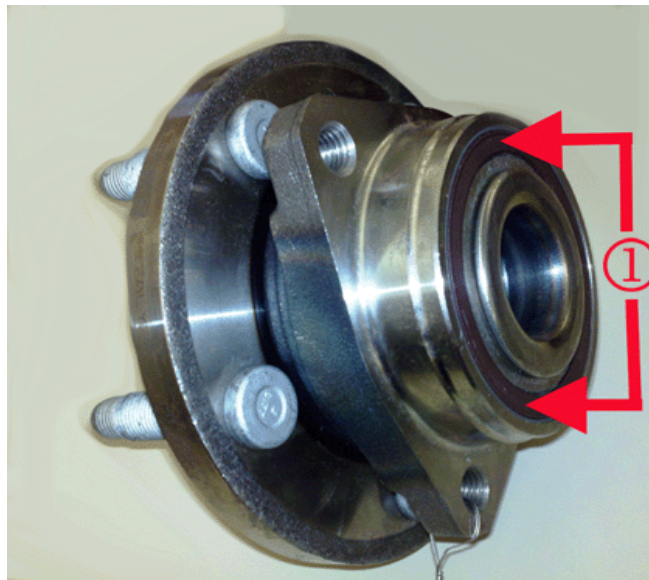
2596032

These conditions may be caused by single or multiple pieces of ferrous metallic debris stuck to the wheel speed sensor magnetic encoder ring. This magnetic encoder ring is now part of the inboard bearing hub assembly.

1. Magnetic Encoder Ring

Inspect and clean debris from the Encoder Ring.
