# SERVICE BULLETIN

Classification: EC12-012	Reference: NTB12-051	Date: June 19, 2012
-----------------------------	-------------------------	------------------------

## 2011 - 2012 ALTIMA; MIL "ON" WITH DTC P0101

**APPLIED VEHICLES:** 2011 - 2012 Altima Sedan (L32) with QR25 only  
2011 - 2012 Altima Coupe (CL32) with QR25 only

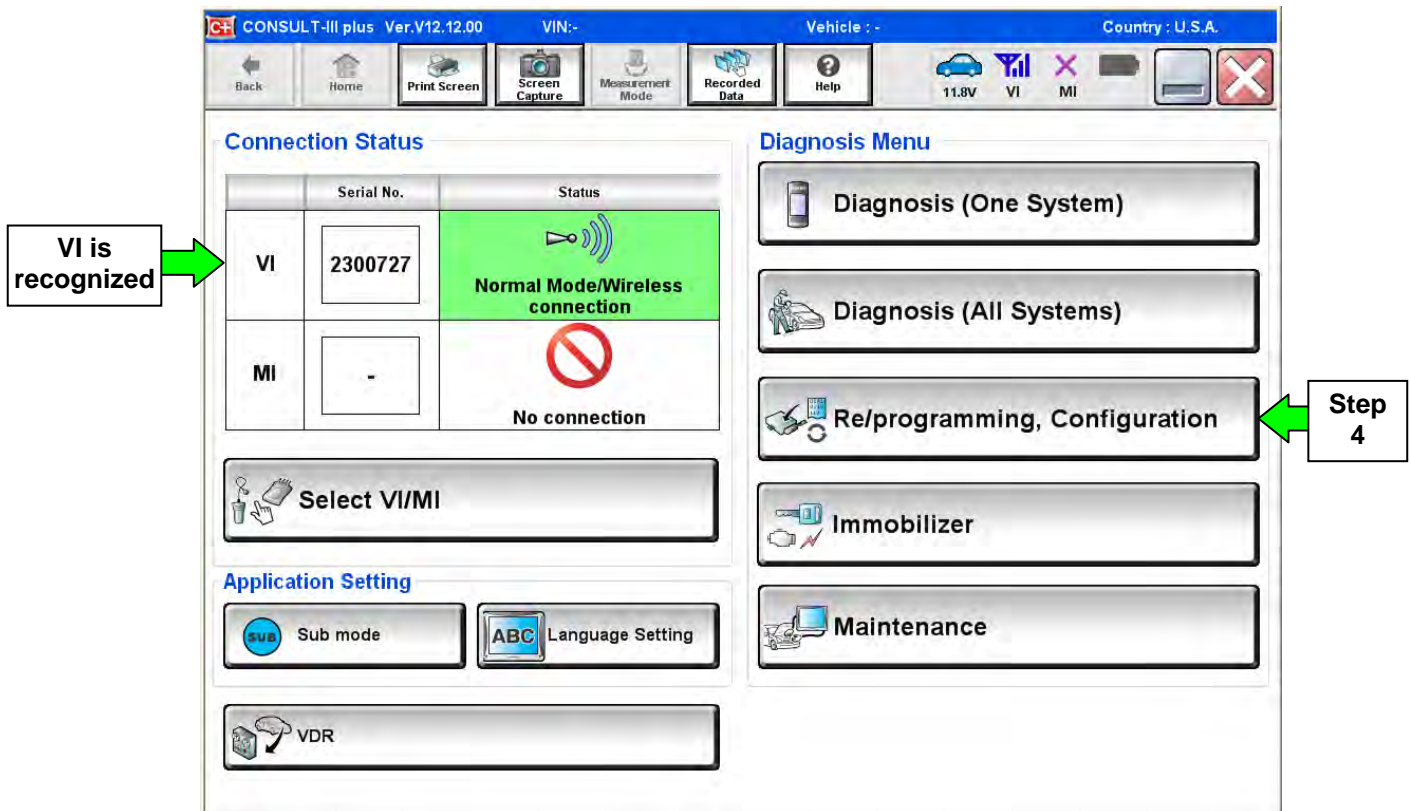
Figure 1

1. Connect the CONSULT PC to the vehicle to begin the reprogramming procedure.
2. Open ASIST on the CONSULT PC and start C-III plus.
3. Wait for the plus VI to be recognized / connected.
  - The serial number will display when the plus VI is recognized / connected.
4. Select **Re/programming, Configuration**.

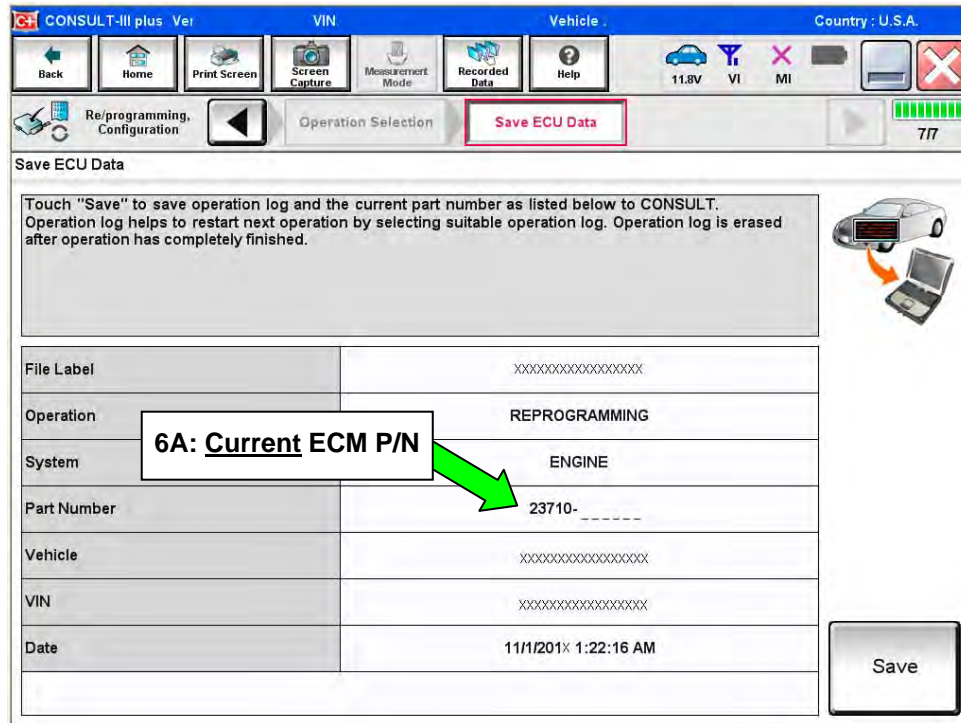
Figure 2

6. When you get to the screen shown in Figure 2, confirm this bulletin applies as follows.
- A. Find the ECM **Part Number** and write it on the repair order.

**NOTE:** This is the current ECM Part Number (P/N).

- B. Compare the P/N you wrote down to the numbers in the **Current ECM Part Number** column in **Table A** below.
- If there is a match, this bulletin applies. Continue with the reprogramming procedure.
  - If there is not a match, this bulletin does not apply. Close C-III plus and refer to ASIST for further diagnostic information.

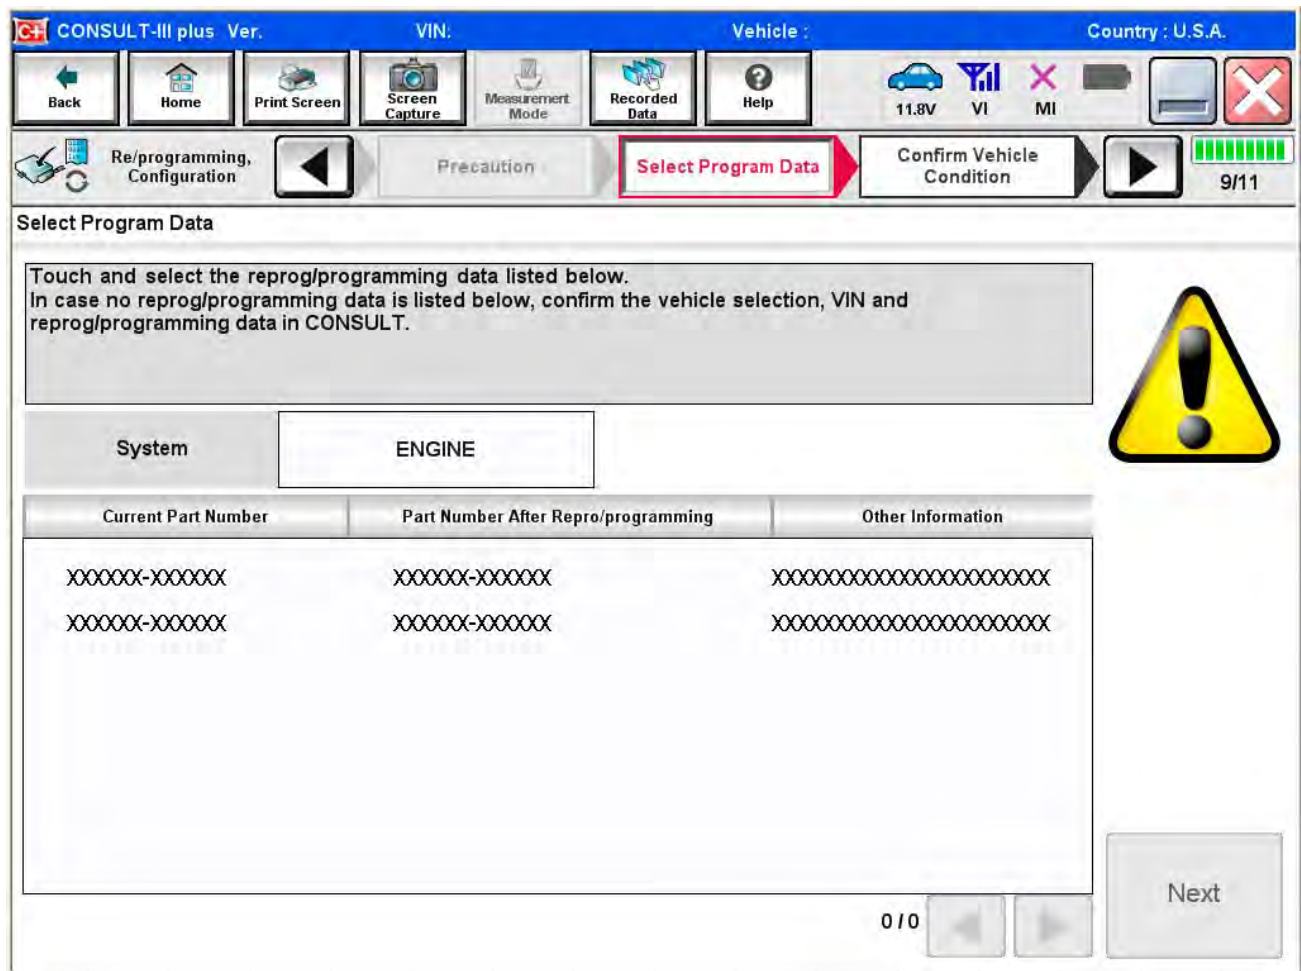
- In some cases, more than one new P/N for reprogramming is available.
  - In this case, the screen in Figure 3 displays.
  - Select and use the reprogramming option that **does not** have the message “Caution! Use ONLY with NTBXX-XXX”.
- If you get this screen and it is blank (no reprogramming listed), it means there is no reprogramming available for this vehicle. Close C-III plus and refer back to ASIST for further diagnosis.

7. Follow the on-screen instructions to navigate C-III plus and reprogram the ECM.

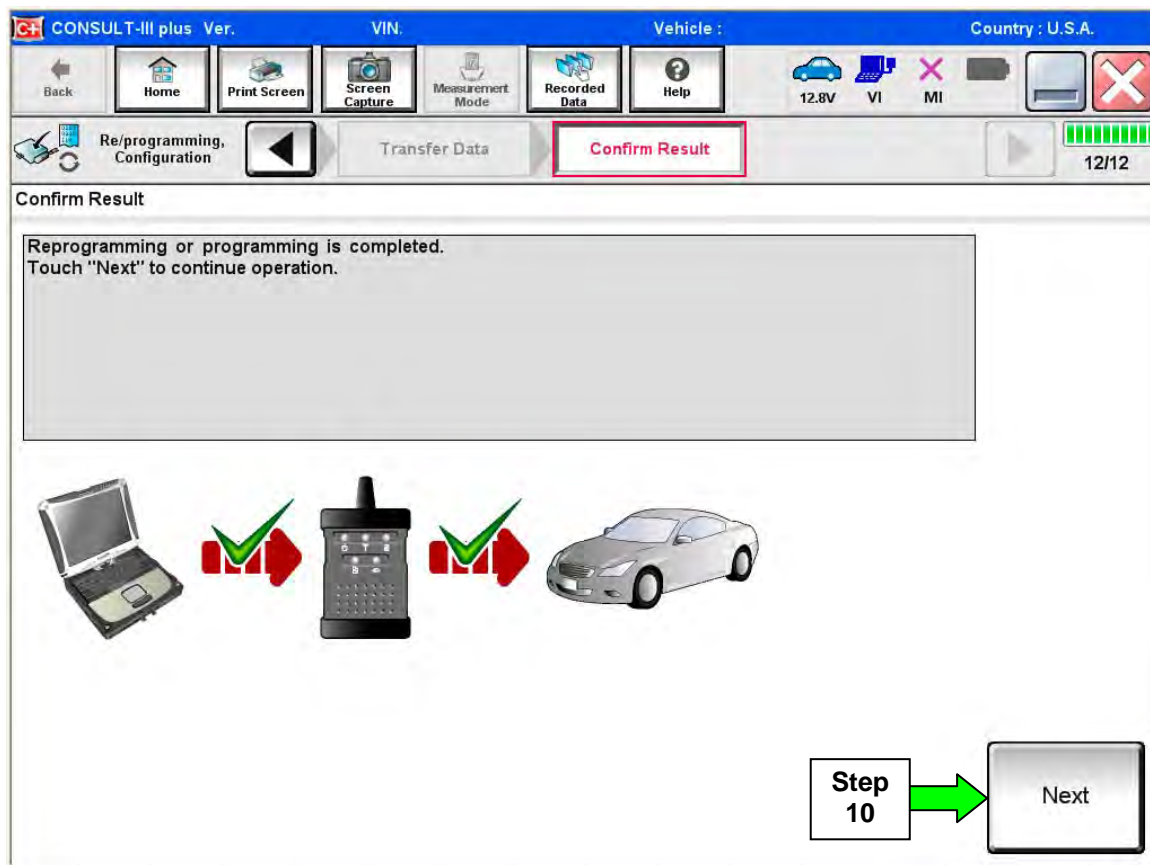
8. When the screen in Figure 4 displays, reprogramming is complete.

**NOTE:** If the screen in Figure 4 does not display (reprogramming does not complete), refer to the information on page 7.

9. Disconnect the battery charger from the vehicle.

10. Select **Next**.

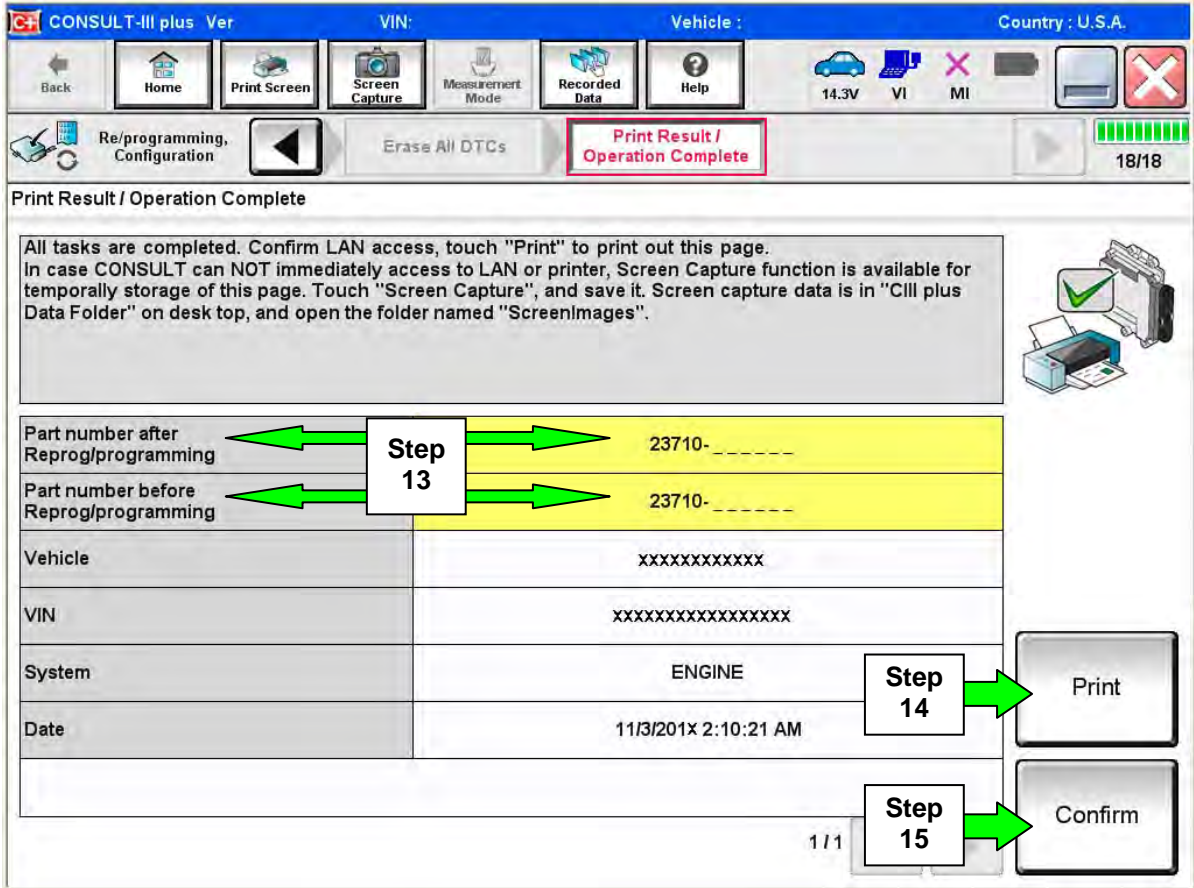
- 12. When the entire reprogramming process is complete, the screen in Figure 7 will display.
- 13. Verify the before and after part numbers are different.
- 14. Print a copy of this screen (Figure 7) and attach it to the repair order for warranty documentation.
- 15. Select **Confirm**.

- 16. Close C-III plus.
- 17. Turn the ignition OFF.
- 18. Disconnect the plus VI from the vehicle.
- 19. Test drive the vehicle and make sure it operates correctly and the MIL is OFF.
  - If the MIL comes ON, go back to ASIST for further diagnostic information.
  - Diagnosis and repairs beyond ECM reprogramming are not covered by this bulletin.
