VOLVO CARS SERVICE AND PARTS BUSINESS

Technical Journal

TITLE:
**No or intermittent unlocking function from door handles
(S60 w/ Keyless drive)**

REF NO: TJ 26520	ISSUING DEPARTMENT: Technical Service	CAR MARKET: United States and Canada		
PARTNER: 3 US 7510 Volvo Cars North America		ISSUE DATE:		
FUNC GROUP: 8340	FUNC DESC: Lock, handle	YEAR 2014	MONTH 03	DAY 04
Page 1 of 5

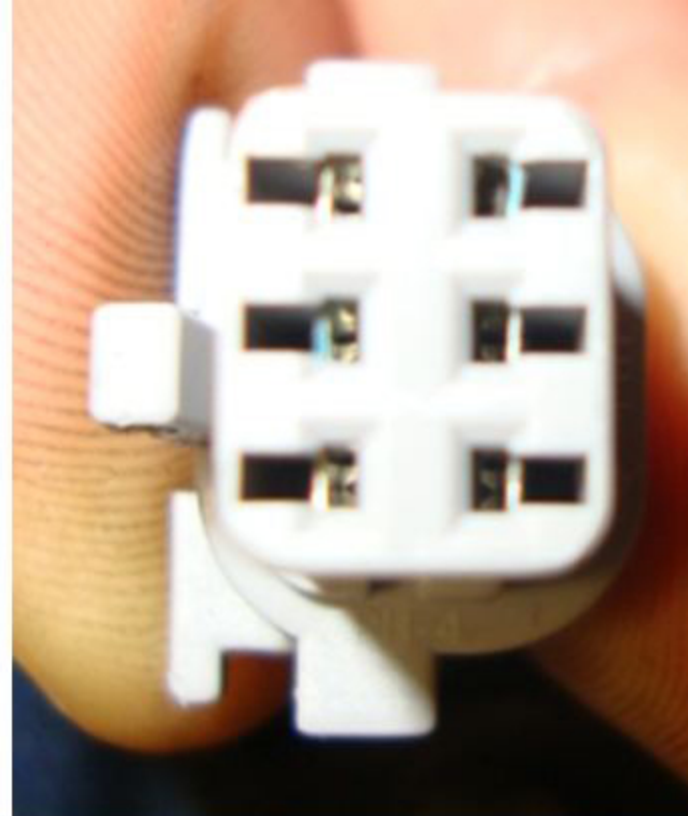
See Corrosion.JPG .

If corrosion is found, the door handle must also be replaced, as it is likely that the corrosion was caused by water leakage through the handle. See TJ 27787 for instructions on reusing painted outer door handle covers.

If the corrosion has extended deep enough into the harness that the copper is discolored at the location where the splices would be made, the harness cannot be properly repaired with the extension cables; the entire door harness must be replaced.
