SERVICE BULLETIN

APPLICABILITY: 2013MY Legacy and Outback 2.5L Models
 2012-13MY Impreza 2.0L Models
 2013MY XV Crosstrek
 2011-2014MY Forester
 2013MY BRZ

NUMBER: 11-130-13R
DATE: 04/05/13
REVISED: 01/28/14

SUBJECT: Difficulty Starting, Rough Idle, Cam Position or Misfire DTCs
 P0340, P0341, P0345, P0346, P0365, P0366, P0390, P0391,
 P0301, P0302, P0303 or P0304

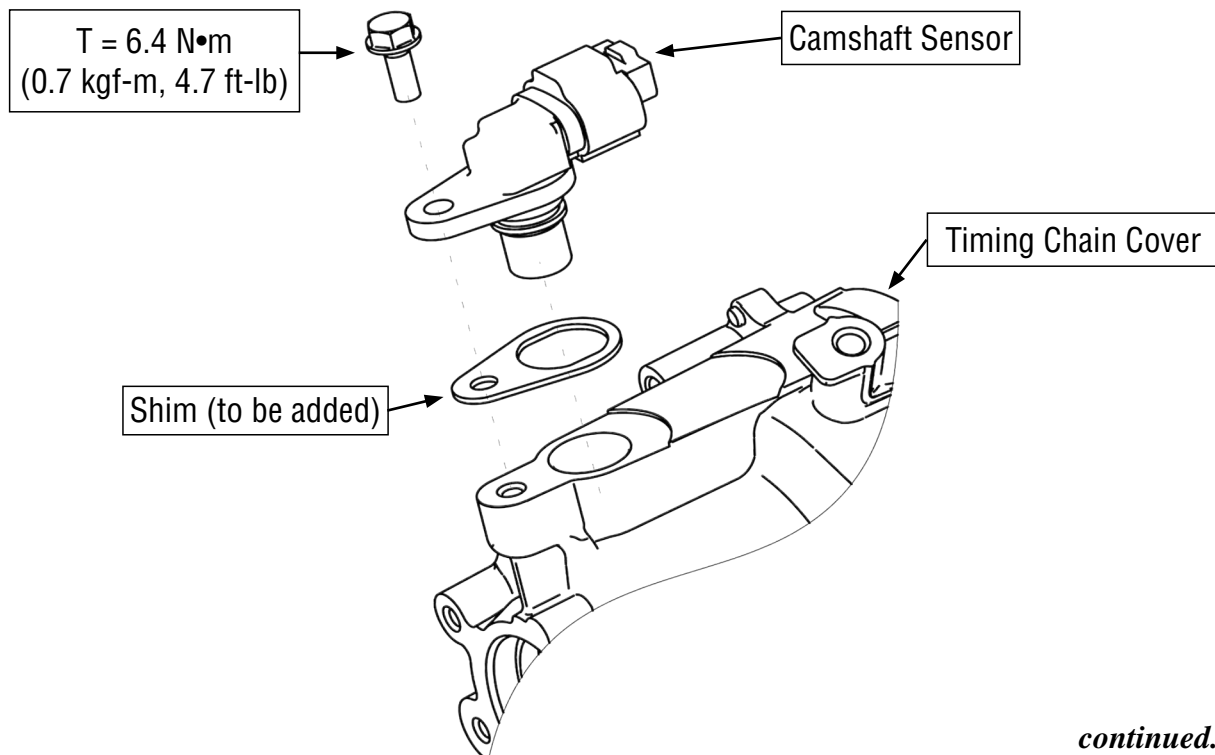
The specified clearance is 1.3 +/- .05mm (1.25 to 1.35mm or .049" to .053").

1. Record the customer's radio station presets (and navigation system favorites if applicable).
2. Disconnect the negative battery cable.
3. Remove the camshaft position sensor from the timing chain cover using the procedure in the applicable Service Manual.

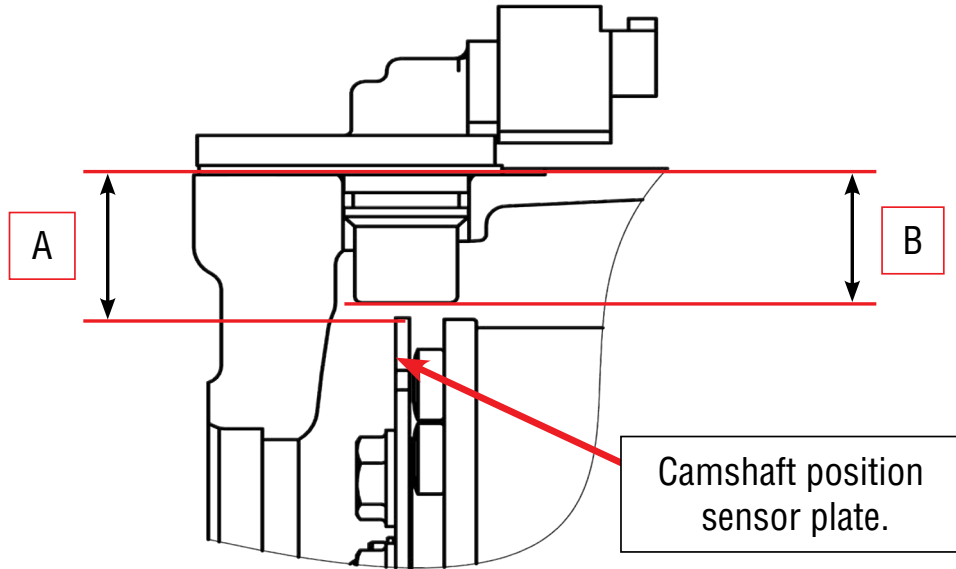
A = Top of timing chain cover to camshaft position sensor plate

B = Camshaft position sensor mating surface to the bottom of the sensor

NOTE: When measuring “A”, make sure you are measuring to the outside diameter or “top” of the sensor plate and not to the bottom of a notch as shown below. Be sure to record all measurements.

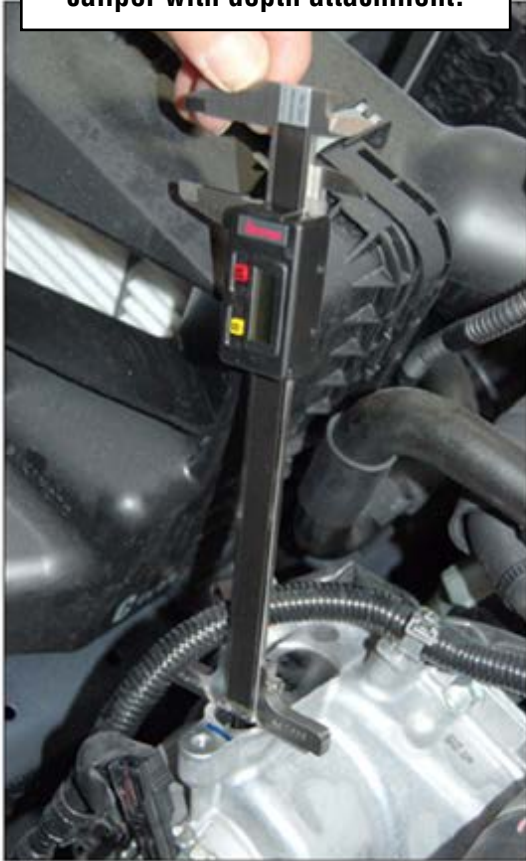
Measurement taken using digital caliper with depth attachment.

1. Take a measurement and record the reading.
2. Using a breaker bar and 22mm socket, place the socket on the crankshaft pulley bolt and rotate the engine clockwise approximately 70°. **CAUTION:** Do not rotate the engine counter-clockwise, doing so will loosen the crankshaft pulley bolt. If the engine is accidentally turned counter-clockwise make sure the bolt is re-torqued following the proper procedure in the applicable Service Manual.
3. Take a measurement and record the reading.
4. Rotate the engine clockwise approximately 70°.
5. Take a measurement and record the reading.
6. Use the smallest of the three measurements and record the result.

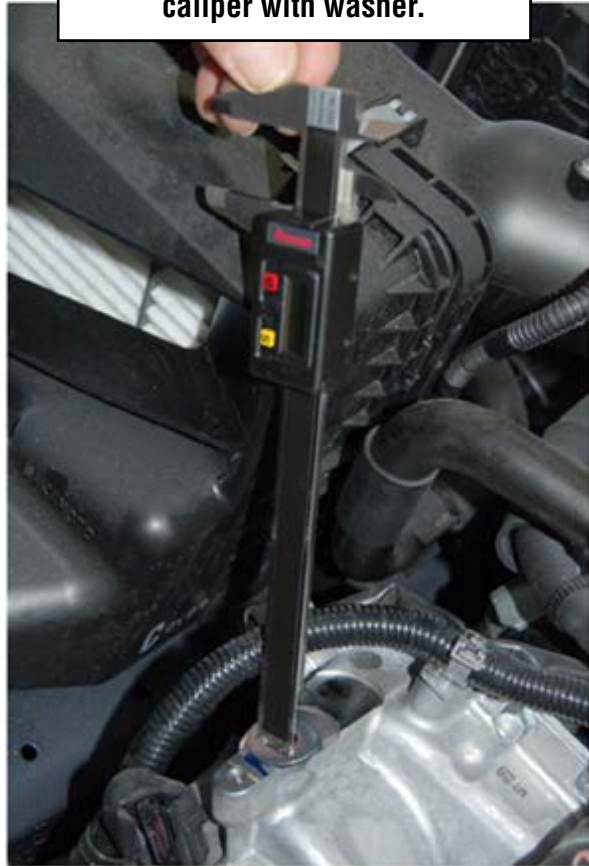
Measurement taken using digital caliper with washer.

IMPORTANT: When using the flat washer, make sure the washer is fully seated on the machined surfaces of the timing cover or your measurements will not be accurate.

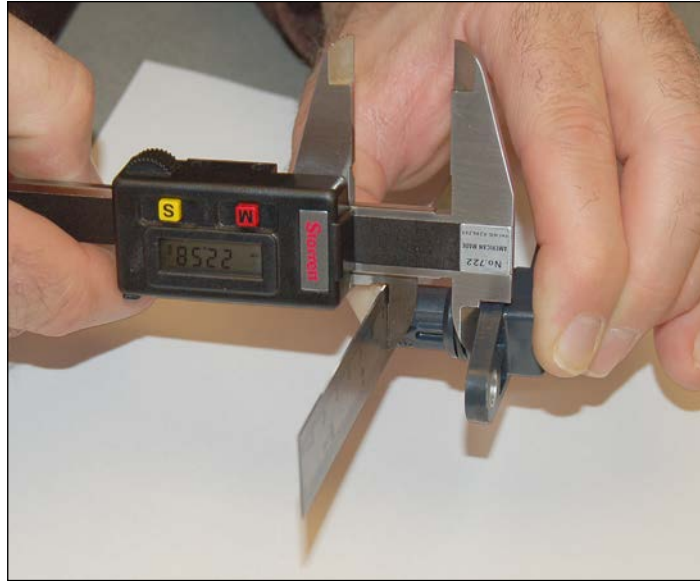
When taking measurement “B”, use a flat steel ruler or equivalent along with the digital caliper.

7. Measure the distance between the camshaft position sensor mounting surface and the bottom of the sensor as shown above.

IMPORTANT: Be sure to account for the thickness of the flat washer (if you are using one) when performing your calculations to determine the required shim thickness.

8. After the correct shim is selected and a normal oscilloscope pattern has been verified:
 - a. Install a NEW camshaft position sensor o-ring (one-time use item).
 - b. Reinstall the camshaft position sensor and shim.
 - c. Torque the sensor retaining bolt to 6.4 Nm (4.7 ft. lbs. or 56.4 inch-pounds).
 - d. Reconnect the sensor engine wiring harness connector.
 - e. Reconnect the negative battery cable then reset the radio station presets (and navigation system favorites if applicable) to complete the repair.
