# Technical Service Bulletin

## 28G6 UPDATE – Ignition Coils (NVLW)

Model(s)	Year	VIN Range	Vehicle-Specific Equipment
A4	2010-2013	See Campaign/Action screen in ElsaWeb	2.0L Engine
A5/A5 Cab	2010-2013		2.0L Engine
A6	2013		2.0L Engine
Q5	2011-2013		2.0L Engine

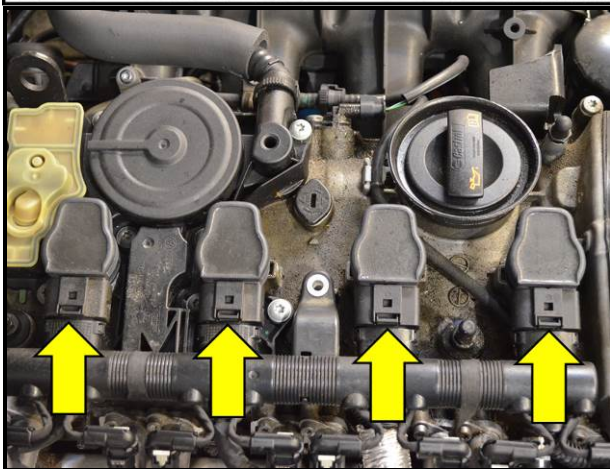
**WARNING: DO NOT** use a screwdriver, prybar, etc. to disconnect the electrical connectors. This can result in damage to the plastic connector housing. Damage to these connectors will not be covered under this action.

- ⇐ Carefully disengage the locking tab on each ignition coil connector <arrows>.
