Subject: Limited Service Campaign (LSC) D0N
Certain 2011 – 2012 Model Year Highlander Hybrid Vehicles
Rear Driveshaft Assembly Replacement

TECHNICAL INSTRUCTIONS
FOR
LIMITED SERVICE CAMPAIGN D0N
REAR DRIVESHAFT ASSEMBLY REPLACEMENT
CERTAIN 2011-2012 MODEL YEAR HIGHLANDER HV

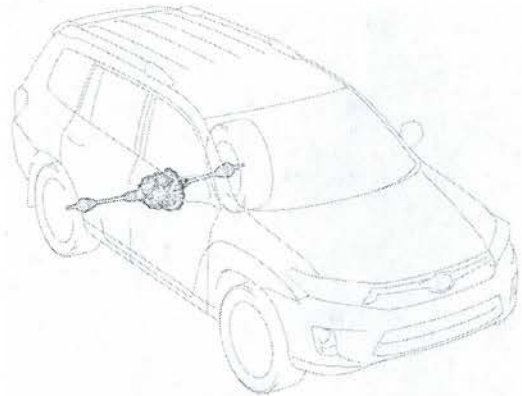
Due to an assembly error during manufacturing, the Rear Driveshaft in certain 2011-2012 Model Year Highlander Hybrid vehicles can disengage from its inboard joint assembly. If this occurs, the driveshaft could vibrate and rattle inside the inboard joint, causing a loud noise from the rear of the vehicle while driving. Continuing to drive the vehicle can damage the housing of the Rear Differential Motor. If the housing is damaged, the entire differential motor would also require replacement.

Authorized Toyota dealerships are requested to inspect and replace the Rear Driveshaft Assemblies (both right and left) at **NO CHARGE** to the vehicle's owner. If the dealership determines that the driveshaft has disengaged from the inboard joint assembly, the Rear Differential Motor assembly will be replaced at **NO CHARGE** to the vehicle's owner.

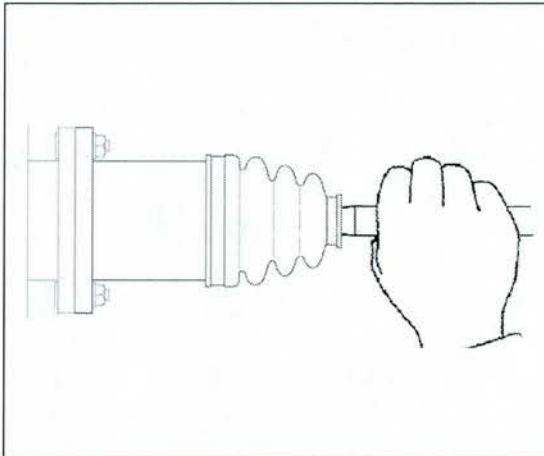
VI. INSPECT THE REAR DRIVESHAFT ASSEMBLY

1. INSPECT THE REAR DRIVESHAFT ASSEMBLY FOR DISENGAGEMENT

- a) Approximately one inch from the inner rubber boot, firmly grab the metal portion of the driveshaft.
- b) Move the driveshaft assembly from side to side and up-and-down. If the driveshaft moves excessively, the inner bearing has disengaged from the shaft.

NOTE: Disengagement of the driveshaft may cause damage to the inside of the rear differential motor. If either driveshaft is found to be disengaged, replacement of the rear differential motor is required.

Results	ACTION REQUIRED
BOTH Driveshafts Engaged OK	REPLACE THE REAR DRIVESHAFT ASSEMBLY Both drive shafts must be replaced. Proceed to section VII
One or both shafts disengaged NG	REPLACE THE REAR DIFFERENTIAL MOTOR ASSEMBLY AND REAR DRIVESHAFT ASSEMBLY. The rear differential motor assembly AND both driveshafts must be replaced. Proceed to Section VIII

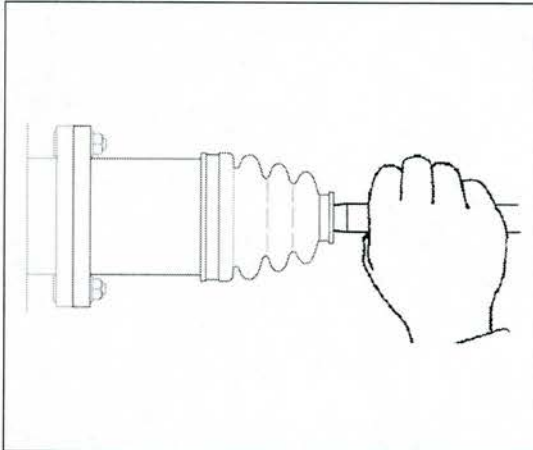
1. INSPECT THE REAR DRIVESHAFT ASSEMBLY FOR DISENGAGEMENT

- a) Approximately one inch from the inner rubber boot, firmly grab the metal portion of the driveshaft.
- b) Move the driveshaft assembly from side to side and up-and-down. If the driveshaft moves excessively, the inner bearing has disengaged from the shaft.

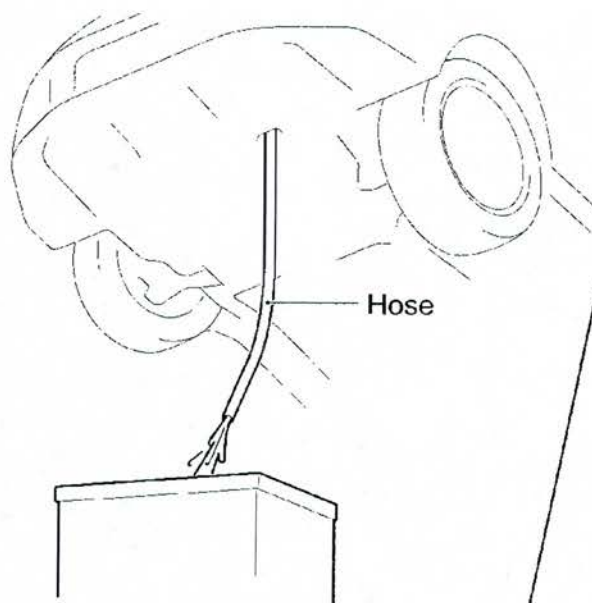
Radiator side:

Reusable

- Confirm the coolant is not hot before beginning any work.
- The coolant drained from the radiator must be reused, confirm that a clean container is used when draining the coolant.
- **DO NOT** reuse any coolant that is drained when disconnecting the coolant hoses by the exhaust gas control actuator, this coolant may be contaminated when drained.
- **DO NOT** mix the coolant drained from the radiator with the coolant drained from the hoses.

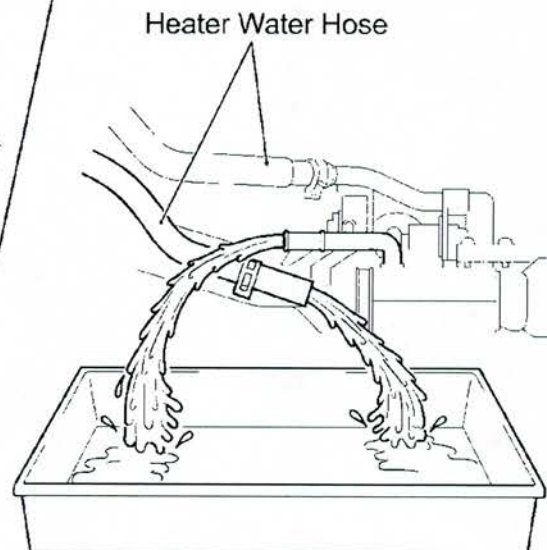
Exhaust heat recirculation system side:

Non-reusable
