**SB-10054723-3282**

**Title:** Horton VMaster Ultra (Stratis) Viscous Fan Hub Diagnostics and Troubleshooting Guide

**Applies To:** ProStars, LoneStars, WorkStar, TranStar, IBB

This article is a Troubleshooting Guide for the Horton VMaster Ultra (Stratis) Viscous Fan Drive.

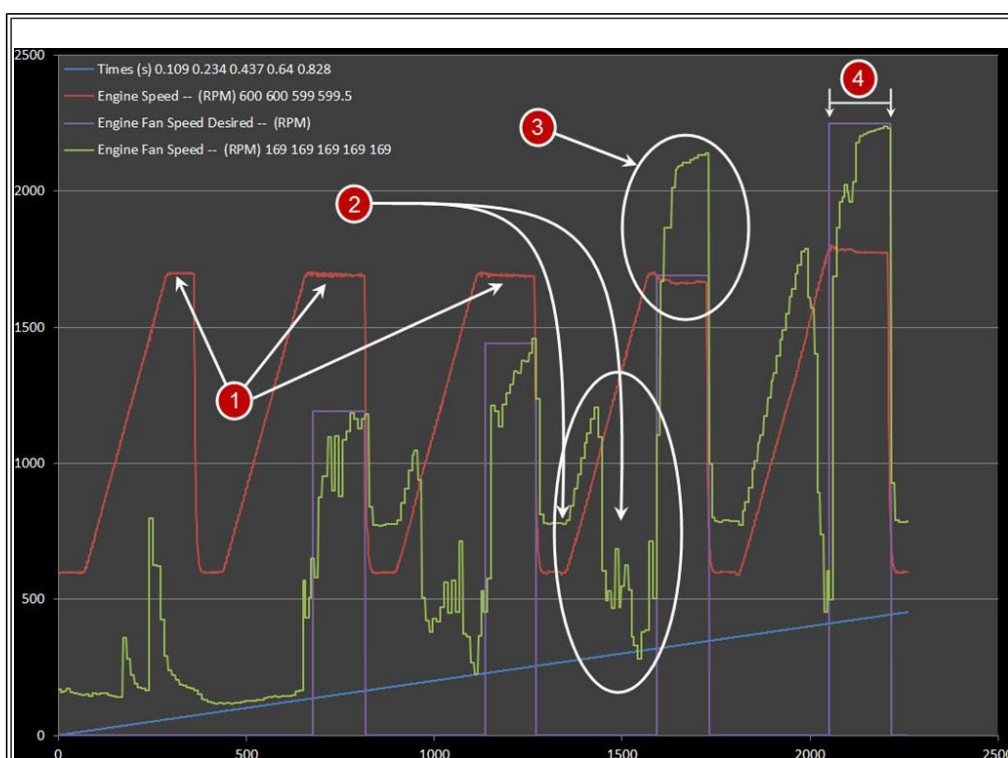
**Figure 8 - Properly Working Fan Hub Assembly**

1. The engine ramps to the same speed for each section of the test.
2. When the ECM is no longer requesting a set fan speed, the fan disengages. However, as the engine ramps to start the next section of the test, the fan speed increases. This is normal due to the viscous characteristics of the fan hub. As the fan hub stabilizes you see the fan speed then continues to decrease.
3. This section of the test shows the fan speed higher than the desired fan speed. This is due to engine speed and desired speed being very similar values. The fan is then commanded ON, and the fan speed is 125% of desired. This is normal.
4. This is showing the duration of the fan on command. Notice in each section the fan does not match up and perfectly align. This is due to the PWM (Pulse Width Modulated) signal that is being sent to the fan hub.

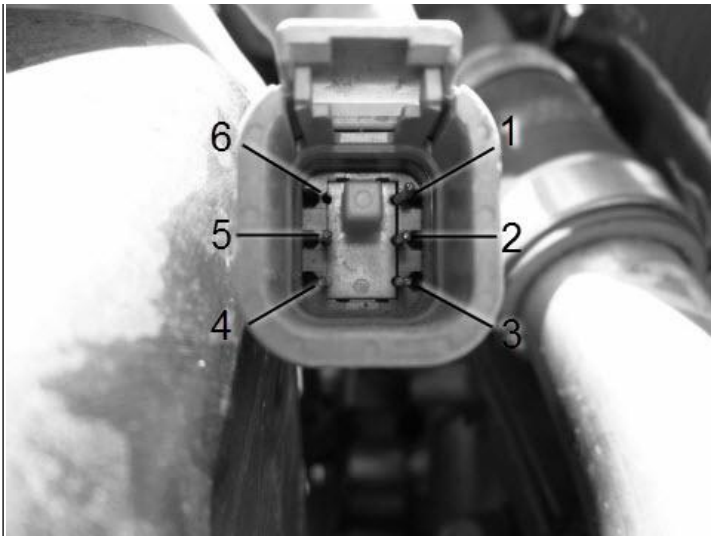
**Figure 18 - Pin Location Map (Front View)**

- 1. Brown Wire
- 2. Red Wire
- 3. Grey Wire
- 4. Blue Wire
- 5. Green Wire
- 6. Empty

13. Install wires into terminals in fan clutch harness connector following pin location map (*Figure 18*).
