**SB-10054723-6187**

**Title: Horton VMaster Ultra (Stratis) Viscous Fan Hub Diagnostics and Troubleshooting Guide**
**Applies To: ProStars, LoneStars, WorkStar, TranStar, IBB**
**CHANGE LOG**

This article is a Troubleshooting Guide for the Horton VMaster Ultra (Stratis) Viscous Fan Drive.

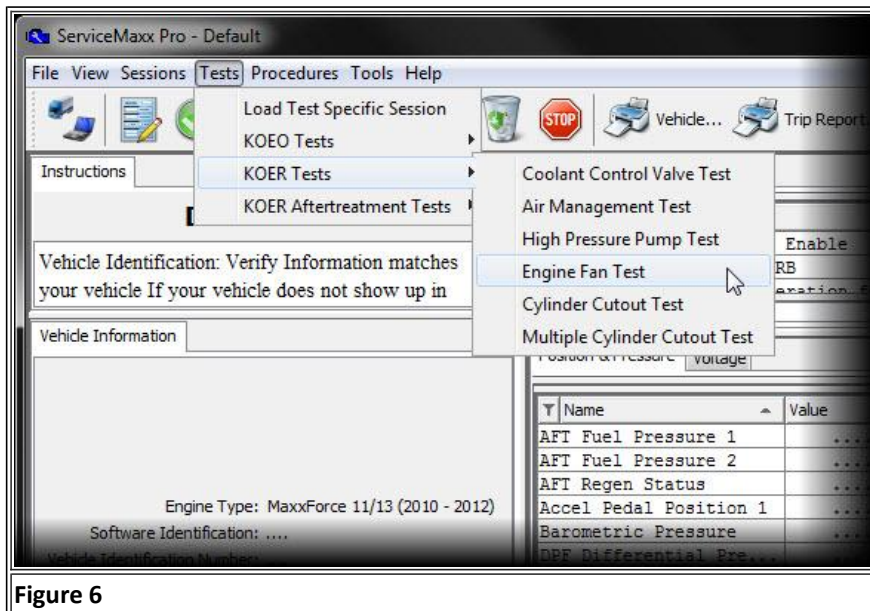
Figure 6

1. Manually apply 12 volts to Pin 3 and Ground to Pin 1, checking fan operation. It should be disengaged. Some surging may be normal depending on the temperature of the fan hub.
2. Bring engine to operating temperature. 175°F-180°F.
3. Connect with ServiceMaxx and perform "Engine Fan Test" (Figure 6).
4. The entire test (5 test points) must be recorded and submitted with the warranty claim (Figure 7).
5. If the visual, electrical and functional tests all check OK, the fan hub is not the cause of the customer complaint. **Do NOT** replace the fan hub.

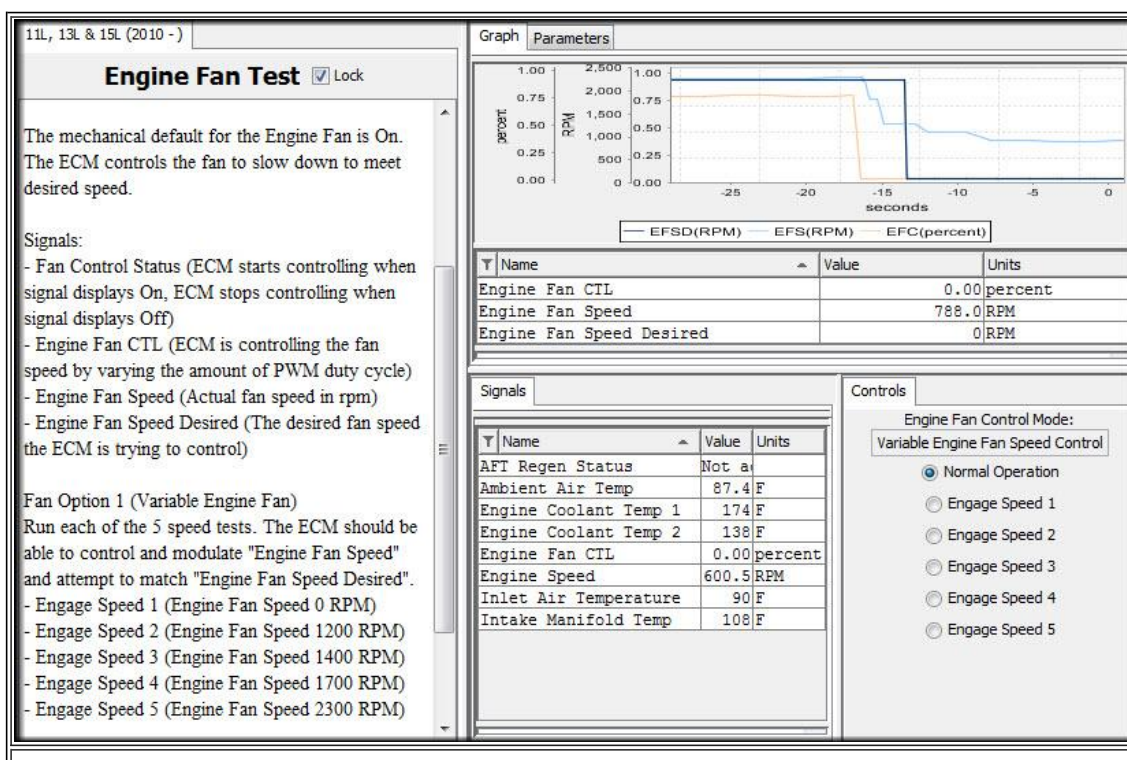
**Figure 7****Engine Fan Test Results:**

1. You will need to monitor the entire fan test while it is running to determine if the fan has passed or failed.
2. The fan needs to operate within the limits at each test point. The fan should engage and remain engaged during the entire engagement request.
3. The actual fan speed should be approx  $\pm 250$  RPM of desired. Some viscous properties of the fan hub may vary the results. See examples below (*Figure's 8, 9 & 10*).
4. Notice in the chart below (*Figure's 8, 9 & 10*), when the engine ramps with 0 RPM desired fan speed, the fan does pick up some speed. This is normal due to the viscous properties of the fan hub.
4. Also as Item 3 points out (*Figure's 8, 9 & 10*), the engine speed and desired fan speed nearly match. If the fan is requested on 100%, the fan may actually engage at 125% of engine speed as shown.

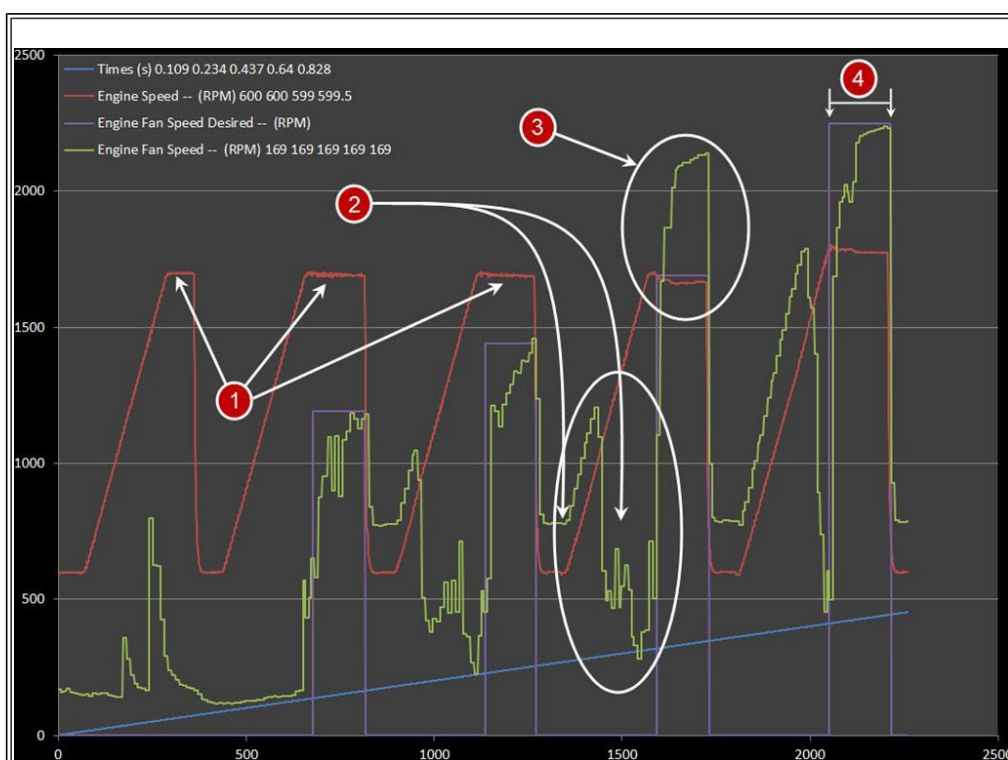
**Figure 8 - Properly Working Fan Hub Assembly**

1. The engine ramps to the same speed for each section of the test.
2. When the ECM is no longer requesting a set fan speed, the fan disengages. However, as the engine ramps to start the next section of the test, the fan speed increases. This is normal due to the viscous characteristics of the fan hub. As the fan hub stabilizes you see the fan speed then continues to decrease.
3. This section of the test shows the fan speed higher than the desired fan speed. This is due to engine speed and desired speed being very similar values. The fan is then commanded ON, and the fan speed is 125% of desired. This is normal.
4. This is showing the duration of the fan on command. Notice in each section the fan does not match up and perfectly align. This is due to the PWM (Pulse Width Modulated) signal that is being sent to the fan hub.

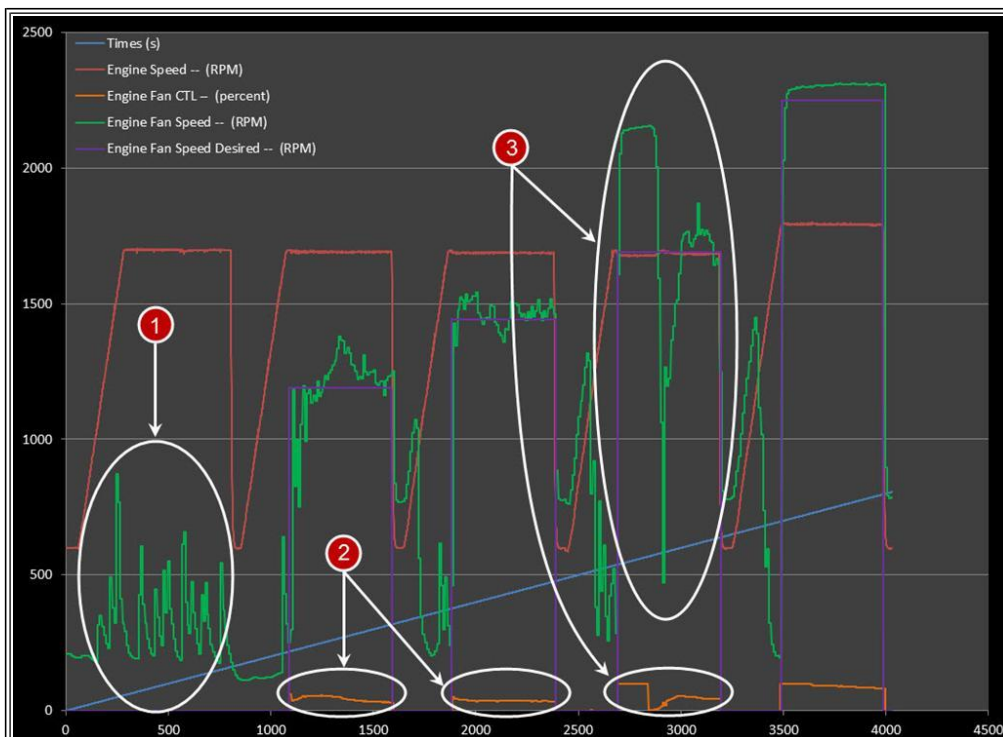
**Figure 9 - Properly Working Fan Hub Assembly (Example 2)**

1. Again, notice the fan speed varies when the engine ramps for the first time and desired fan speed is zero. This is normal due to the viscous properties of the fan hub, and is normal operation.
2. The Fan Control % has been added to this chart.
3. As stated in the chart above, due to the engine speed and desired fan speed being very similar values, the ECM commands the fan on at 98.04%. However, in this test the ECM tries to change the fan speed by changing the fan control percent. The fan control percent drops near zero to attempt to achieve this. While this is a different reaction for this portion of the test than the chart above, it is still normal operation.
  - You can review your fan test in ServiceMaxx to see a chart view of the signals shown in this chart.
  - If you have any questions of the results, attach your fan test snapshot to your case file for review.

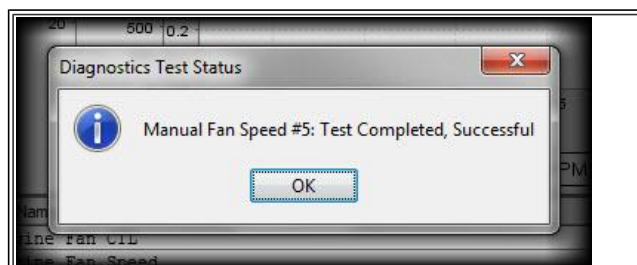
**Figure 11**

5. The "Test Completed, Successful" (*Figure 11*) window at the conclusion of the test does not indicate the fan has passed. It only indicates the test has been completed successfully. You will need to determine if the fan has passed or failed.
