## SB-10054723-7072

**Title:** Horton VMaster Ultra (Stratis) Viscous Fan Hub Diagnostics and Troubleshooting Guide

**Applies To:** ProStars, LoneStars, WorkStar, TranStar, IBB

This article is a Troubleshooting Guide for the Horton VMaster Ultra (Stratis) Viscous Fan Drive.

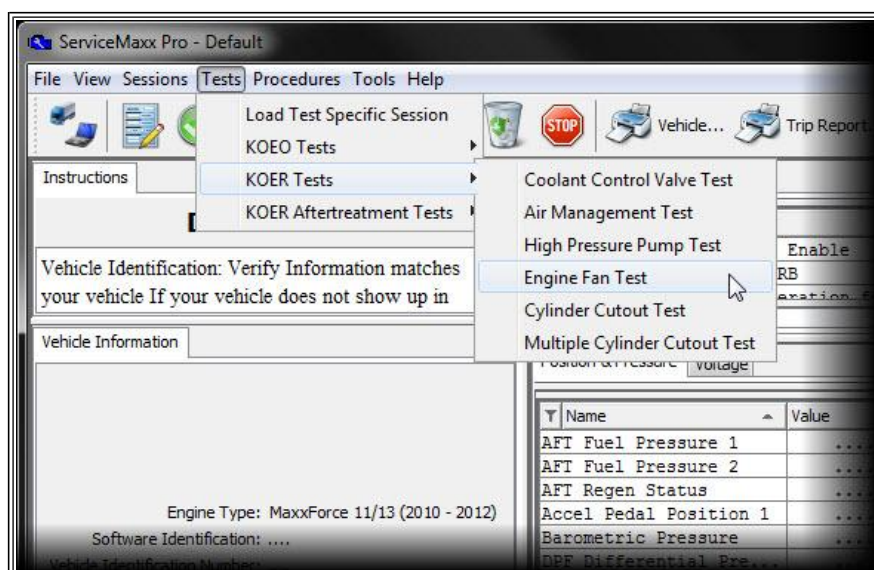
**Figure 6**

1. Manually apply 12 volts to Pin 3 and Ground to Pin 1, checking fan operation. It should be disengaged. Some surging may be normal depending on the temperature of the fan hub.
2. Bring engine to operating temperature. 175°F-180°F.
3. Connect with ServiceMaxx and perform "Engine Fan Test" (*Figure 6*).
4. The entire test (5 test points) must be recorded and submitted with the warranty claim (*Figure 7*).
5. If the visual, electrical and functional tests all check OK, the fan hub is not the cause of the customer complaint. **Do NOT** replace the fan hub.

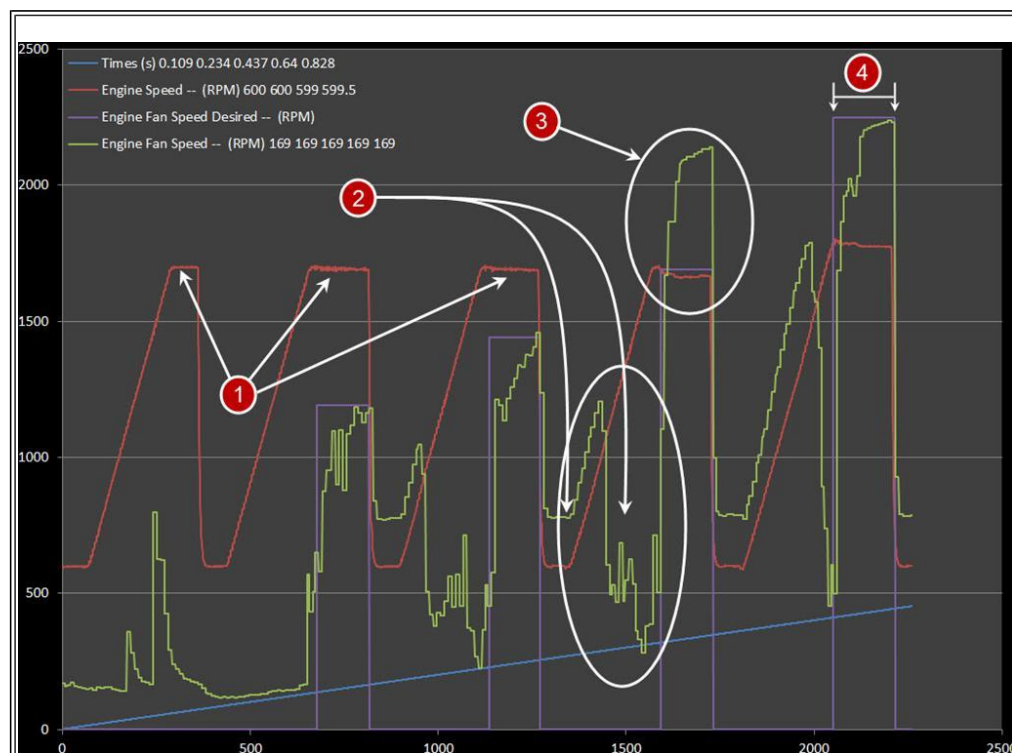
**Figure 8 - Properly Working Fan Hub Assembly**

- The engine ramps to the same speed for each section of the test.
- When the ECM is no longer requesting a set fan speed, the fan disengages. However, as the engine ramps to start the next section of the test, the fan speed increases. This is normal due to the viscous characteristics of the fan hub. As the fan hub stabilizes you see the fan speed then continues to decrease.

- This section of the test shows the fan speed higher than the desired fan speed. This is due to engine speed and desired speed being very similar values. The fan is then commanded ON, and the fan speed is 125% of desired. This is normal.

- This is showing the duration of the fan on command. Notice in each section the fan does not match up and perfectly align. This is due to the PWM (Pulse Width Modulated) signal that is being sent to the fan hub.

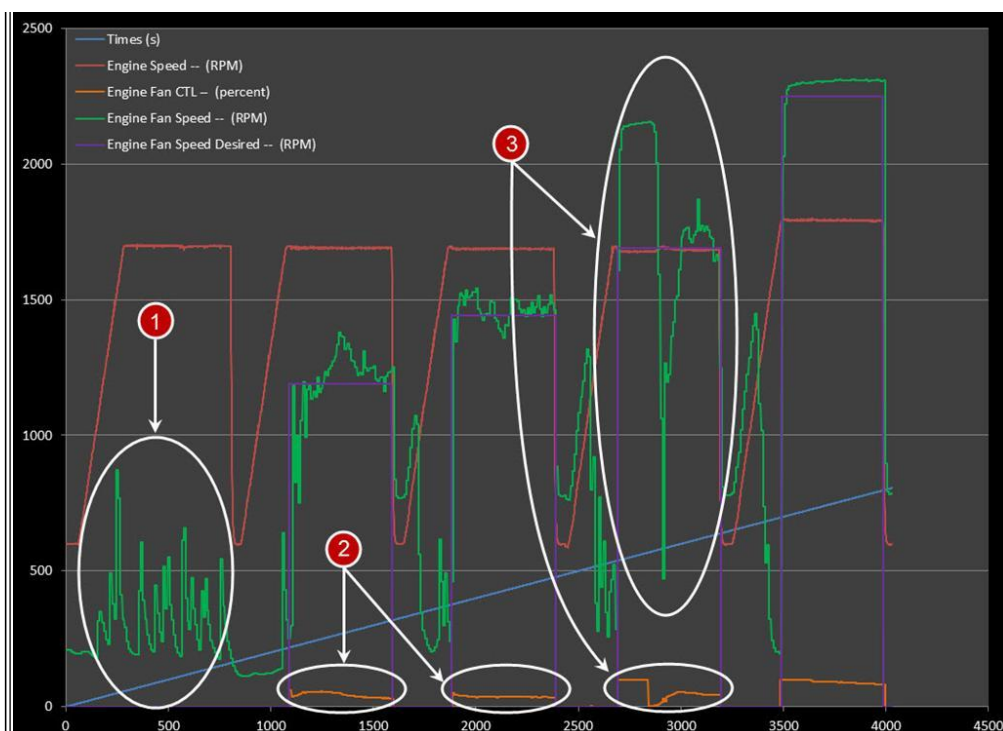
**Figure 9 - Properly Working Fan Hub Assembly (Example 2)**

- Again, notice the fan speed varies when the engine ramps for the first time and desired fan speed is zero. This is normal due to the viscous properties of the fan hub, and is normal operation.

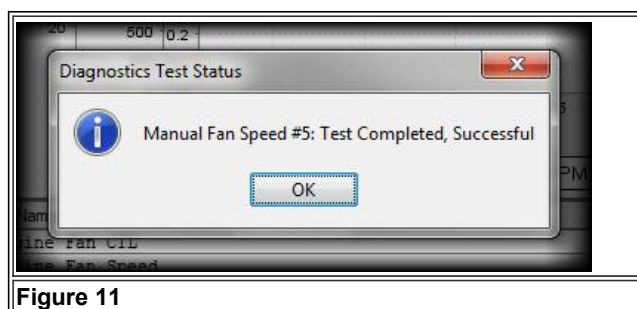
5. The "Test Completed, Successful" (*Figure 11*) window at the conclusion of the test does not indicate the fan has passed. It only indicates the test has been completed successfully. You will need to determine if the fan has passed or failed.
