SERVICE BULLETIN

EC14-002

February 14, 2014

2014 VERSA NOTE; MIL ON WITH DTC P059F STORED

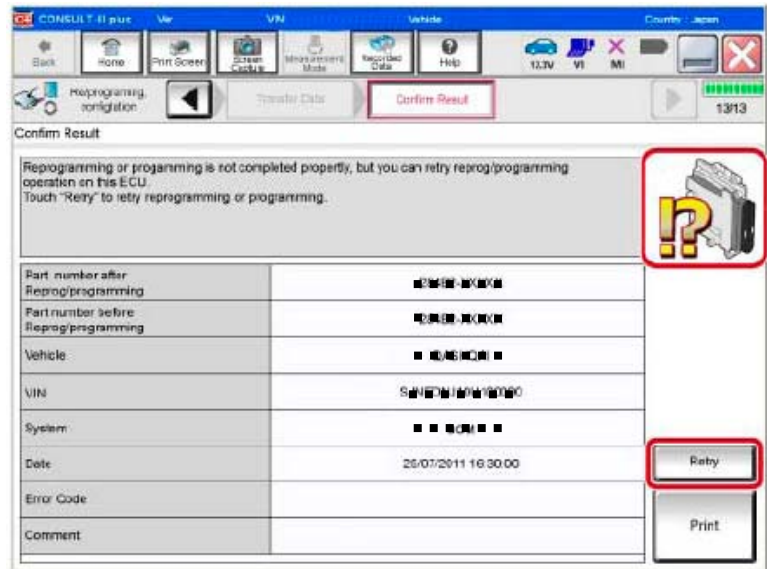
Figure 5

If reprogramming does not complete and the “!?” icon displays as shown in Figure 5:

- Check battery voltage (12.0–15.5 V).
- Ignition is ON, engine OFF.
- External Bluetooth® devices are OFF.
- All electrical loads are OFF.
- **Select retry and follow the on screen instructions.**
- “Retry” may not go through on first attempt and can be selected more than once.

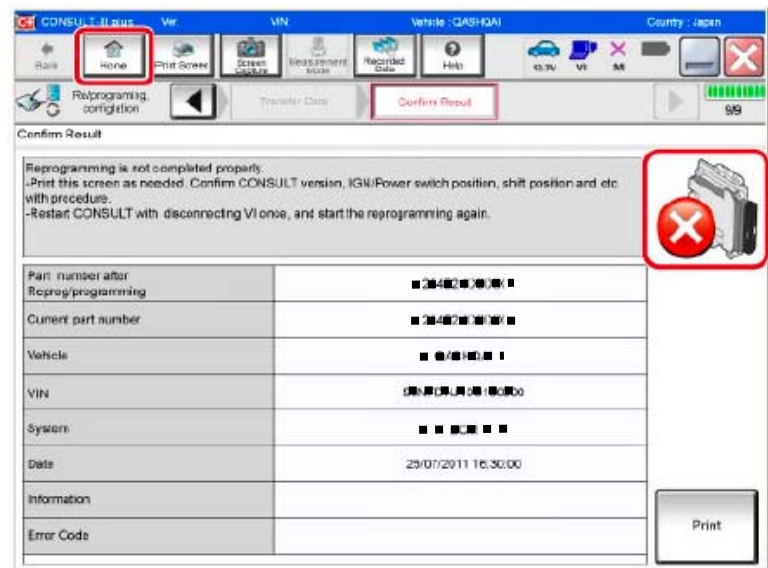
Figure 6

If reprogramming does not complete and the “X” icon displays as shown in Figure 6:

- Check battery voltage (12.0 – 15.5 V).
- CONSULT A/C adapter is plugged in.
- Ignition is ON, engine OFF.
- Transmission is in Park.
- All C-III plus / VI cables are securely connected.
- All C-III plus updates are installed.
- **Select Home, and restart the reprogram procedure from the beginning.**
