# WARRANTY BULLETIN

CAN-AM® ROADSTER

### SB-10055104-7966

Subject: **Spyder™**

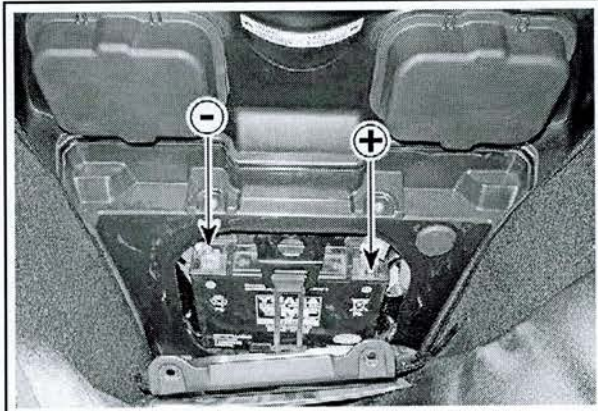
rmr2014-029-005\_c  
**CONNECTION AT BATTERY POSTS, BEHIND BATTERY ACCESS PANEL IN FRONT STORAGE COMPARTMENT**

1. Ensure the vehicle battery is fully charged.
2. Connect a portable power pack (fully charged) to the vehicle battery.

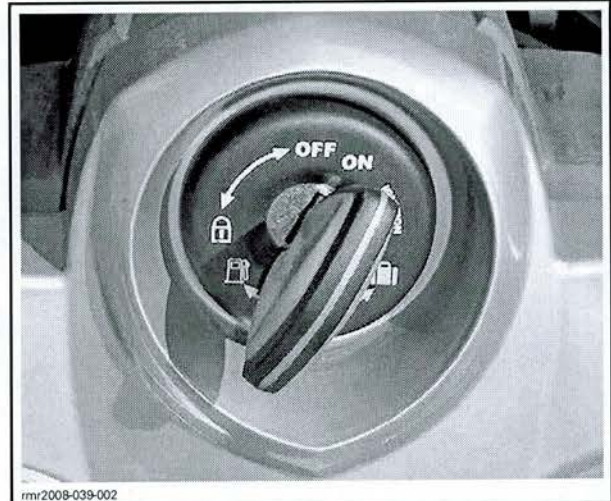
rmr2008-039-002  
**TYPICAL - IGNITION KEY ON**

2. Start B.U.D.S. and logon.
3. Turn ignition key ON.

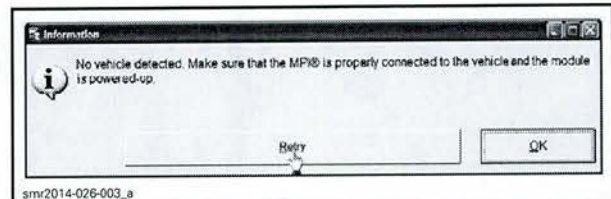
smr2014-026-003\_a  
**RETRY BUTTON**

**NOTE:** If the following message does not automatically go away, click the Retry button.

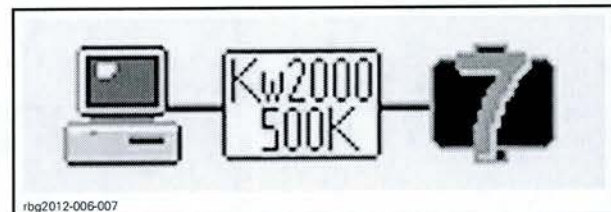
rbg2012-006-007  
**EXAMPLE**

Compare number of modules shown in B.U.D.S. with following table.

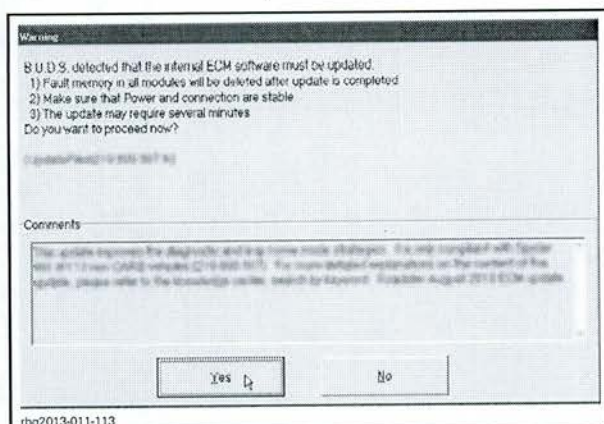
ECM UPDATE CONFIRMATION - CLICK "YES"

2. When the following message appears, click "Yes" to start the update.

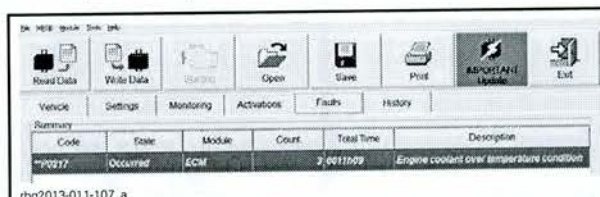
ECM SOFTWARE UPDATE REMINDER

NOTE: The following top menu button will continue to flash until the ECM software update is performed.

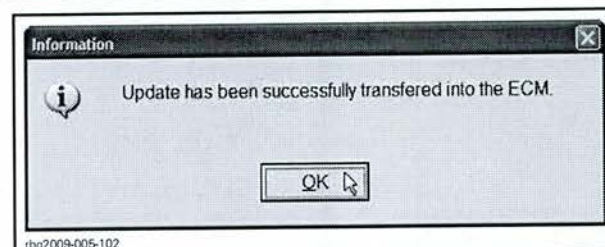
SUCCESSFUL ECM UPDATE CONFIRMATION - CLICK "OK"

**NOTICE** While the ECM is being updated, an hour glass will appear on the computer. The computer screen and cluster might also go blank. DO NOT TOUCH ANYTHING (PC and vehicle) until the following message appears. Then, click the "OK" button.

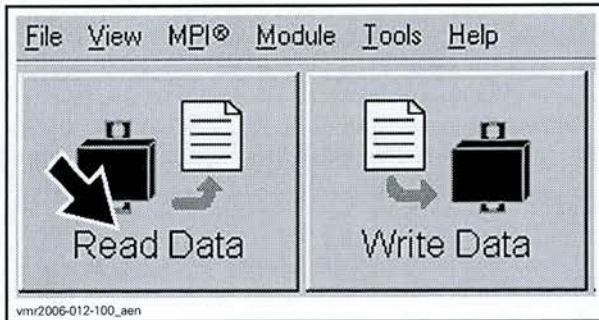
READ DATA BUTTON

1. Click on Read Data button.

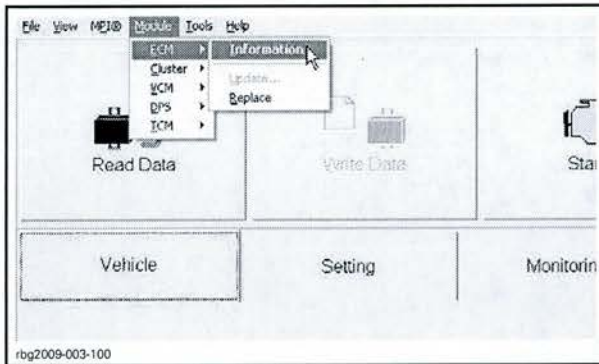
MODULE, ECM, INFORMATION

2. Check if the update has been successful.

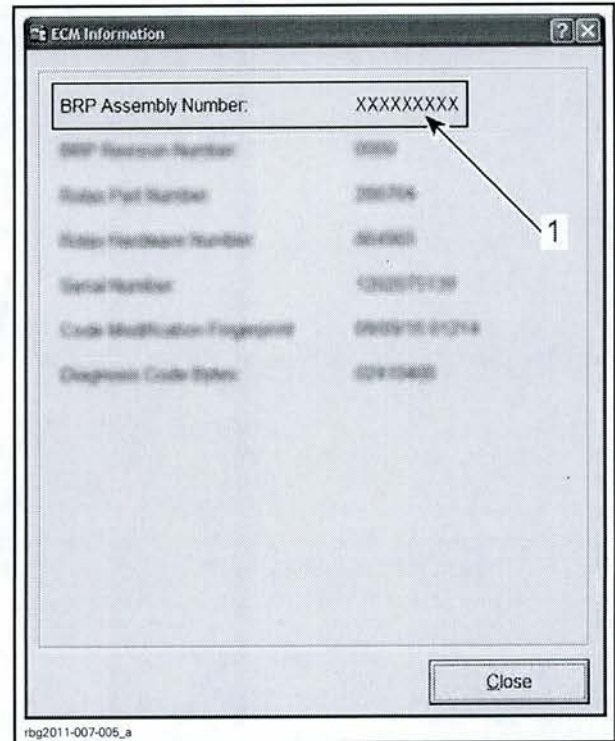
TYPICAL  
1. BRP Assembly number

3. Look at the "BRP Assembly Number", compare with list in table.

4. If any number in the table is found in B.U.D.S., then the update was successful.

5. If a wrong number is found, repeat the update procedure.

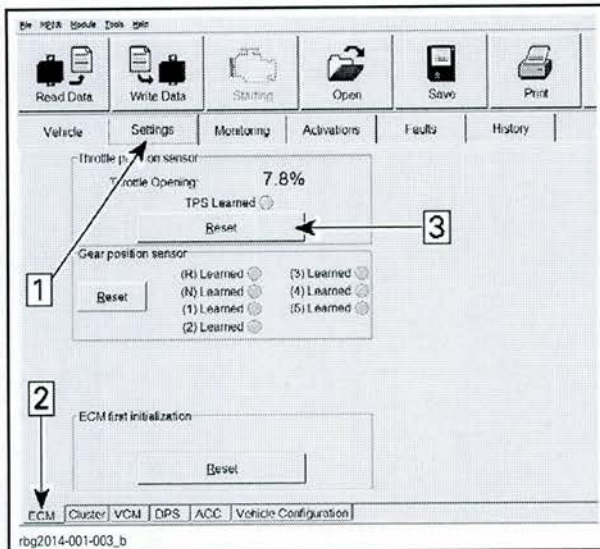
Step 1: Setting tab  
 Step 2: ECM tab  
 Step 3: Reset (TPS)

1. In B.U.D.S., click the items in the illustrated order.

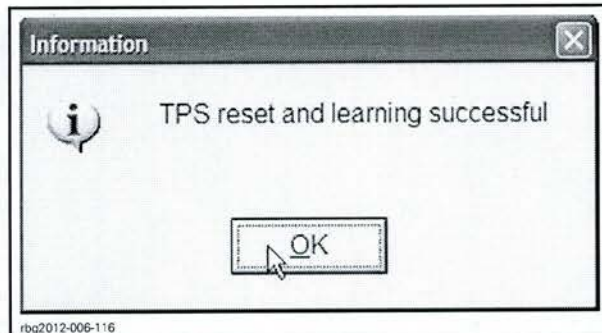
CLICK "OK"

2. When the following message appears, click "OK".

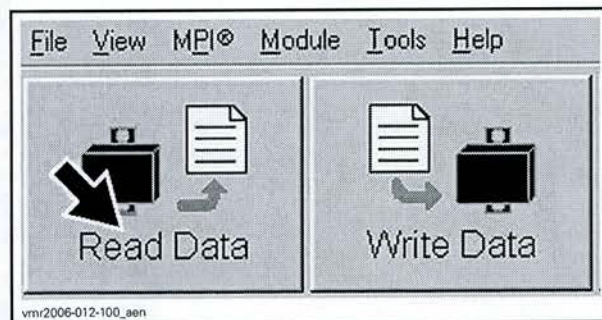
READ DATA BUTTON

1. In B.U.D.S., click on Read Data.

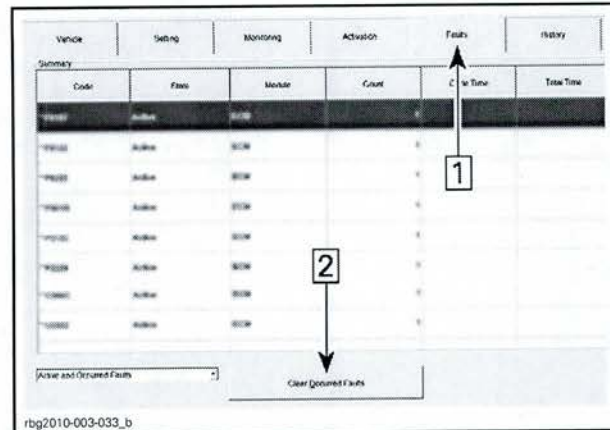
### CLEARING FAULTS

Step 1: Faults

Step 2: Click "Clear Occurred Faults" button

2. Click the items in the illustrated order.

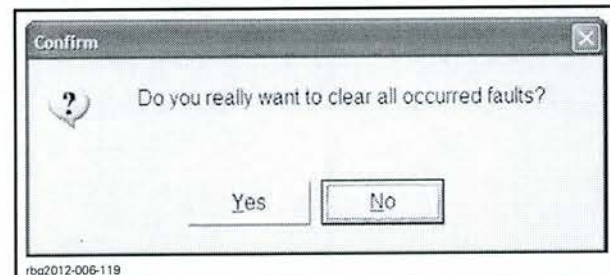
CONFIRM CLEAR FAULTS REQUEST - "YES"

3. When the following message appears, click "Yes".

NOTE: To clear all faults, it may be necessary turn the ignition key OFF, wait a few seconds, turn the ignition key back ON and activate the Clear Occurred Faults button once more.
